Zeitschrift: **Swiss bulletin für angewandte Geologie = Swiss bulletin pour la géologie appliquée = Swiss bulletin per la geologia applicata = Swiss bulletin for applied geology**

# Ground improving injections underneath historical buildings: five case histories as an overview of a technique

Valentina Berengo<sup>1</sup>

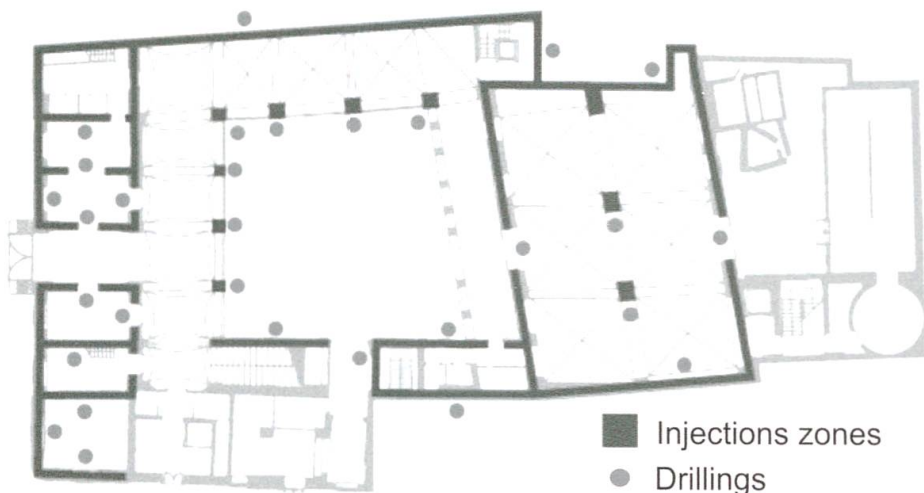
Fig. 2: Above: foundation survey at Palatium Vetus. Below: survey and intervention map.

bished and enlarged so many times that the soil stress state has changed under the foundation system. The final configuration is constituted by only one body with two levels, lying on several types of foundations. To investigate the foundation system a series of drillings were performed. A manual boring machine was used (max energy per bump: 12-14 Joule, frequency: 1.200-2.800 bumps per minute), making holes of 26 mm diameter (Fig. 2). Drillings were performed along-

Fourteen different areas around the entire building were investigated (Fig. 2): walls were found to be constituted by bricks and binder with no discontinuities, the foundation base level varies from 0.5 m to 3.2 m depth and a 10-15 cm layer of crushed stones lies under the foundation system.

side the perimetral wall to identify the base level of the foundations and also at increasing distance from the wall to investigate the presence of enlargements or connecting beams among the plinths.

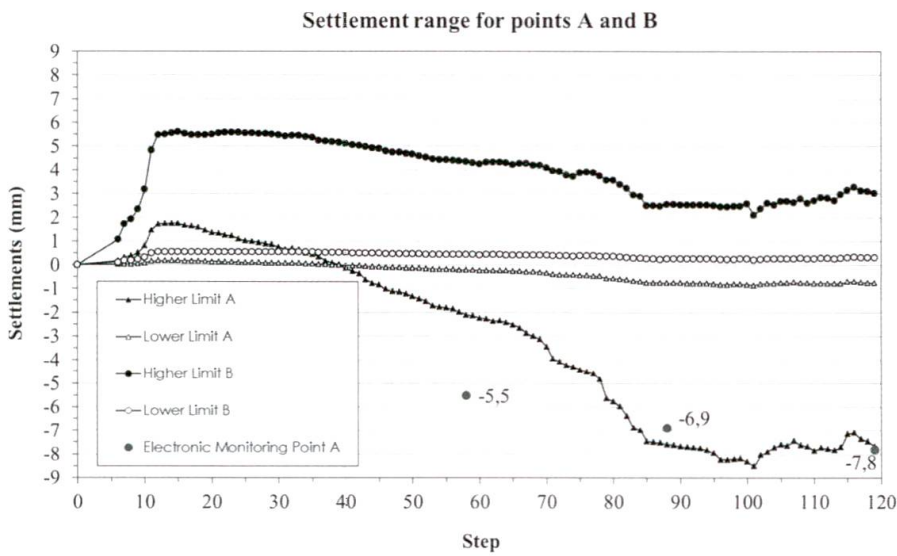
Fig. 6: Time-settlement calculated curves and real measurements at Città di Castello tower.

All throughout the work a real time electronic monitoring was operating. Fig. 6 shows how slight the differences are between the calculated time/settlement curve and the real settlement measurements after every injection phase, thus confirming the reliability of a numerical analysis that reproduces the resin injections.

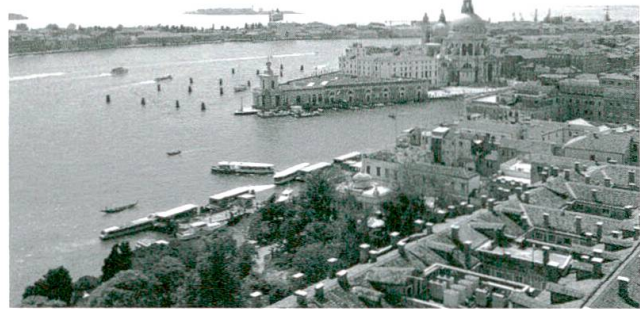
Fig. 7: Punta della Dogana view (above), map (below).

The main building has a width that varies from 16 m to 75 m and floors lie on ten brick walls, parallel to one another, as described in Fig. 7. Foundations are constituted by bricks and binder walls laying on four different substrates: directly on the soil, on a rigid shelf laid on the ground, on a shelf that lies on wooden piles or on the foundations of an existing tower. The foundation base level varies from 0.69 m to 2.84 m depending on the position.

«Punta della Dogana» is a historical place in Venice where trade occurred. The trapezium-shaped buildings were built in 1677 on the basis of the design of the architect Giuseppe Benoni (Fig. 7).

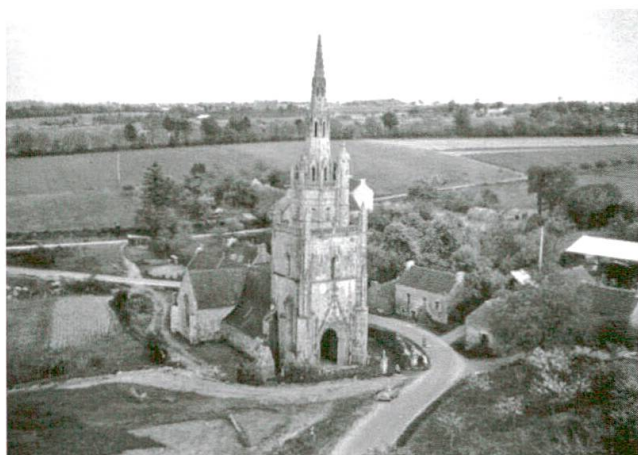
Fig. 10: Chapelle Saint Nicodème in France.

There are cases in which the soil improvement must be accompanied by a wall restoring because the structure is heavily damaged. This was the case of Chapelle Saint Nicodème in France (Fig. 10).

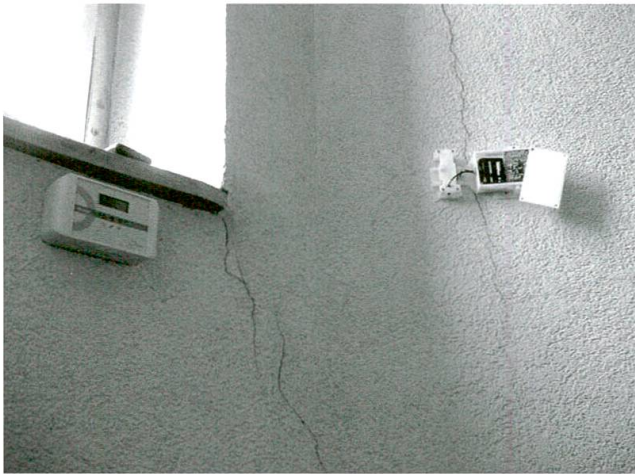
Fig. 15: Easy Crack Monitor System®.

After the intervention a monitoring system called Easy Crack Monitor System® was installed in order to check the crack stabilization. The system allows for the automated and continuous reading of any relative displacement between two lips of a lesion and/or two buildings and/or two structural elements, along two orthogonal directions. It is composed of one or more reading devices in correspondence of the lesions to be monitored and by a central acquisition and transmission of data (Fig. 15). The reading device, rigidly connected to the masonry, detects the relative displacement

between two stiff portions along two orthogonal directions at regular time intervals. The reading of the movements is made at the same point for both directions, with a precision not greater than 0.5 mm. Each system is also equipped with a temperature sensor. The control unit has the function of collecting data from several reading devices and to transmit them by means of GPRS protocol, at regular intervals, to a server for storage and display.
