Artikel: Albania Dam Safety Monitoring

Albania Dam Safety Monitoring

Michael Furrer, Max Osterried, Marialis Çelo, Hans-Jakob Becker

Abstract

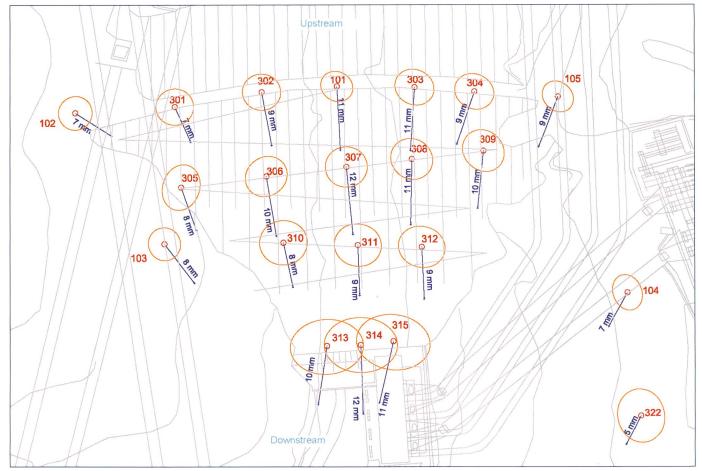
Figure 9. Fierza HPP with horizontal displacement vectors and confidence ellipses 95%.

In Fierza significant horizontal shifts towards the downstream side are recognisable. However, the displacements include a transversal component, which indicates an opening and closing of the valley cross section and a resulting influence on the dam (see *figure 9*).

The valley cross section narrows in spring by about 8 mm at a distance of about 420 m, but the uncertainty with only one measurement is high. In the meantime, the dam operator carried out a second sequence reading which confirmed this effect. The «breathing of the valleys» was already observed in Switzerland during the permanent monitoring related to AlpTransit Gotthard [1], [2]. There a continious series of measurements over several years is available and the validity of the results is much higher. It is interesting that in Albania, this effect is evident only in Fierza, which is probably related to the geology and natural fluctuation in ground water level in this area. Unfortunately the geotechnic lot had not yet been completed and therefore no data from geotechnical sensors such as piezometers were available for the period of the geodetic measurements.
