Albania Dam Safety Monitoring

Michael Furrer, Max Osterried, Marialis Çelo, Hans-Jakob Becker

This article deals with the implementation of geotechnical and geodetic monitoring systems for five hydropower dams in Albania. The dams were equipped with different automatic and manual sensor systems to improve the safety of the dams by monitoring the behaviour of the structures and their surroundings. The topography and accessibility in this wild and beautiful country presented a very special challenge.

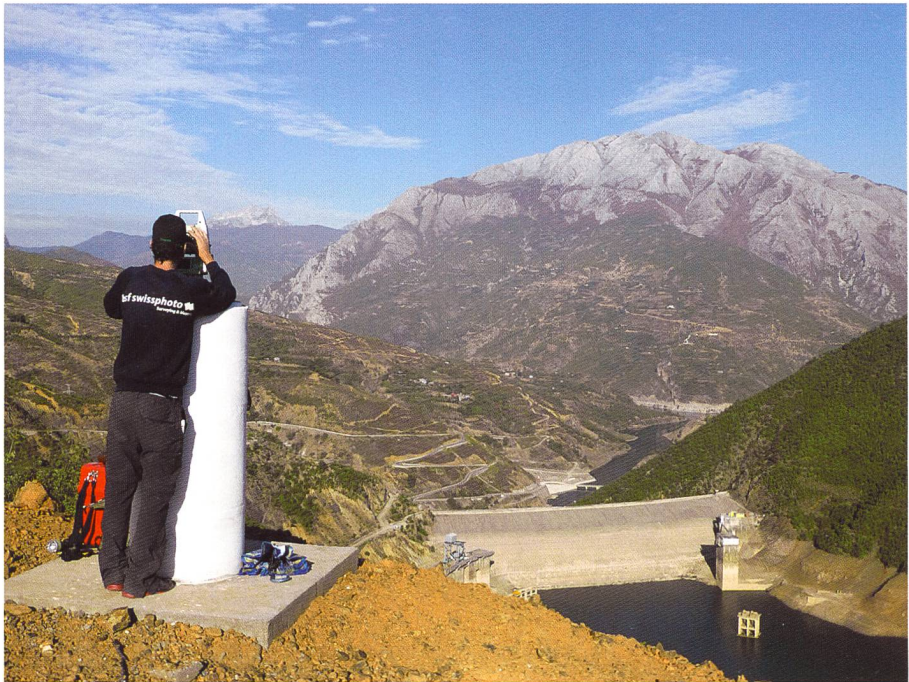
Figure 1. Geodetic Monitoring at Fierza HPP.

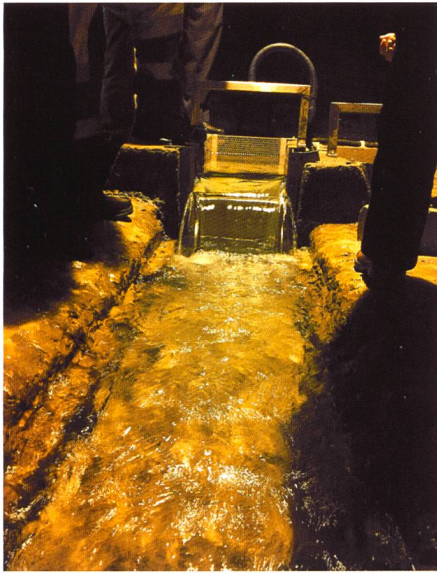
Figure 2. Automated rectangular weir measuring seepage flow inside Komani dam.

To monitor the structural integrity of the dams a three-pronged approach is used. Seepage through the dam body is monitored using automated piezometers behind the grout curtain and by collecting and measuring seepage run-off via automated V-notch weirs (see figure 2). Standpipe piezometers are used on the downstream dam face and the abutments to monitor water levels. And lastly, an automated seismic network records vibrations in a background mode and seismic events.

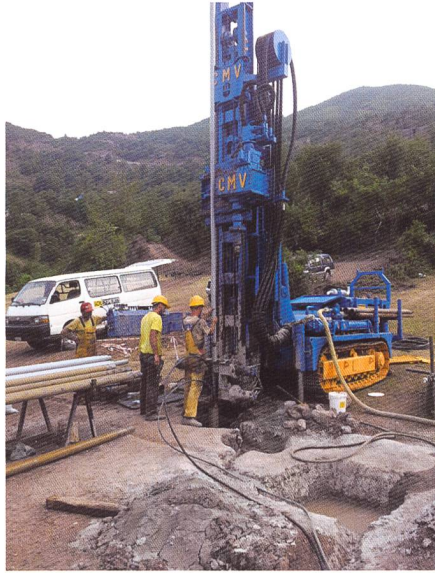
Figure 3. Drilling works for inclinometers with sub-contractors Altea Geostudio2000 at Porava.

Other measurement points include inclinometers installed in landslide areas near the dams (Fierza HPP and Komani HPP). An example is shown in figure 3 regarding the Porava landslide area near HPP Fierza. Furthermore, jointmeters and pendulums are used inside Ulza dam to monitor its deformations depending on the reservoir level.

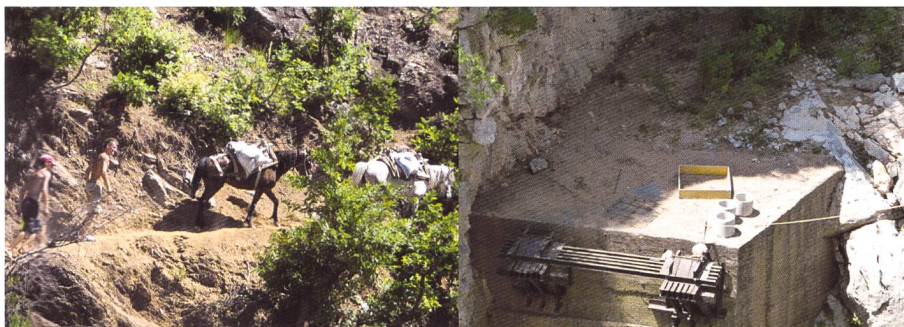
Figure 6. Transport of construction material, Mules, improvised cable cars.

The civil work for the reference points was carried out in the summer months May to September 2012 and proved to be difficult due to the topography and accessibility. Most of the locations are in steep and rocky terrain and cannot be reached by car. The construction material such as cement, gravel, water, etc. had to be transported by mules or by pretty adventurous self-made cable cars. There

we were happy to have the support of a local subcontractor who had the experience and creativity to make it happen. All the excavations were done manually (see figure 6).

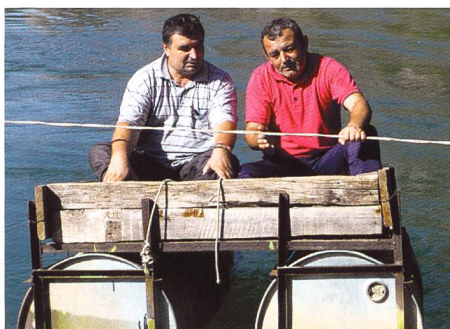
Figure 8. Improvised ferry service downstream of Shkopet HPP, Installation of object points at Ulza HPP.

The measurements were taken by a team consisting of specialists from BSF Swissphoto and KESH. Meanwhile on the job training was given. The measurements were completed within two days at each dam. Due to the difficult access and long distances between the points we were happy to have additional personnel of the hydropower plants at our disposal (see figure 8).
