Artikel: Albania Dam Safety Monitoring
Autor: Furrer, Michael / Osterried, Max / Çelo, Marialis
DOI: <https://doi.org/10.5169/seals-939754>

Albania Dam Safety Monitoring

This article deals with the implementation of geotechnical and geodetic monitoring systems for five hydropower dams in Albania. The dams were equipped with different automatic and manual sensor systems to improve the safety of the dams by monitoring the behaviour of the structures and their surroundings. The topography and accessibility in this wild and beautiful country presented a very special challenge.

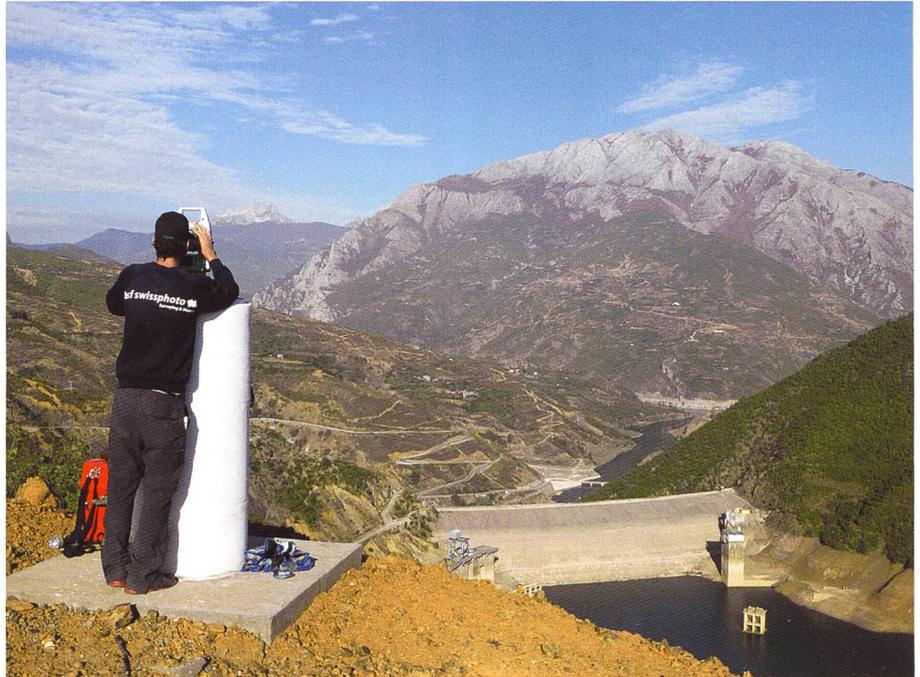
Figure 1. Geodetic Monitoring at Fierza HPP.

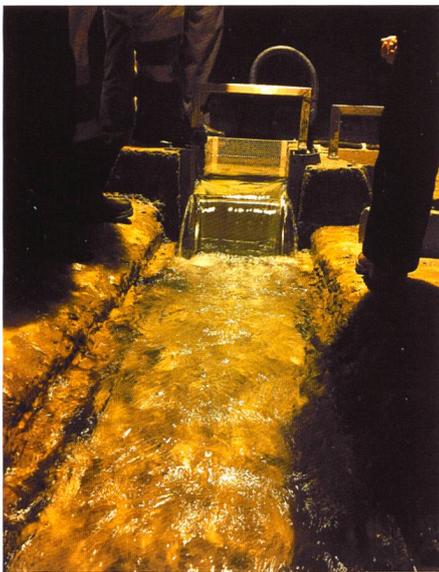
Figure 2. Automated rectangular weir measuring seepage flow inside Komani dam.

To monitor the structural integrity of the dams a three-pronged approach is used. Seepage through the dam body is monitored using automated piezometers behind the grout curtain and by collecting and measuring seepage run-off via automated V-notch weirs (see figure 2). Standpipe piezometers are used on the downstream dam face and the abutments to monitor water levels. And lastly, an automated seismic network records vibrations in a background mode and seismic events.

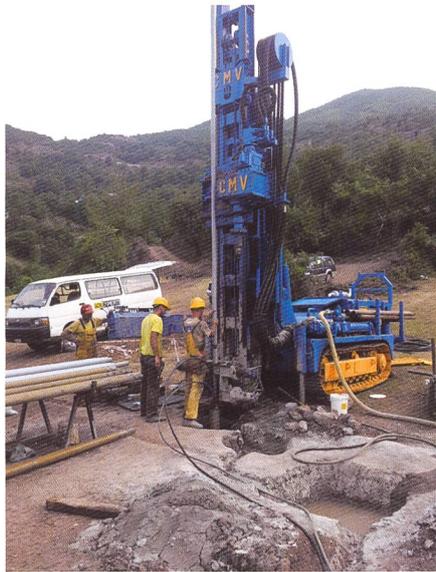
Figure 3. Drilling works for inclinometers with sub-contractors Altea Geostudio2000 at Porava.

Other measurement points include inclinometers installed in landslide areas near the dams (Fierza HPP and Komani HPP). An example is shown in figure 3 regarding the Porava landslide area near HPP Fierza. Furthermore, jointmeters and pendulums are used inside Ulza dam to monitor its deformations depending on the reservoir level.

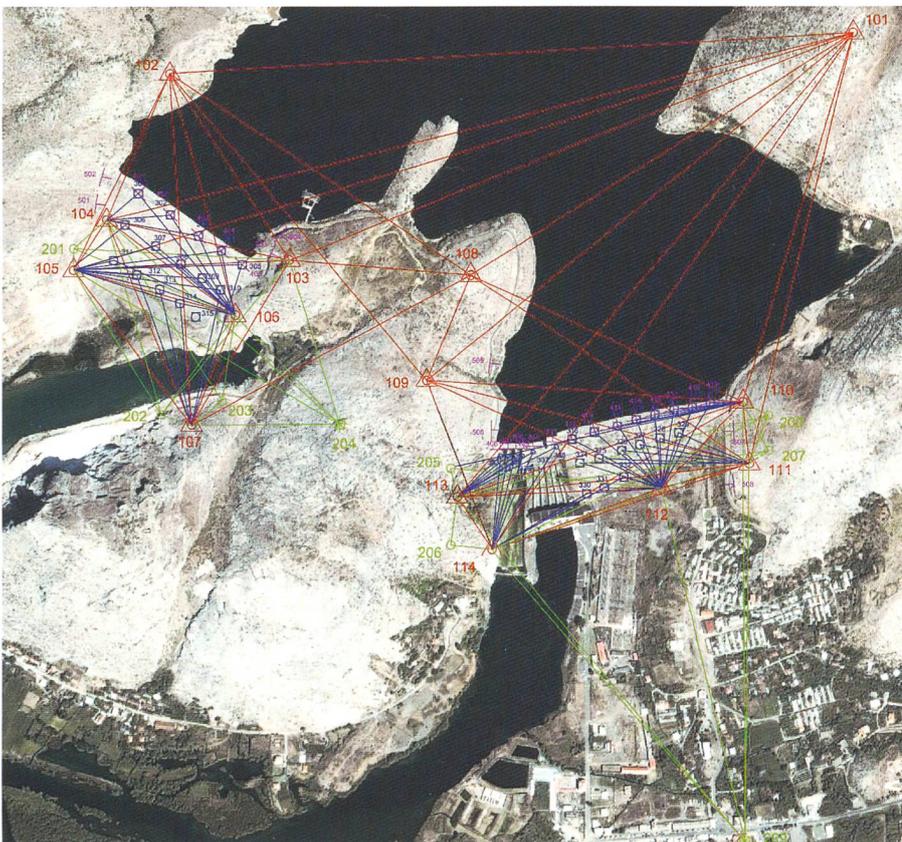
Figure 4. Geodetic Network for Vau I Dejes HPP (with Zadeje and Qyraq dams), reference points and lines of sight in red and green, object points and lines of sight in blue, levelling points and lines in purple.

The reference points were mainly built as doublewall survey pillars with centring plate and protective cover. The foundation of the pillars reaches up to 1.5 m into the soil and is wherever possible sounded in proper rock (see figure 5). Additional reference points have been mounted in the vicinity of the pillars as a back-up. Every network consists of approx. 10 pillars and 5 to 7 additional reference points (see figure 4).

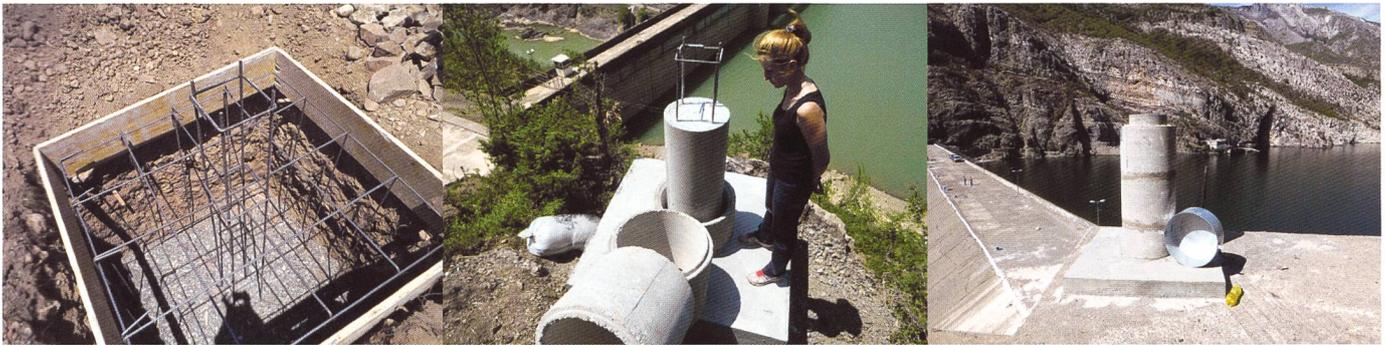
Figure 5. The construction steps of a double-wall pillar, foundation, concrete, finish.

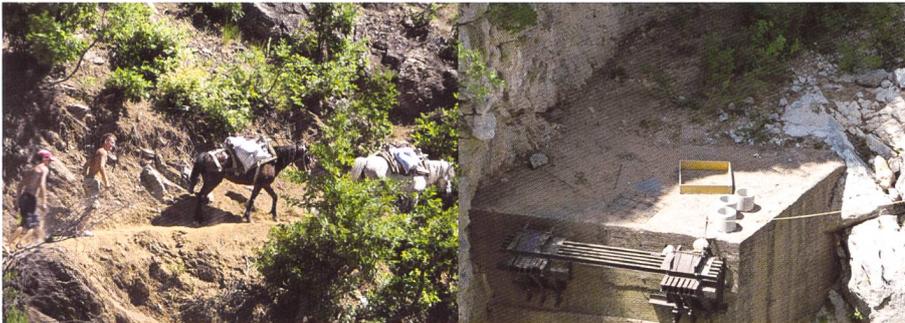
Figure 6. Transport of construction material, Mules, improvised cable cars.

The civil work for the reference points was carried out in the summer months May to September 2012 and proved to be difficult due to the topography and accessibility. Most of the locations are in steep and rocky terrain and cannot be reached by car. The construction material such as cement, gravel, water, etc. had to be transported by mules or by pretty adventurous self-made cable cars. There

we were happy to have the support of a local subcontractor who had the experience and creativity to make it happen. All the excavations were done manually (see figure 6).

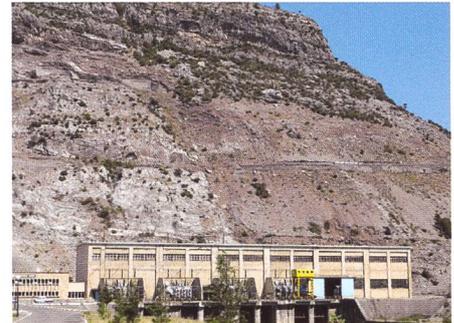
Figure 7. Powerhouse in Koman with land slide area in the background.

In Koman the rock mass above the intake and the slope above the power house proved to be very unstable and represents a serious hazard to the infrastructure (see figure 7). To monitor the move-

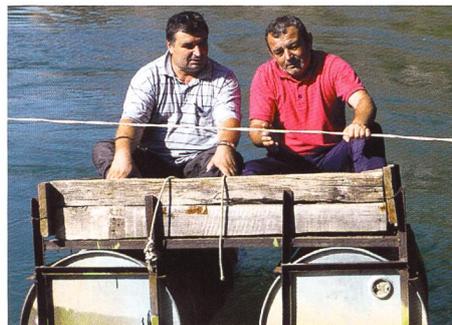
Figure 8. Improvised ferry service downstream of Shkopet HPP, Installation of object points at Ulza HPP.

The measurements were taken by a team consisting of specialists from BSF Swissphoto and KESH. Meanwhile on the job training was given. The measurements were completed within two days at each dam. Due to the difficult access and long distances between the points we were happy to have additional personnel of the hydropower plants at our disposal (see figure 8).

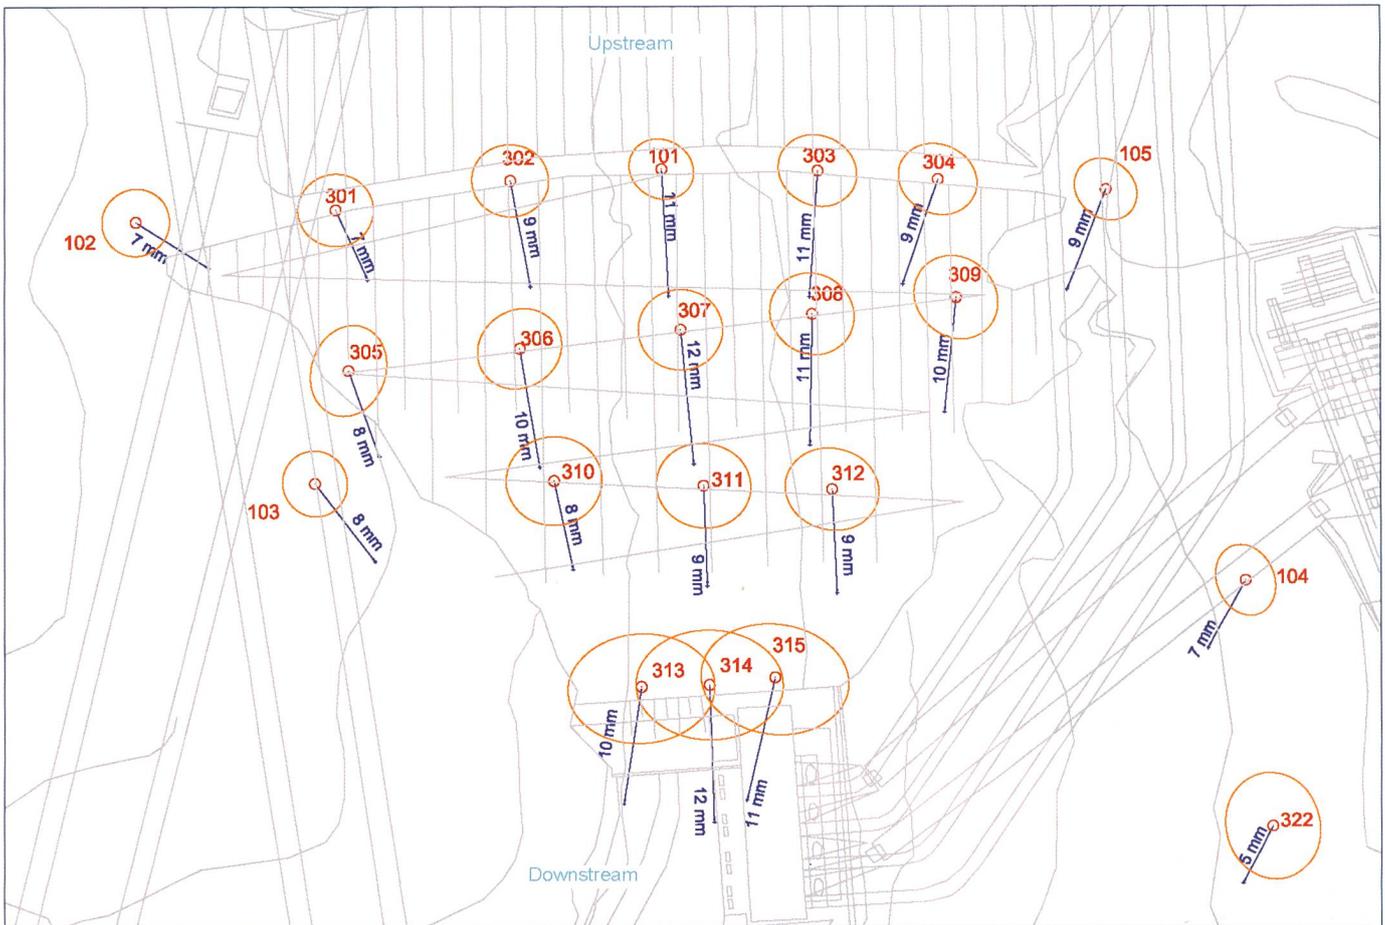
Figure 9. Fierza HPP with horizontal displacement vectors and confidence ellipses 95%.

In Fierza significant horizontal shifts towards the downstream side are recognisable. However, the displacements include a transversal component, which indicates an opening and closing of the valley cross section and a resulting influence on the dam (see figure 9).

The valley cross section narrows in spring by about 8 mm at a distance of about 420 m, but the uncertainty with only one measurement is high. In the meantime, the dam operator carried out a second sequence reading which confirmed this effect. The «breathing of the valleys» was already observed in Switzerland during the permanent monitoring related to AlpTransit Gotthard [1], [2]. There a continuous series of measurements over several years is available and the validity of the results is much higher. It is interesting that in Albania, this effect is evident only in Fierza, which is probably related to the geology and natural fluctuation in ground water level in this area. Unfortunately the geotechnic lot had not yet been completed and therefore no data from geotechnical sensors such as piezometers were available for the period of the geodetic measurements.

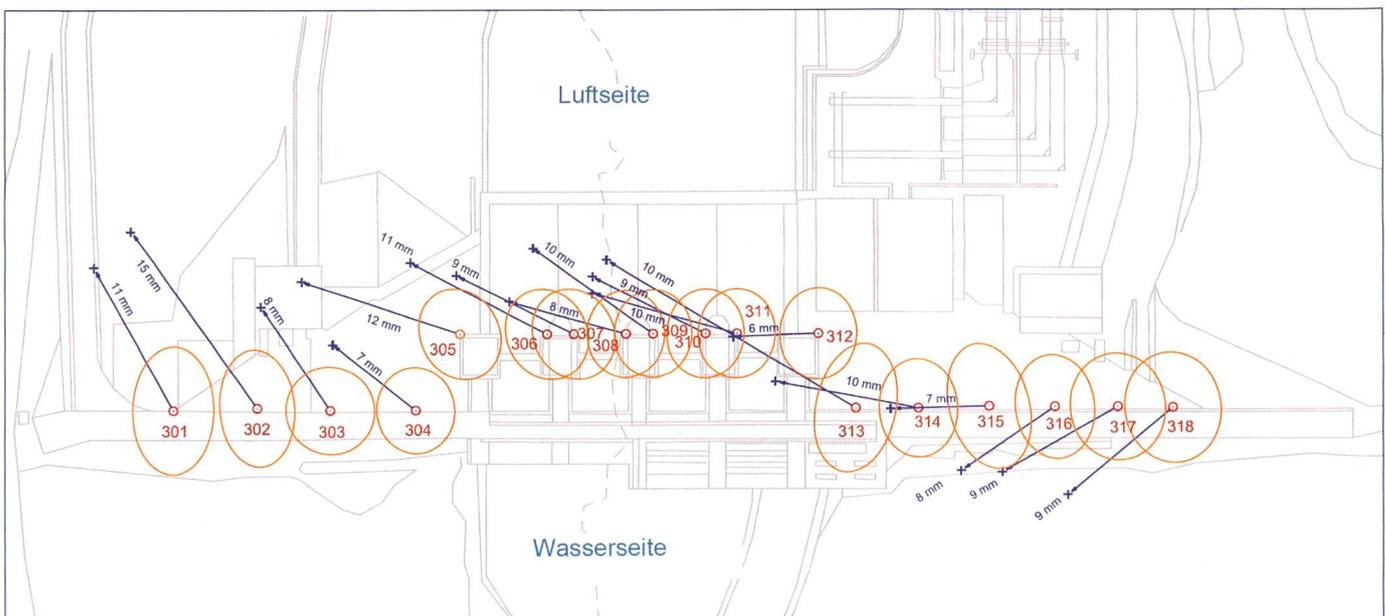
Figure 10. Ulza HPP with horizontal displacement vectors and confidence ellipses 95%.

On the gravity dam in Ulza, significant deformations that resemble the shape of a folding motion, occur (see figure 10). The settlements along the dam crest are significant with up to 5 mm over the entire crest (see figure 11). Again, the uncertainty

with only one measurement is high and the behavior of the dam can not be conclusively determined. However, it is conceivable that the additional applied load due to the higher water level (+12 m) causes a settlement and vertical tilting. Although the settlements are at their maximum in the middle of the dam, the largest horizontal displacement or tilting can be found towards the left abutment. This might be caused by either topography/geologie or structural unstabilities. The downstream tilting/displacement seems to effect the whole structure by pulling the right abutment towards the left abutment.

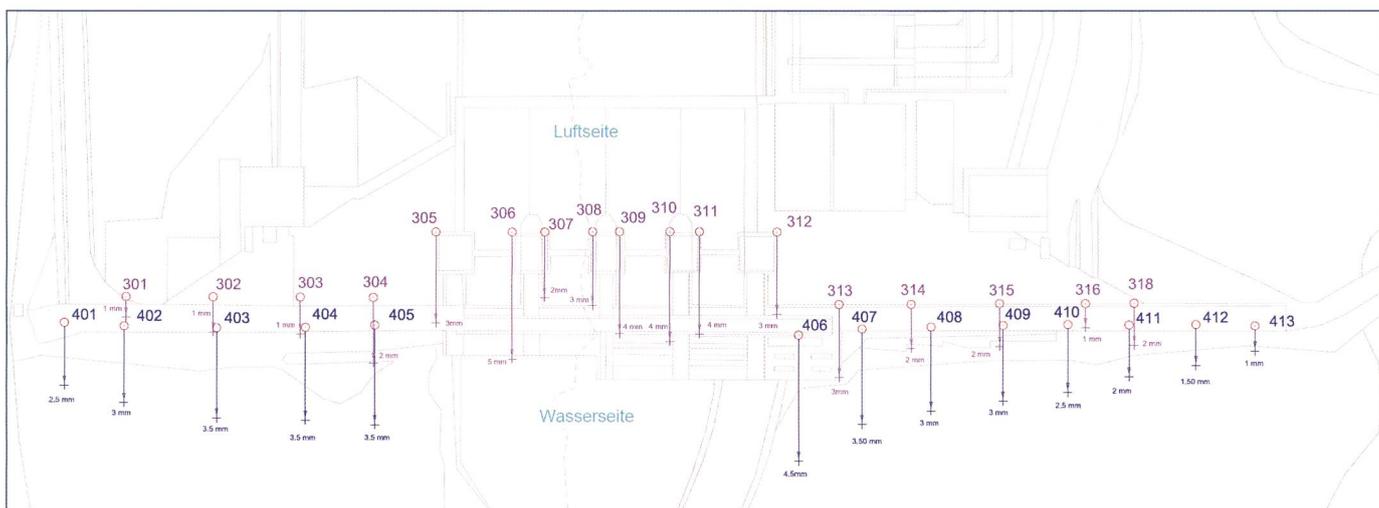
Figure 11. Ulza HPP with vertical displacement vectors.
