Albania Dam Safety Monitoring

Michael Furrer, Max Osterried, Marialis Çelo, Hans-Jakob Becker

This article deals with the implementation of geotechnical and geodetic monitoring systems for five hydropower dams in Albania. The dams were equipped with different automatic and manual sensor systems to improve the safety of the dams by monitoring the behaviour of the structures and their surroundings. The topography and accessibility in this wild and beautiful country presented a very special challenge.

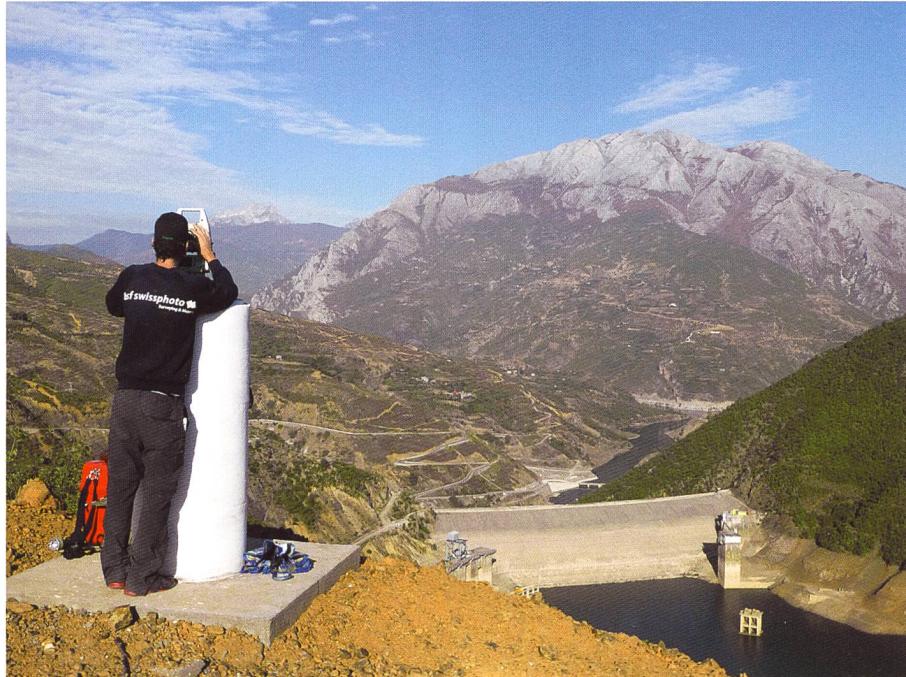
Figure 1. Geodetic Monitoring at Fierza HPP.

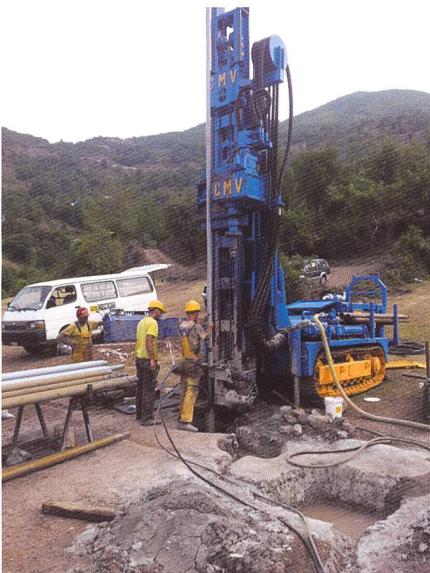
Figure 3. Drilling works for inclinometers with sub-contractors Altea Geostudio2000 at Porava.

Other measurement points include inclinometers installed in landslide areas near the dams (Fierza HPP and Koman HPP). An example is shown in figure 3 regarding the Porava landslide area near HPP Fierza. Furthermore, jointmeters and pendulums are used inside Ulza dam to monitor its deformations depending on the reservoir level.

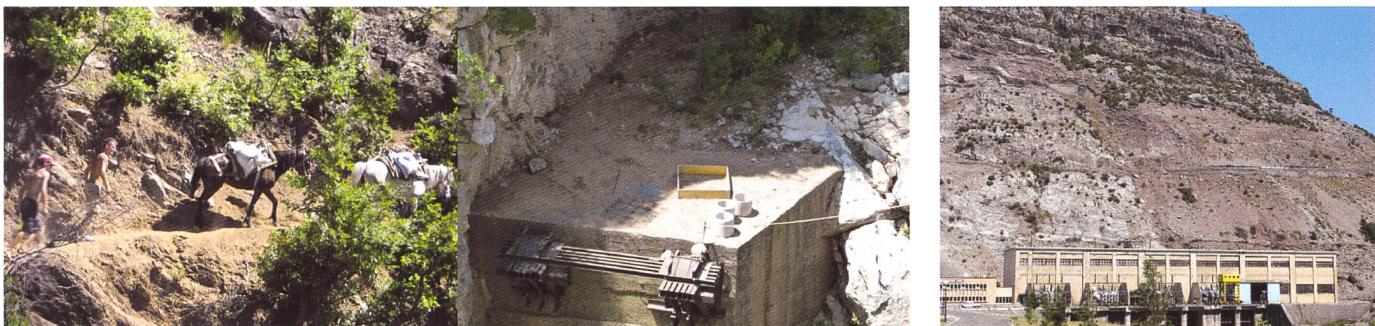
Figure 6. Transport of construction material, Mules, improvised cable cars.

The civil work for the reference points was carried out in the summer months May to September 2012 and proved to be difficult due to the topography and accessibility. Most of the locations are in steep and rocky terrain and cannot be reached by car. The construction material such as cement, gravel, water, etc. had to be transported by mules or by pretty adventurous self-made cable cars. There

we were happy to have the support of a local subcontractor who had the experience and creativity to make it happen. All the excavations were done manually (see figure 6).

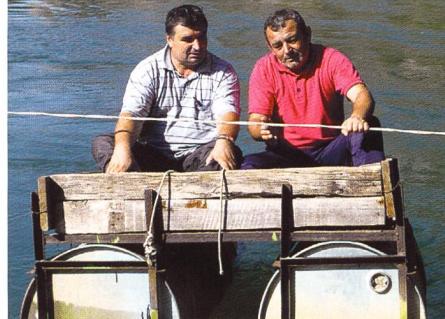
Figure 8. Improvised ferry service downstream of Shkopet HPP, Installation of object points at Ulza HPP.

The measurements were taken by a team consisting of specialists from BSF Swissphoto and KESH. Meanwhile on the job training was given. The measurements were completed within two days at each dam. Due to the difficult access and long distances between the points we were happy to have additional personnel of the hydropower plants at our disposal (see figure 8).
