**Artikel:** The detached wall paintings from the attic of the monastery church St.  
Johann in Müstair in the collection of the Swiss National Museum :  
research and development of a conservation and restoration concept

# The detached wall paintings from the attic of the monastery church St. Johann in Müstair in the collection of the Swiss National Museum – research and development of a conservation and restoration concept

by NATALIE ELLWANGER, TIZIANA LOMBARDO, PATRICK CASSITTI, CAMILLA MARTINUCCI, ALBERTO FELICI, MARTA CAROSELLI, MARKUS LEUTHARD and RUFINO EMMENEGGER

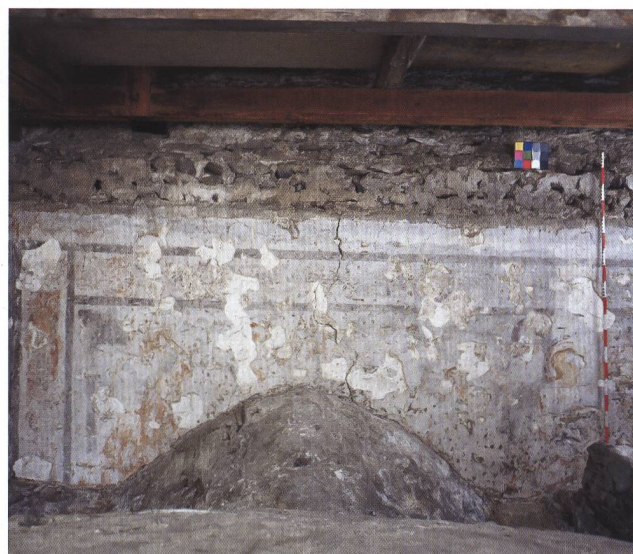
Figure 2. Situation in the attic: east wall with the remains of the Carolingian wall paintings after the detachment.

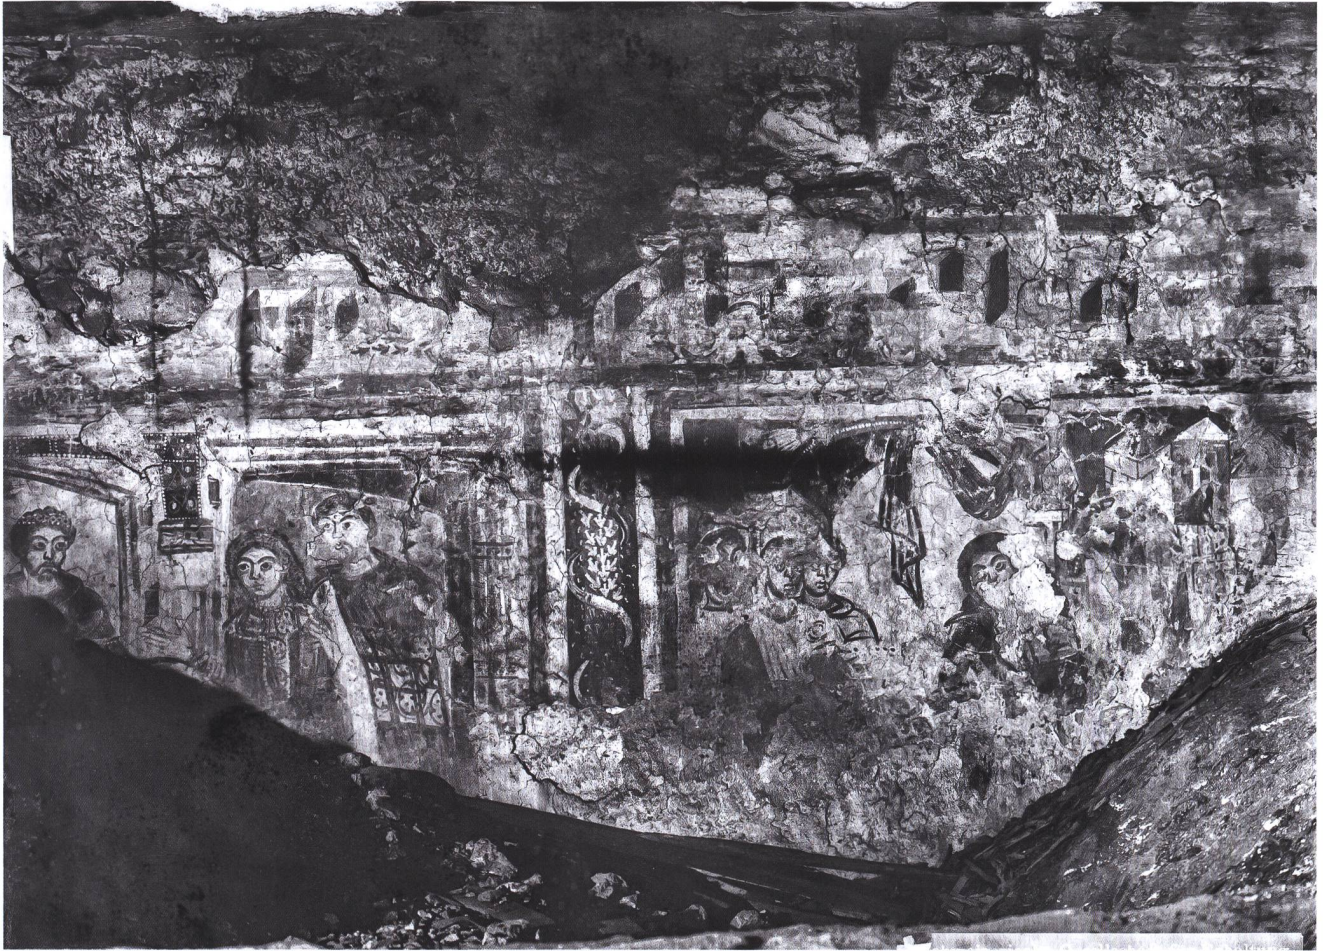
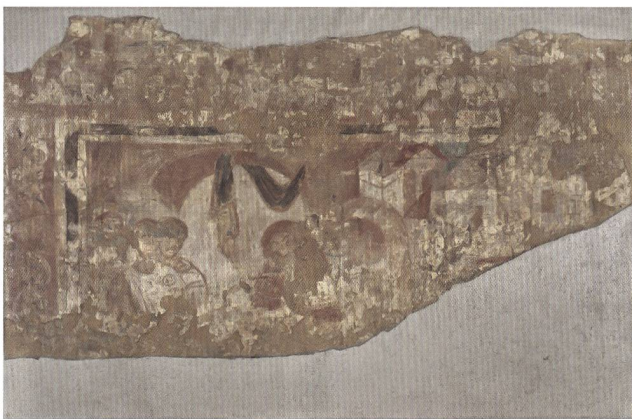
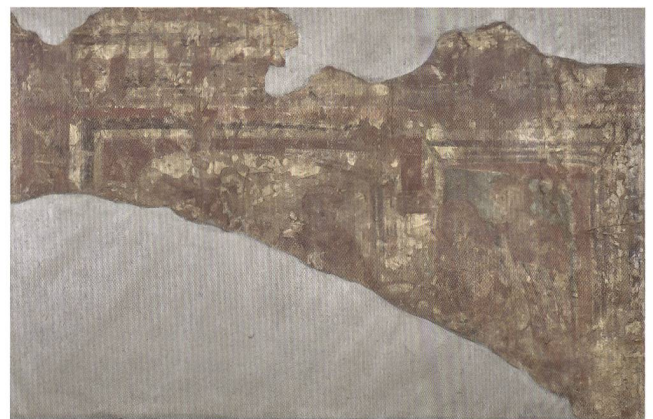
Figure 4. Picture taken from the north wall: Absalom is led by Joab to David [upper figure left side], and: Absalom steals the hearts of the men of Israel [upper figure right side] in the attic of the monastery church Müstair before the detachment in 1908; and corresponding objects in the collection of the Swiss National Museum. LM-II1991.2 (bottom, left) and LM-II1991.3 (bottom, right)

The archival research at the Federal Archives of Historic Monuments EAD brought to light a photograph showing a fragment of a wall painting from the attic of the monastery church of Münstair before its detachment in 1908. It depicts a scene on the northern wall from which the objects LM-11991.2-3 were detached (Fig. 4).

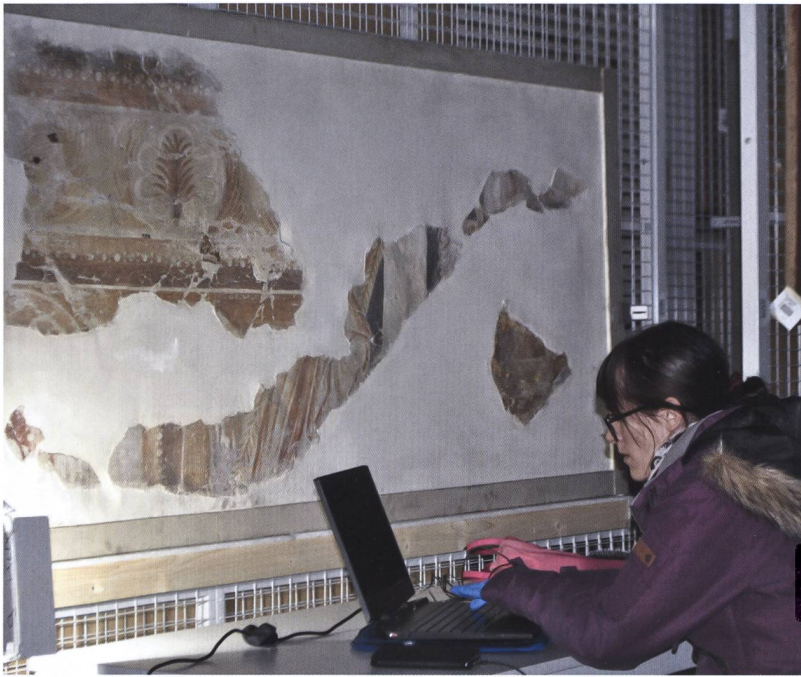
Figure 5. Examination and mapping of the Romanesque painting LM-111995.1 in Affoltern am Albis.

During phase 1 all research addressed the two object groups, the detached wall paintings as well as the *imprints*<sup>22</sup> in the attic (Figs. 5 and 6). An extensive survey was carried out with the aim of gaining a better understanding of painting techniques and constituent materials (original and attributable to the detachment process or later conservation treatments) and to assess the presence of alterations.

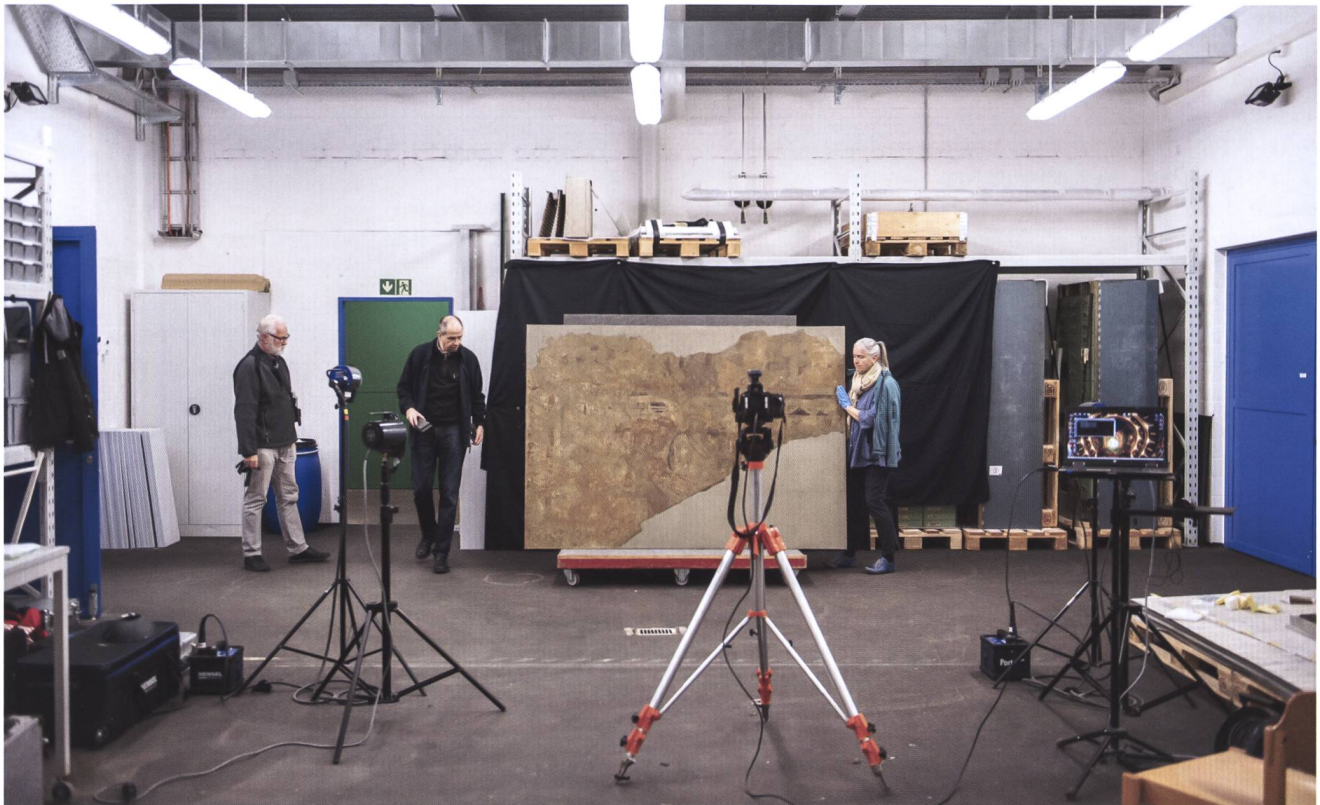
Figure 8. Setting during the photogrammetric photography in the SNM Collection Centre.

Photogrammetric documentation was executed by Mr. Gisbert Sacher, fokus GmbH Leipzig (Fig. 8).

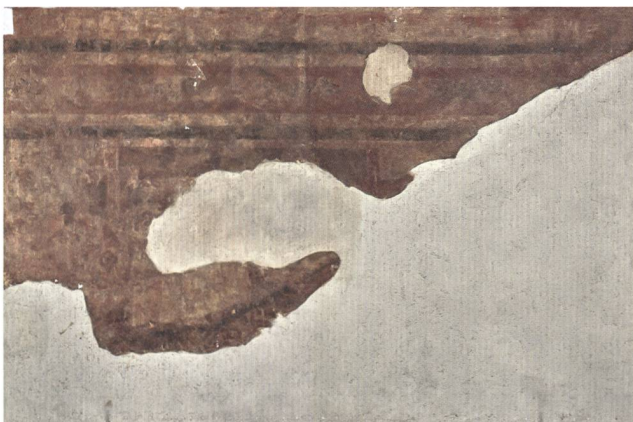
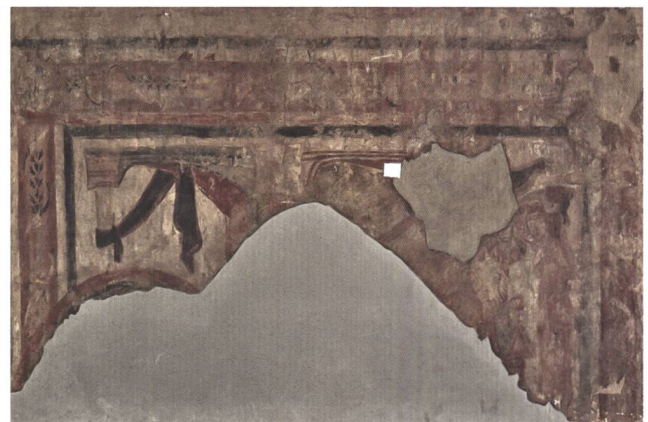
coatings (Fig. 11). Over time, these have yellowed considerably, changing the colours altogether and preventing the observation of *secco* finishing.

Figure 11. LM-11992.2 (Ark of the Covenant in Jerusalem) (left) with a yellowed coating in comparison to LM-11992.4 (King David and Nathan (?)) (right) presenting a different type of coating. The latter object is more brilliant and details are more visible.

All objects are quite dusty due to their long period of exhibition and storage. *Dry cleaning* of the surfaces front and back with soft brushes is the recommended minimal intervention. The *removal of coatings* is urgent above all from a conservation point of view. Aesthetically, there may be a visual alignment within the object group. There are several paintings in an unstable condition, which

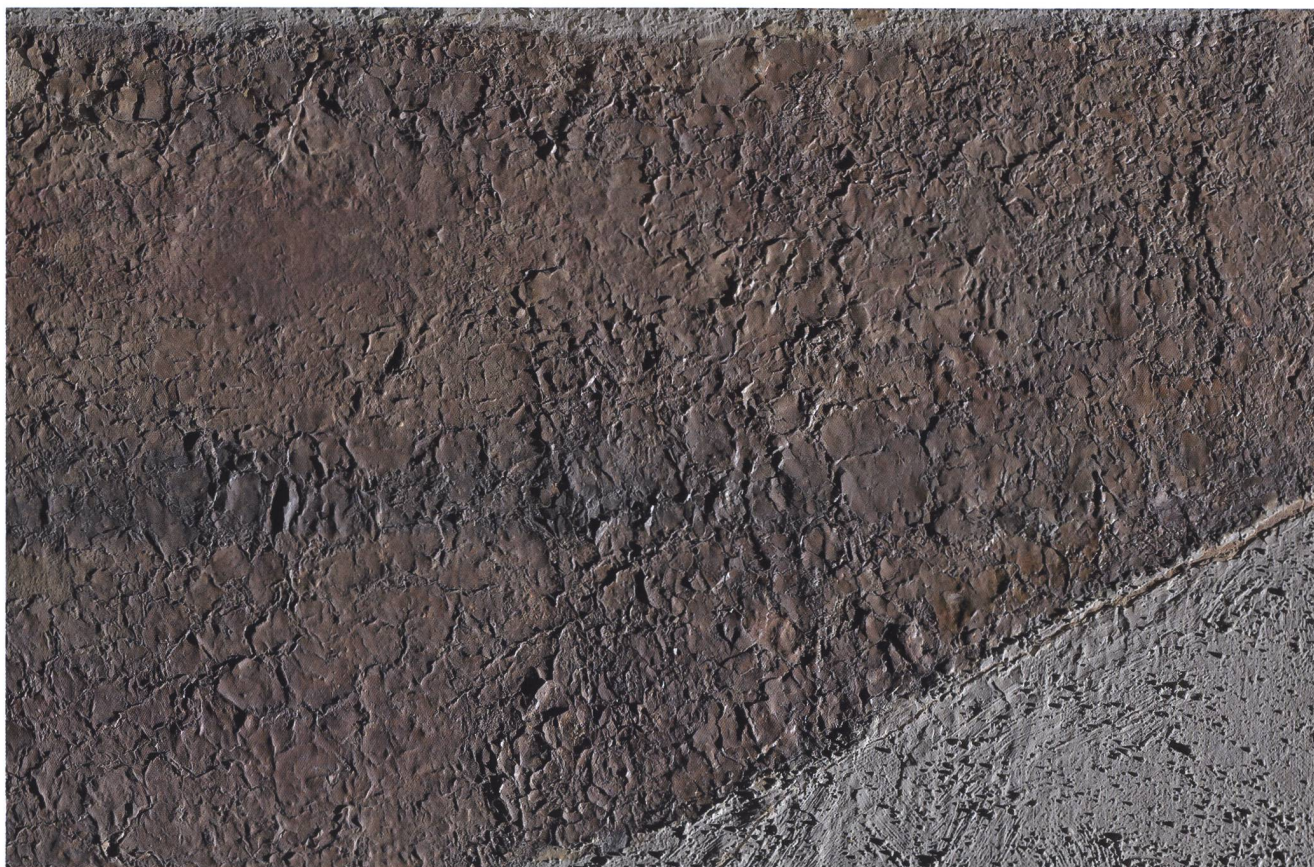
Many *strappi* require closer examination to determine whether the render residues and the paint layers no longer

adhere to the textile support (Figs. 12 and 13). As a consequence, losses can be expected during any manipulation.

Figure 12. LM-II991.2 Detail of brittle paint layer, which is only stabilised by the coating.

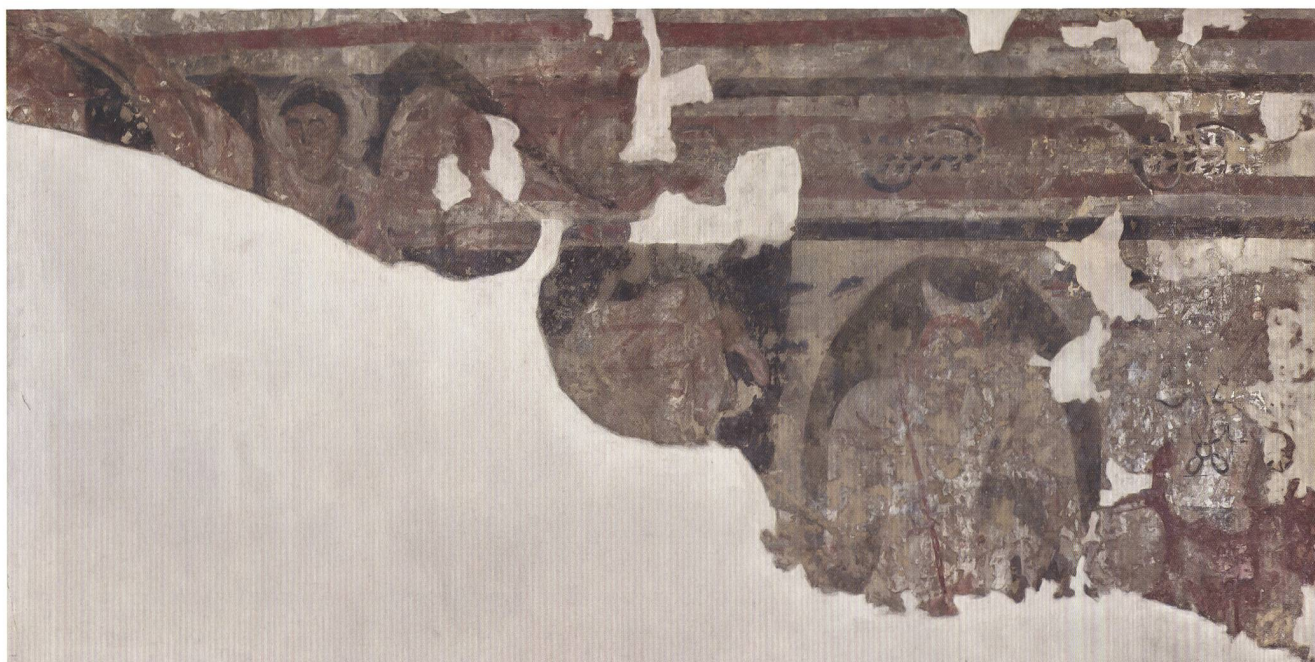
The *strappi* from the east wall were restored in the 1970s, at which time previous treatments were removed, and loose paint layers were comprehensively fixed. Presumably because of this last treatment, these paintings are in stable condition. The scenes are richly decorated, of high quality and the depiction is of importance (Fig. 14). Probably these were the main reasons why this cycle (LM-11990.1–4a) was chosen for extensive conservation treatment.

Figure 14. LM-II990.3 Ascension of Christ with Angels and Luna.

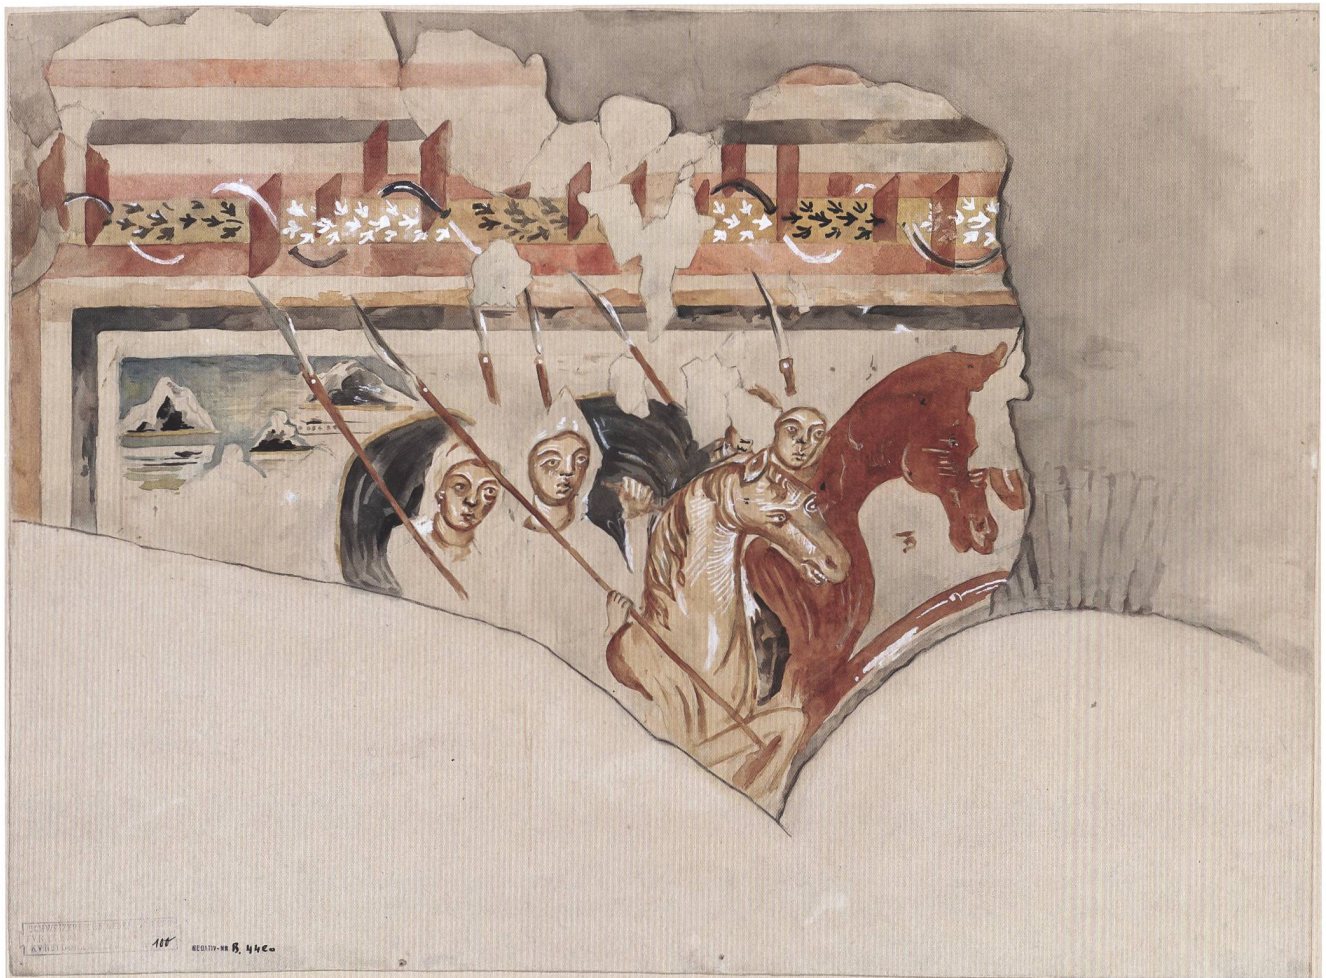
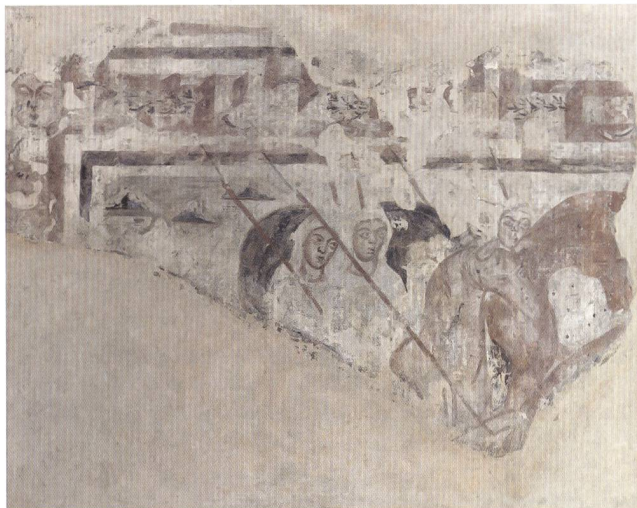
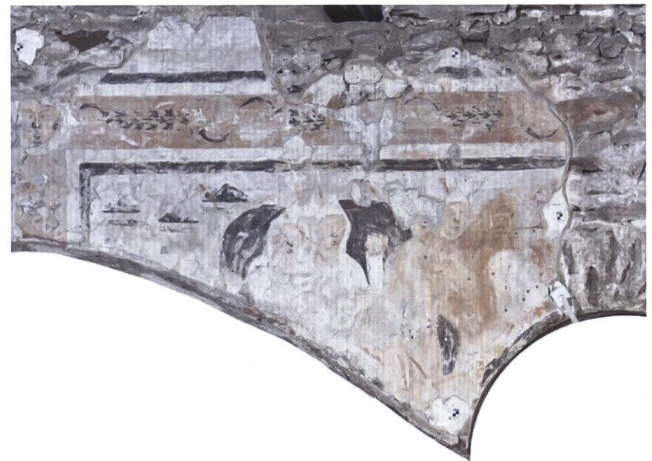
In addition the Zemp and Durrer watercolours<sup>24</sup> have been helpful to understand alterations, losses, and lacunae as well as repainted parts of the objects (Fig. 17).

Figure 17. Comparison of the Zemp and Durrer watercolour<sup>III</sup> for the scene Mü-18 (above) with the strappo (bottom left) LM-11991.6 and the imprints in situ (bottom right).

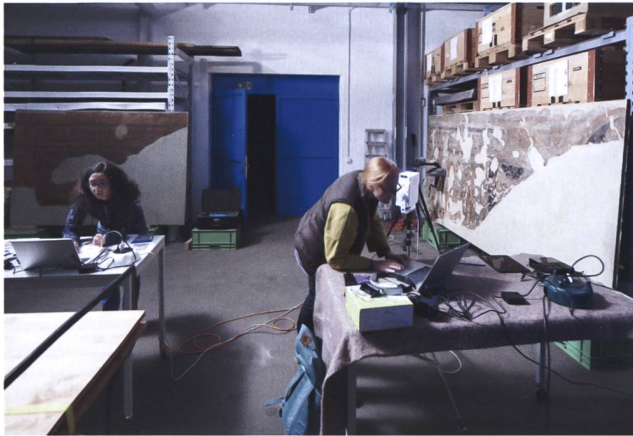
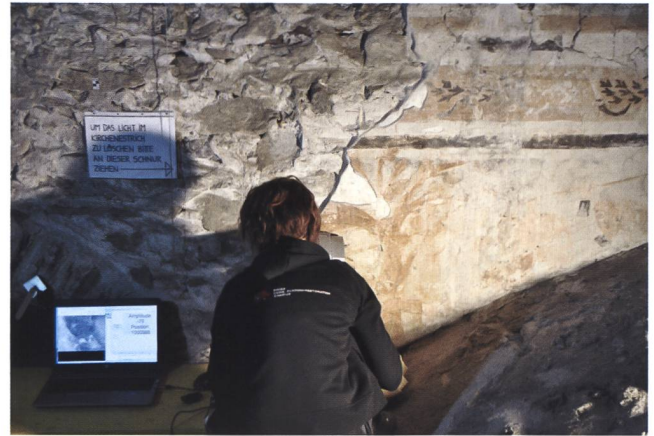
Firstly, analysis was carried out using non-destructive techniques such as portable X-Ray Fluorescence (p-XRF) and portable Fourier Transform Infra-Red (p-FT-IR) spectrometry. Only when more information was needed, samples were collected and investigated in the lab using several further techniques.<sup>25</sup> The in situ non-destructive investigations were performed on the SNM objects (21 in total) as well as on the objects in the attic of Müstair church (15 scenes) (Fig. 18). The selection of the most significant areas to be investigated was made using the information arising from the multispectral images as well as the watercolours by Zemp and Durrer, and from the object survey carried out during the previous studies. Samples were mostly collected from the SNM objects (70 samples), and few from the attic (3 samples). Most of the samples are small fragments analysed with no preparation, but cross-sections were prepared for the specific investigation of painting techniques.

Figure 18. Non-destructive analytical campaigns taking place in SNM Collection Centre and in the attic of Müstair church.

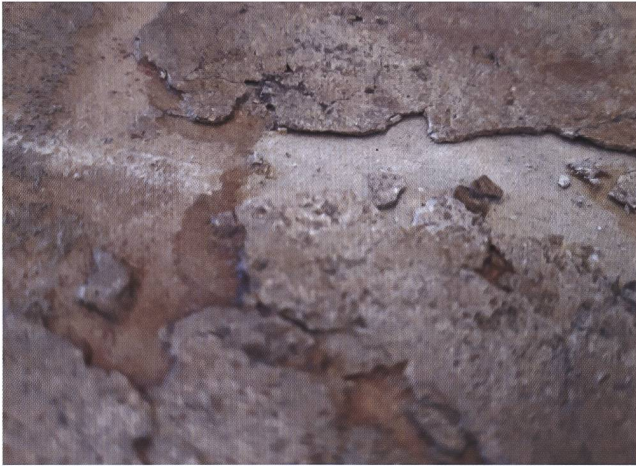
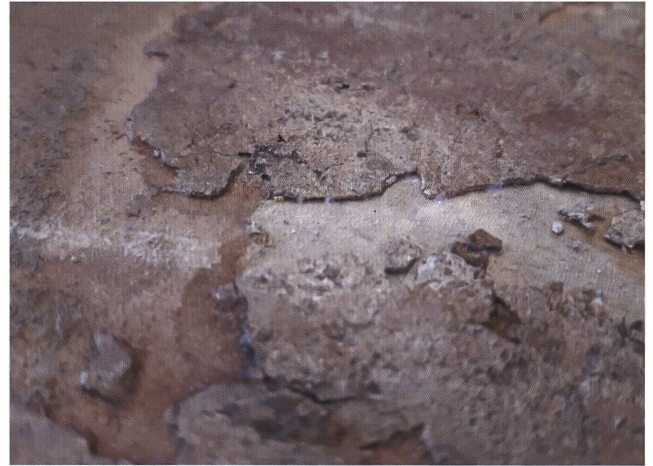
Figure 19. Example of an intermediate stabilisation. Detail of LM-II991.5, unstable portion of the original painting support before (right) and after fixing points have been made with Lascaux 498 HV (left).

require *intermediate stabilisation* of the paint layer in order to allow further handling and examination (Fig. 19). A large number of paintings have an extensive need for paint layer *consolidation*. During the tests and trials, several adhesives were tested and amongst those, a few were found suitable (Figs. 20 and 21). The *removal of infills* might be necessary for various reasons. For conservation purposes, there is the hope that the removal of the massive infill layers might have a positive impact on the deformed textile support along the edges of the paint layers. There are various approaches as to how these areas could then be dealt with. As has already been done in the past with the *strappo* LM-11990.1 and others, the shapes of the vaults and lacunae could be left as bare canvas. Alternatively, the infills could be *substituted* by designing the shapes of the vaults and gaps differently, be it in terms of colouring or structure. This decision will certainly have to be discussed. The *stretchers* are integral parts of the objects and should therefore be retained if possible. By adding rigid supports in combination with non-woven fabric (fleece) inlays, a reduction of vibrations can be achieved. As far as possible, the old retouchings should be preserved. Should the preservation not be possible for aesthetic or technical reasons, the extent and the method of *retouching* would undoubtedly need to be discussed before a new intervention.

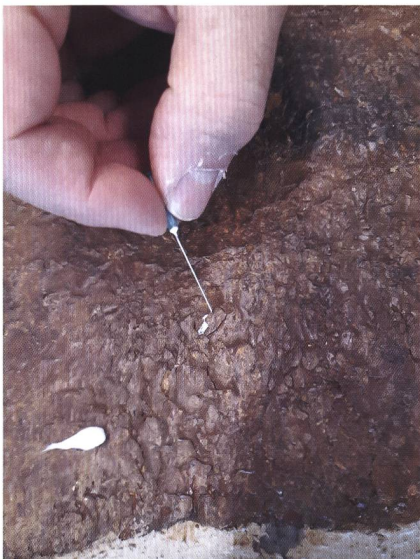
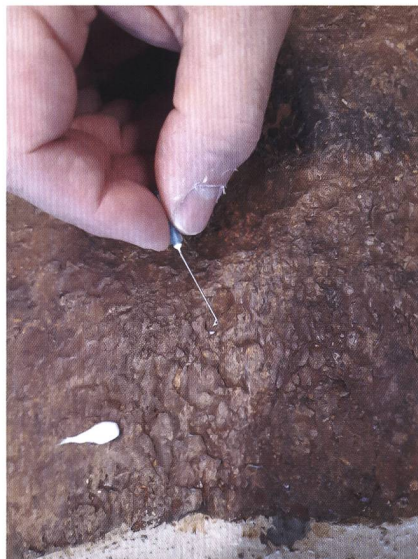
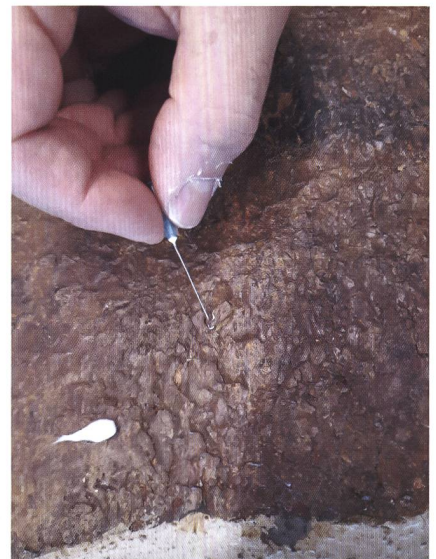
Figure 20. LM-II992.2. fixing and readjustment of a complete detached flake carried out with few drops of EVA.

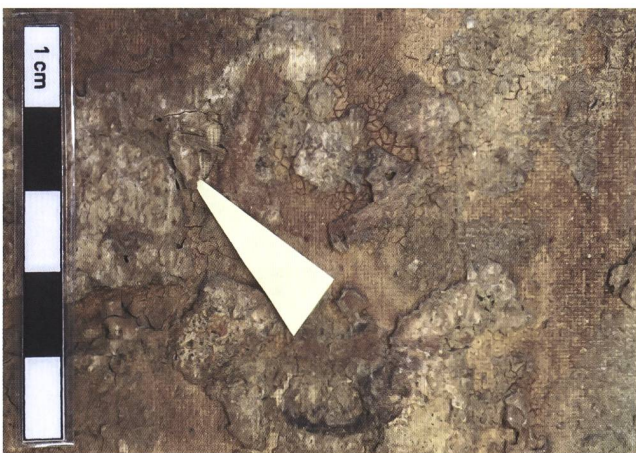
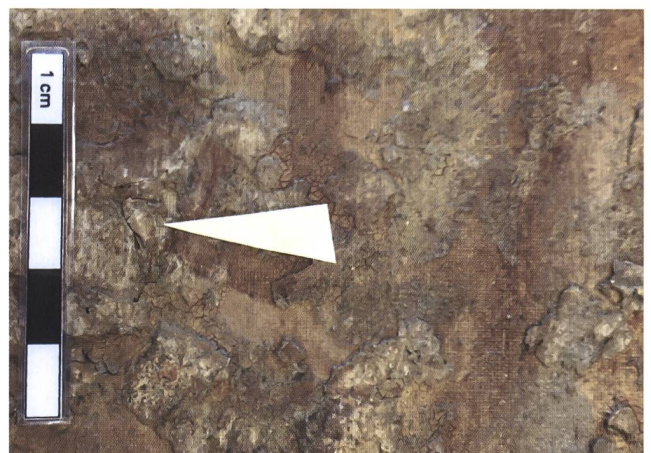
Figure 21. LM-II991.5. Picture of a flake before (left) and after (right) fixing with sturgeon glue.
