Artikel: The detached wall paintings from the attic of the monastery church St.
Johann in Müstair in the collection of the Swiss National Museum :
research and development of a conservation and restoration concept

The detached wall paintings from the attic of the monastery church St. Johann in Müstair in the collection of the Swiss National Museum – research and development of a conservation and restoration concept

by NATALIE ELLWANGER, TIZIANA LOMBARDO, PATRICK CASSITTI, CAMILLA MARTINUCCI, ALBERTO FELICI, MARTA CAROSELLI, MARKUS LEUTHARD and RUFINO EMMENEGGER

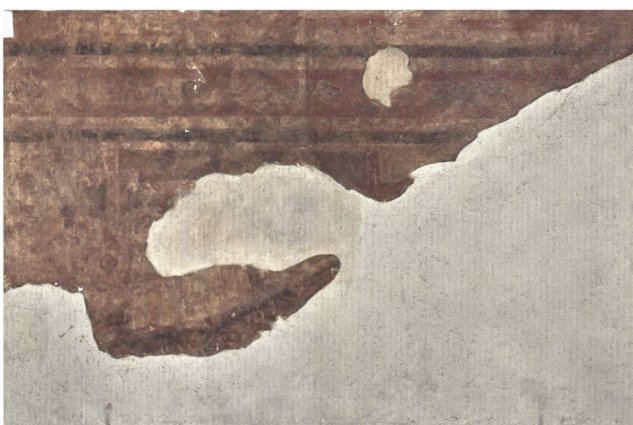
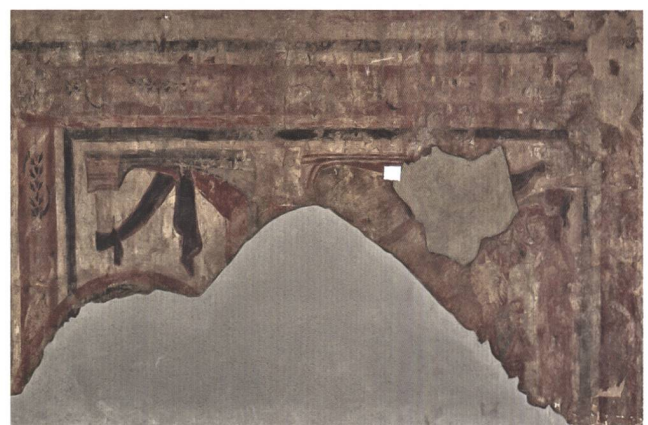
coatings (Fig. 11). Over time, these have yellowed considerably, changing the colours altogether and preventing the observation of *secco* finishing.

Figure 11. LM-11992.2 (Ark of the Covenant in Jerusalem) (left) with a yellowed coating in comparison to LM-11992.4 (King David and Nathan (?)) (right) presenting a different type of coating. The latter object is more brilliant and details are more visible.

All objects are quite dusty due to their long period of exhibition and storage. *Dry cleaning* of the surfaces front and back with soft brushes is the recommended minimal intervention. The *removal of coatings* is urgent above all from a conservation point of view. Aesthetically, there may be a visual alignment within the object group. There are several paintings in an unstable condition, which

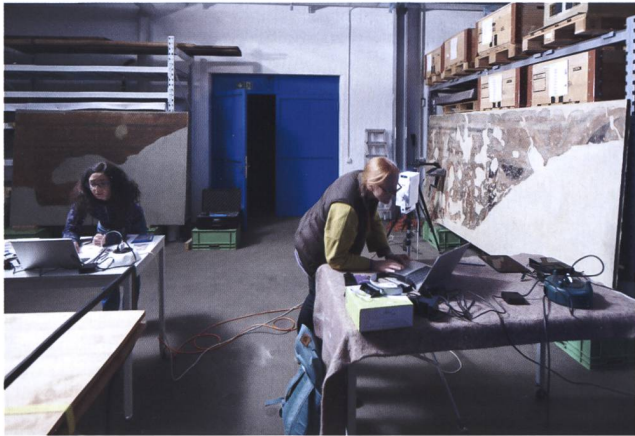
Firstly, analysis was carried out using non-destructive techniques such as portable X-Ray Fluorescence (p-XRF) and portable Fourier Transform Infra-Red (p-FT-IR) spectrometry. Only when more information was needed, samples were collected and investigated in the lab using several further techniques.²⁵ The in situ non-destructive investigations were performed on the SNM objects (21 in total) as well as on the objects in the attic of Müstair church (15 scenes) (Fig. 18). The selection of the most significant areas to be investigated was made using the information arising from the multispectral images as well as the watercolours by Zemp and Durrer, and from the object survey carried out during the previous studies. Samples were mostly collected from the SNM objects (70 samples), and few from the attic (3 samples). Most of the samples are small fragments analysed with no preparation, but cross-sections were prepared for the specific investigation of painting techniques.

Figure 18. Non-destructive analytical campaigns taking place in SNM Collection Centre and in the attic of Müstair church.
