Preservation of newly built and historical buildings

Autor(en): **Croci, Giorgio**

Zeitschrift: **IABSE congress report = Rapport du congrès AIPC = IVBH
Kongressbericht**

Preservation of Newly Built and Historical Buildings

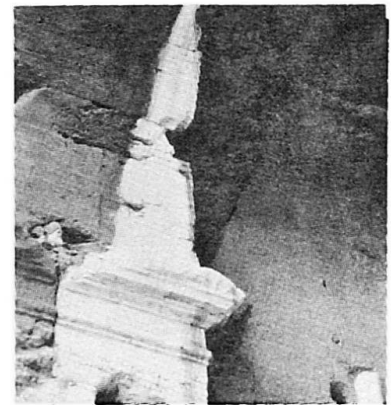
Pic.10,11: Displacements and discontinuities in the structure of Colosseum

Consequences of this outward movement are relative displacement of the blocks (fig. 10) and discontinuity between the outer elliptical structure and the radial masonry (fig. 11).

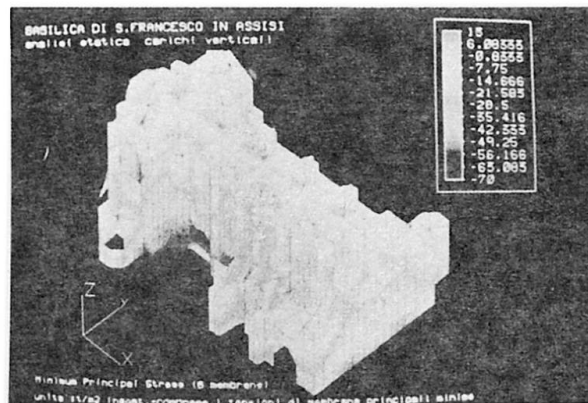
Pic.16: Damages in the Giotto frescos Pic.17: Mathematical models of Basilica of St. Francis in Assisi

The earthquake has been also the main cause of damages in the Basilica of S. Francis of Assisi (fig. 15). Many signs are visible, the cracks in the central columns of the large windows and the damages that in the centuries have effected Giotto frescos (fig. 16).

The mathematical model shows the general stress distribution (fig. 17). In the wall that supports the Giotto frescos we can see in further detail the tensile stresses in the inner surface, and the compression stress in the outer surface, corresponding to bending moments; these stresses change sign many times during the sinusoidal seismic action, causing the cracks that we have observed. In order to reduce these effects, a steel trussed beam will be placed over the internal cornice (fig. 18, 19). This beam is connected to the masonry by oleodynamic dampers in a position to allow thermal deformations, but to react rigidly under the effect of dynamic impulse due to the seismic action.

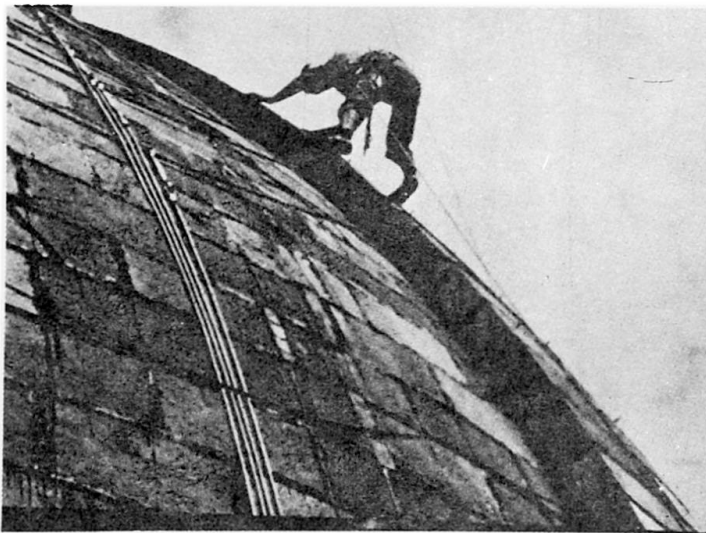
Pic.33: The operations to place the cables

The stainless steel cables have been put in place by "escaladores" (fig. 33) and the phase of pretensioning has been monitored (fig. 34).
