Zeitschrift: **IABSE publications = Mémoires AIPC = IVBH Abhandlungen**

Impact Resistance on Prestressed Concrete Masts¹⁾

P. W. ABELES, London

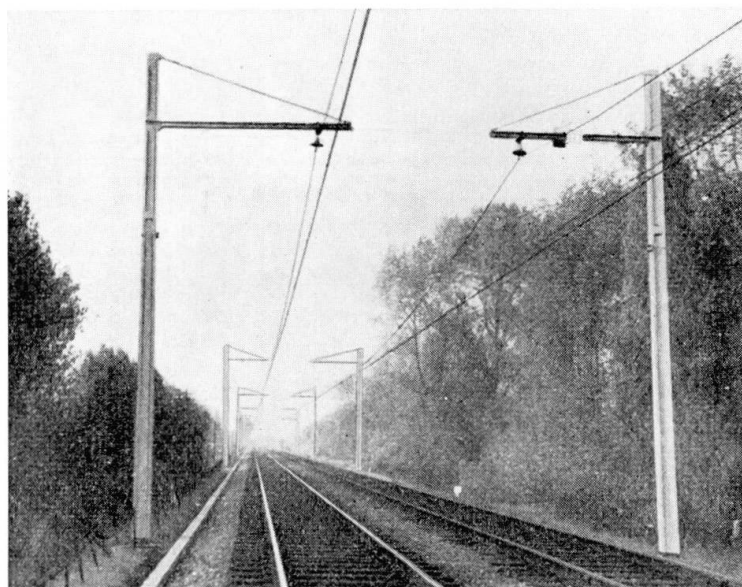
Fig. 1. Prestressed Concrete Cantilever Masts near Southend (England).

From figs. 1—3 it is seen that the prestressed concrete masts differed but little in size from the steel masts. This was achieved by making full use of the tensile resistance of the concrete under working conditions, which is particularly advantageous if loading in opposite directions occurs. Freedom from

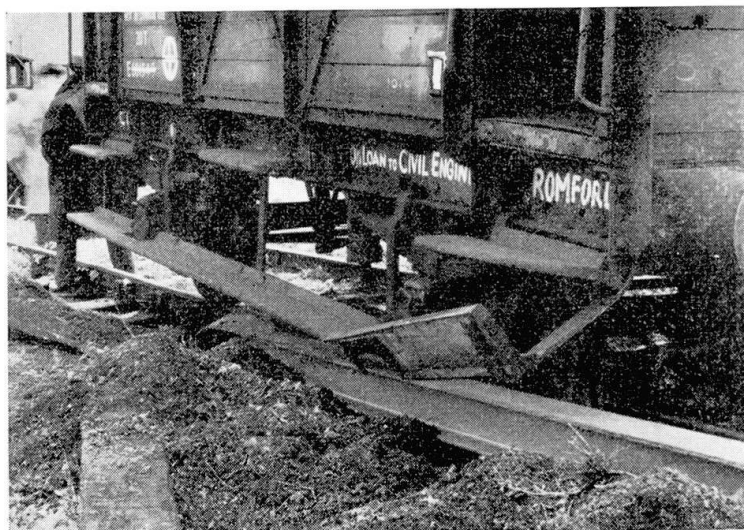
Fig. 4. Romford Impact Tests. Steel Mast After Direct Impact.

The impact was applied by means of a brake van of 20 tons weight which was projected into the mast with a speed of approximately 10 miles per hour. For each individual test the track was slewed so that either the entire mast or only part of a flange was hit. The tests have proved, as was to be expected, that in the event of a direct hit both types of mast become unserviceable. The steel mast was entirely bent down (fig. 4), although it had been expected by those favouring steel that it would only be bent slightly and would still be able to carry the high voltage wires in the air; the prestressed concrete
