#### 4. Debris Torrent Control Facilities (Vancouver, BC, Canada)

**Owner:** Ministry of Transportation  
and Highways, Province of  
British Columbia

**Consulting Engineers:** Thurber Consultants  
Ker, Priestman & Assoc. Ltd.

**Construction Period:** 1984 to 1987

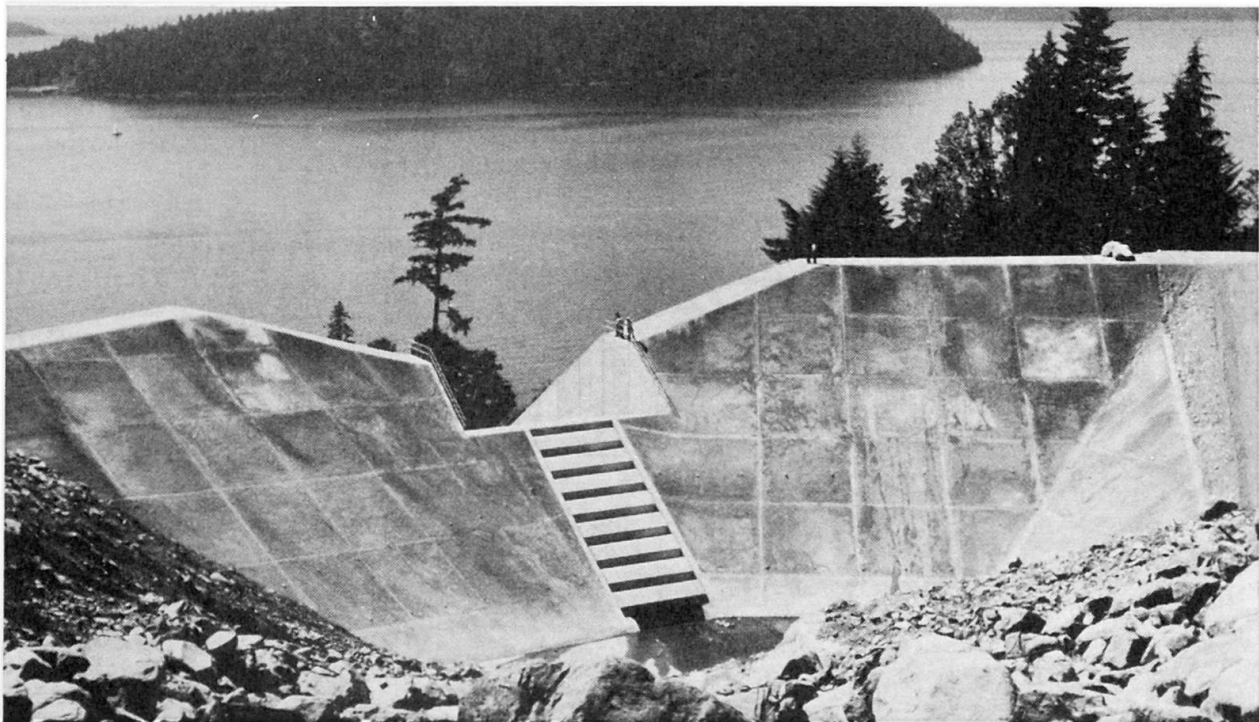
Fig. 1 Fill type debris barrier

At the two other sites where rock was not available, sliding on the steep original ground governed the barrier design resulting in the selection of concrete-faced, zoned fill, structures. The material in the fill barriers was typically obtained by mining the creek above the barrier site to help form storage basin. Each fill barrier features a service spillway for the basin full situation and a decant structure to prevent significant accumulations of water behind the barrier when the basin is only partially full. To control seepage in the zoned fills, a network of relief wells was drilled prior to constructing each barrier and a shotcrete facing and apron was applied to the front of the barrier.
