The effects of localised steady and cyclic over-heating in the Oldbury concrete pressure vessels

The Effects of Localised Steady and Cyclic Over-Heating in the Oldbury Concrete Pressure Vessels

I.W. HORNBY B. Sc. (Eng.),
C. Eng., M.I.C.E.
Central Electricity Research
Laboratories, Leatherhead, U.K.

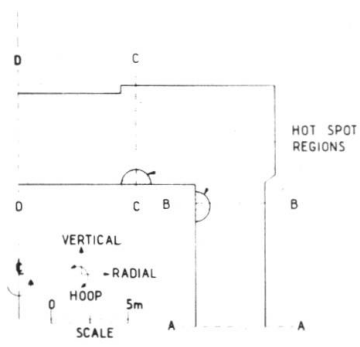
VERTICAL SECTION THROUGH TOP HALF OF VESSEL

- A-A MID-WALL
- B-B UPPER BOILER INSTRUMENT PENETRATION
- C-C CARBON SHIELD BLOCK
- D-D CENTRE OF TOP SLAB

FIG. 1. OLDBURY VESSEL - SECTIONS CONSIDERED IN THE PRELIMINARY CALCULATIONS

Stresses in the vessel at the four positions shown in Fig. 1 were compared for the six loading conditions detailed below. At two of these positions there were several hot-spots whilst, for comparison, the other two positions were in areas operating under normal conditions.

- A Mid wall
- B Upper boiler instrument penetration (hot-spot of 180°C)
- C Carbon shield block (hot-spot of 90°C)
- D Centre of top slab

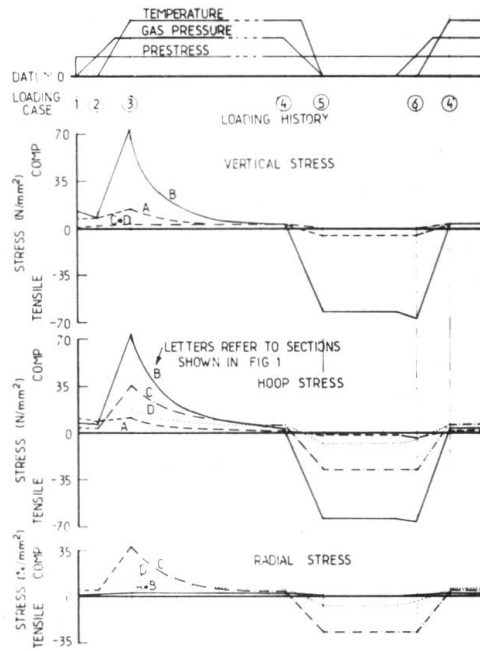
FIG 2 OLDBURY VESSEL - APPROXIMATE STRESS HISTORIES AT THE LINER FACE OF VESSEL SECTIONS A-A, B-B, C-C, AND D-D SHOWN IN FIG 1

The computed radial, hoop and vertical stress histories at the four positions are shown in Fig. 2.

It is apparent from Fig. 2 that in general there are two unavoidable critical loading conditions:-

- (a) At initial start-up (loading case 3), when high compressive stresses occur.
- (b) During the shut-down cycle (loading cases 5 and 6), when high tensile stresses occur.

The worst tensions actually occur when repressurising after a shut-down (loading case 6). The results in Fig. 2 show that under all loading conditions the upper boiler instrument penetration (position B), sustains the highest stresses. For this reason the model was chosen to simulate this position with a hot-spot at approximately 180°C. This simulation would also show the effects of stress concentration due to the penetration. The analysis of the vessel showed that the highest stresses occur in the hoop and vertical directions, the maxima being very similar in these two directions. The choice of a model with equi-biaxial stresses approximately equal to these stresses was therefore justifiable.

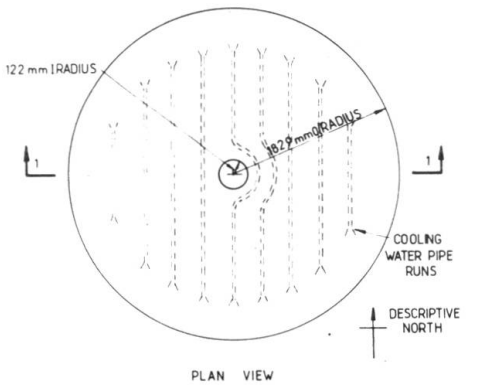
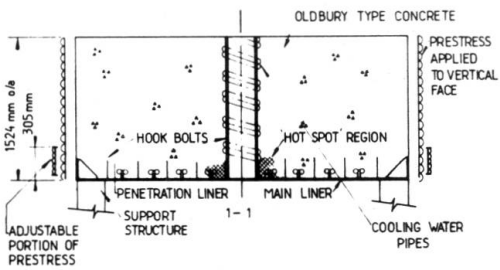
FIG 3 MODEL - GENERAL ARRANGEMENT

The actual model chosen is illustrated diagrammatically in Fig. 3 and is described later in the paper. In order to verify further that the model was representative a separate stress analysis was undertaken. The resulting stress profiles at the simulated penetration were compared with those computed for the vessel during a typical reactor start-up/shut-down cycle. The calculations showed that a steep stress gradient behind the liner is caused by the temperature gradient between the liner and the cooling water pipes which are positioned 100 mm into the concrete. The tensile stresses predicted under loading case 6 greatly exceed the tensile strength of the concrete and cracking would be expected. The results obtained from this preliminary comparison showed that reproduction of the appropriate prestress and temperature pattern in the model would produce a similar stress and strain situation to that in the vessel.

The model is shown diagrammatically in Fig. 3 and Fig. 4, shows the model before concreting. It consisted of a cylindrical disc of concrete 365.8 cm diameter and 152.4 cm thick, mounted with its central axis vertical. The bottom of the concrete was faced with a 12.7 mm thick steel liner, attached to the concrete with 38.1 cm long hook bolts at 30.5 cm equipitch. Fins 10.2 cm high were welded at right angles to the liner at 30.5 cm centres on which were mounted the pairs of cooling water pipes. These ran from north to south across the disc, except for the central pair which curved round the east side of the central penetration.

The boiler instrument penetration was 'sleeve' reinforced with 27.3 cm O.D. steel tube, 14.3 mm thick, thickened locally where it was welded to the liner. The tube was water cooled by two spirally wound pipes welded to its outer surface.

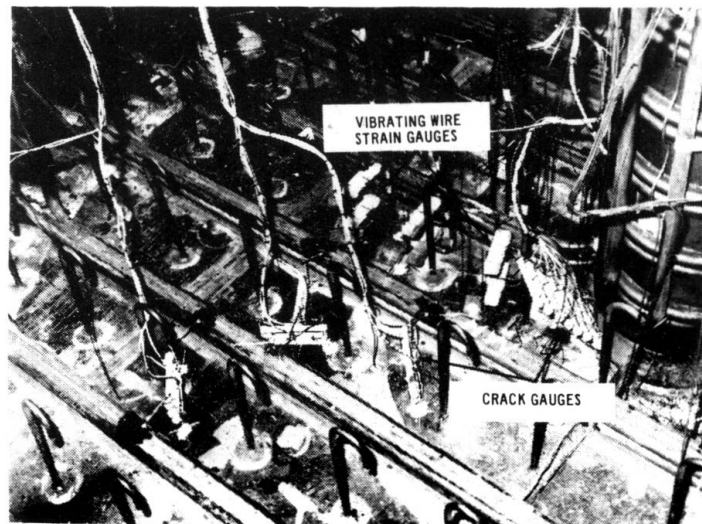
FIG. 4 VIEW OF MODEL DURING CONSTRUCTION, SHOWING INSTRUMENTATION

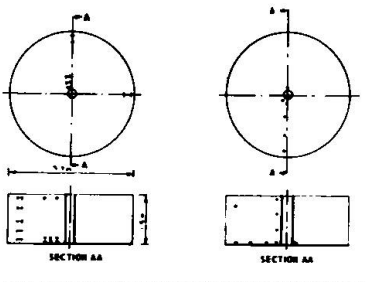
FIG 5 VIBRATING WIRE STRAIN GAUGE (LEFT) AND MOISTURE GAUGE POSITIONS

Eighteen 'Perivale' type 641 vibrating wire strain gauges were positioned as shown in Fig. 5. The gauges were used to measure the strains occurring in the concrete during the tests.

Twelve C.E.R.L. moisture gauges, positioned as shown in Fig. 5 were used to determine the moisture gradients in the concrete during the tests.

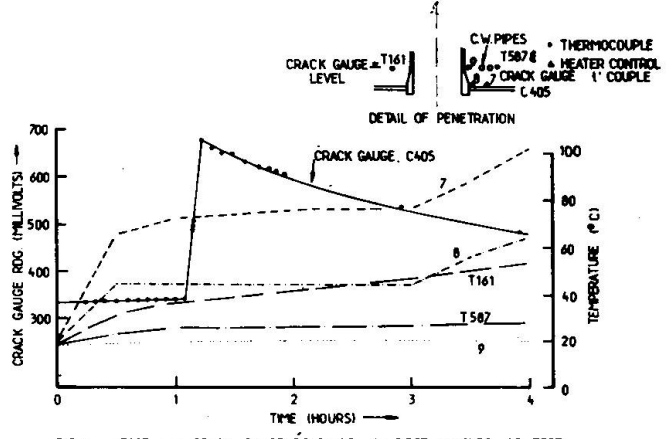
FIG 6 TEST 1 - CRACK GAUGE READINGS IN FIRST 4 HOURS OF TEST

One pair of crack gauges showed a significant change in reading 65 minutes after the start of the first test. A plot of one of these gauge readings is shown in Fig. 6. The readings indicated the formation of a crack wider than 0.5 mm which decreased to zero as the test proceeded.

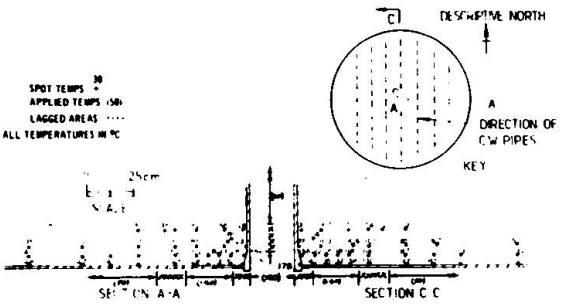
FIG 7 TEST 2 - RECORDED TEMPERATURES AT 24 HOURS AFTER START OF TEST

The temperature distribution applied to the liner is shown in Fig. 7, which also shows the maximum temperatures recorded during the first cycle. The temperature variation at two positions in the model during one 48 hours cycle is shown in Fig. 8.

The cores taken during the first test included ones which penetrated the central pair of cooling pipes (see Fig. 13 and position of core 1/3). For the second test these pipes were isolated and consequently the concrete temperatures local to the central penetration were higher than normal. The conditions imposed on the concrete in this test were therefore more arduous than those experienced in the Oldbury vessel. (See Section AA of Fig. 7).

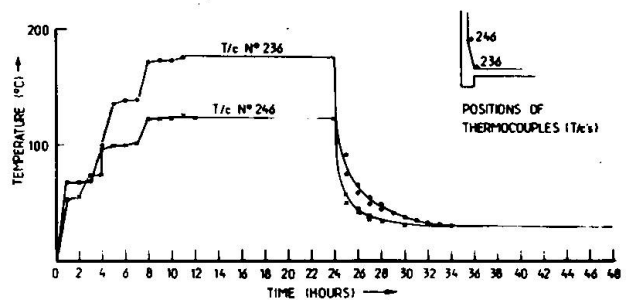
FIG 8 TEST 2 - RECORDED TEMPERATURE VARIATIONS AT HOT-SPOT DURING 1st CYCLE

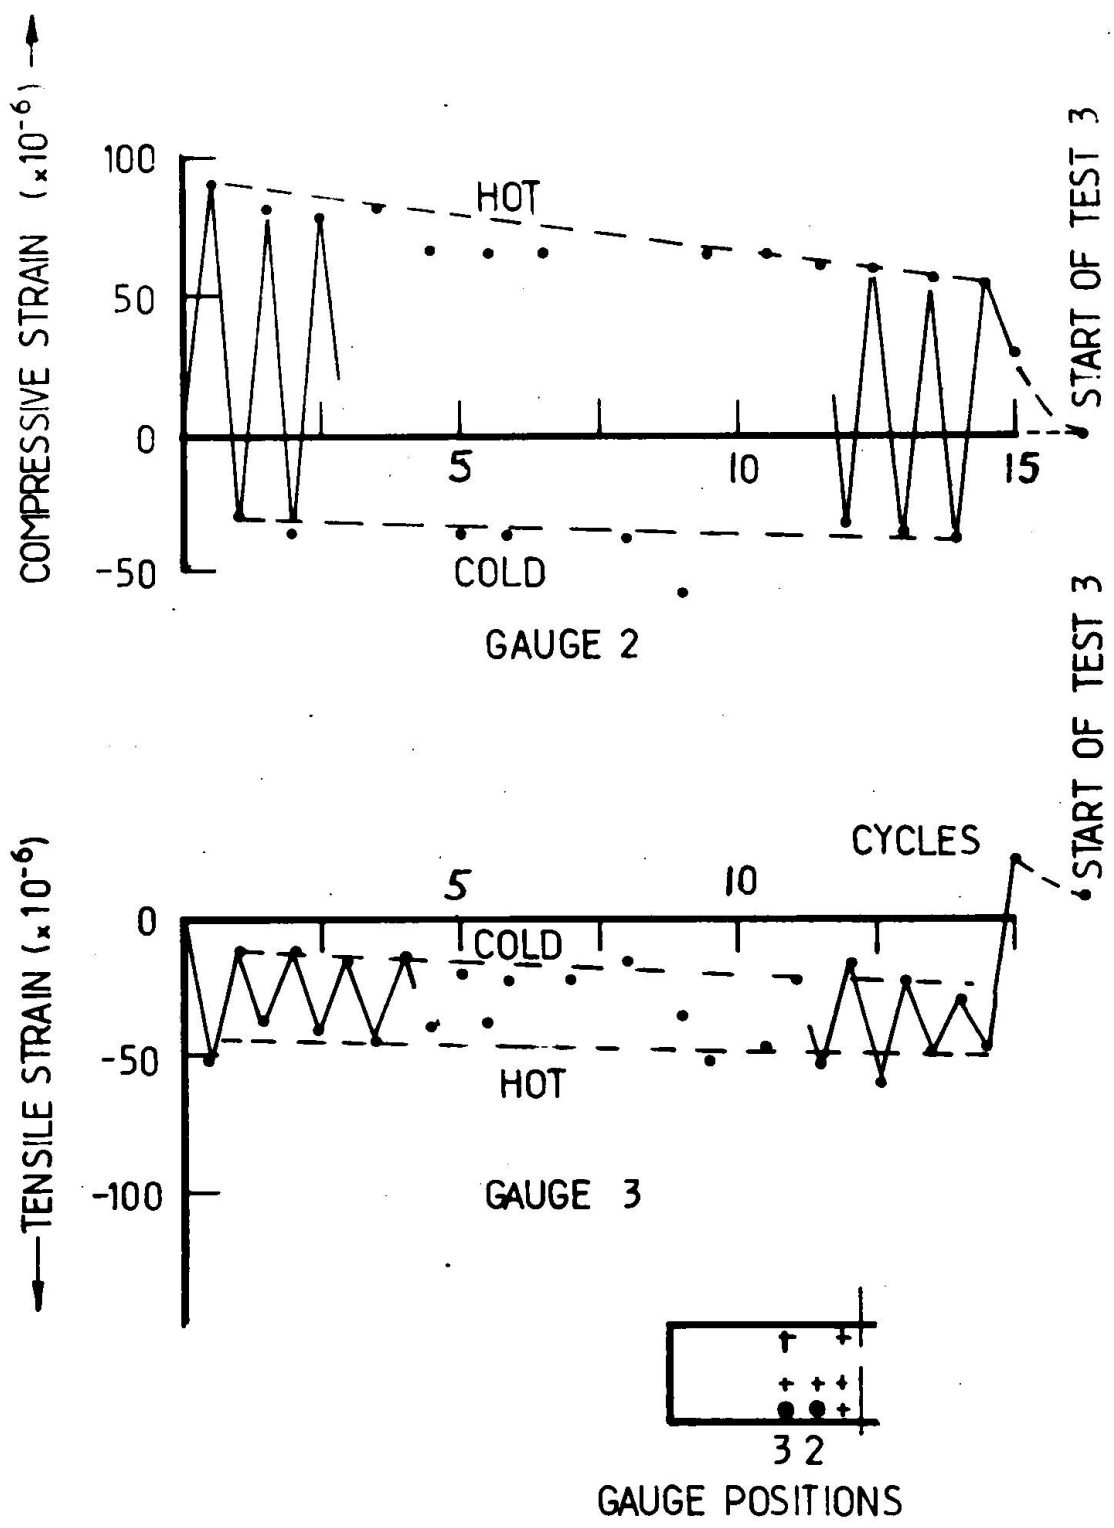
FIG. 9 TEST 2 - RECORDED STRAINS AT GAUGES 2 AND 3 AT 24 HOUR INTERVALS

The strain variation at two gauge positions, at 24 hour intervals, during this test are shown in Fig. 9.

Very little strain change was recorded between the beginning and end of the test. Most gauges showed a trend in the tensile direction the maximum being 35×10^{-6} strain units. Results from two of the gauges in the zone of the crack (Nos 2 and 3) are shown in Fig. 9 and show no residual strain soon after the end of the test. These plots are again illustrated in Figs. 11 and 12. An interesting change occurred at the position of gauge 2. The thermal strain became compressive during the heating up part of the cycle whereas it was tensile during test 1 (Fig. 11). It is thought that this anomalous behaviour was due to the change of temperature distribution resulting from the absence of cooling water flow in the pipes mentioned above.

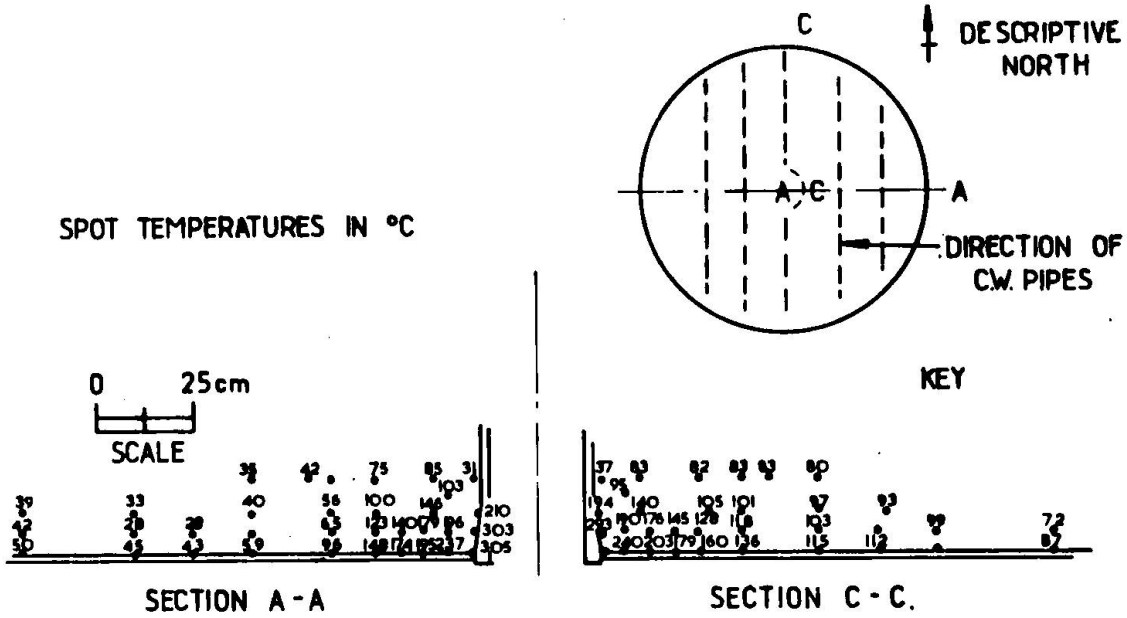
FIG. 10 TEST 3 TEMPERATURES IN THE MODEL AVERAGED FROM VALUES AT DAYS 21, 22, 24, AND 28.

Steady state temperatures recorded by the thermocouples are shown in Fig. 10.

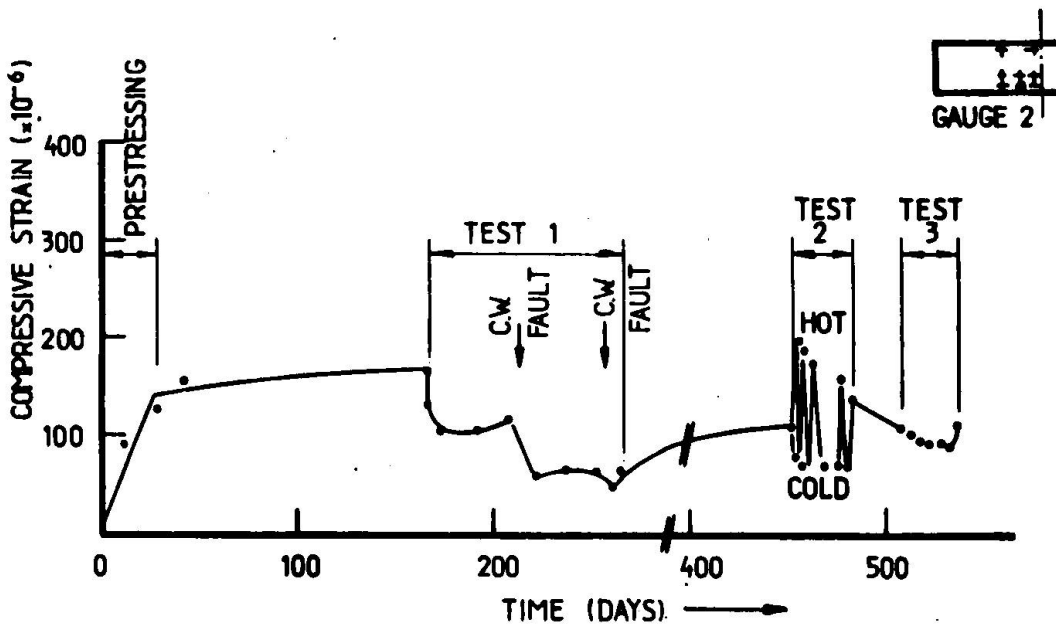
FIG. 11 RECORDED STRAINS AT GAUGE 2 OVER COMPLETE HISTORY OF MODEL.

The strain changes occurring in the hoop gauges adjacent to the central penetration are shown in Figs. 11 and 12. These figures also show the total strain history of these two gauges during the three tests.

The strains which occurred in test 3 show little change during the heated period. It can be seen from Figs. 11 and 12 that there was little change in strain between the end of test 1 and the end of test 3. There was, therefore, little additional permanent deformation in the model caused by either thermal cycling or over-heating.

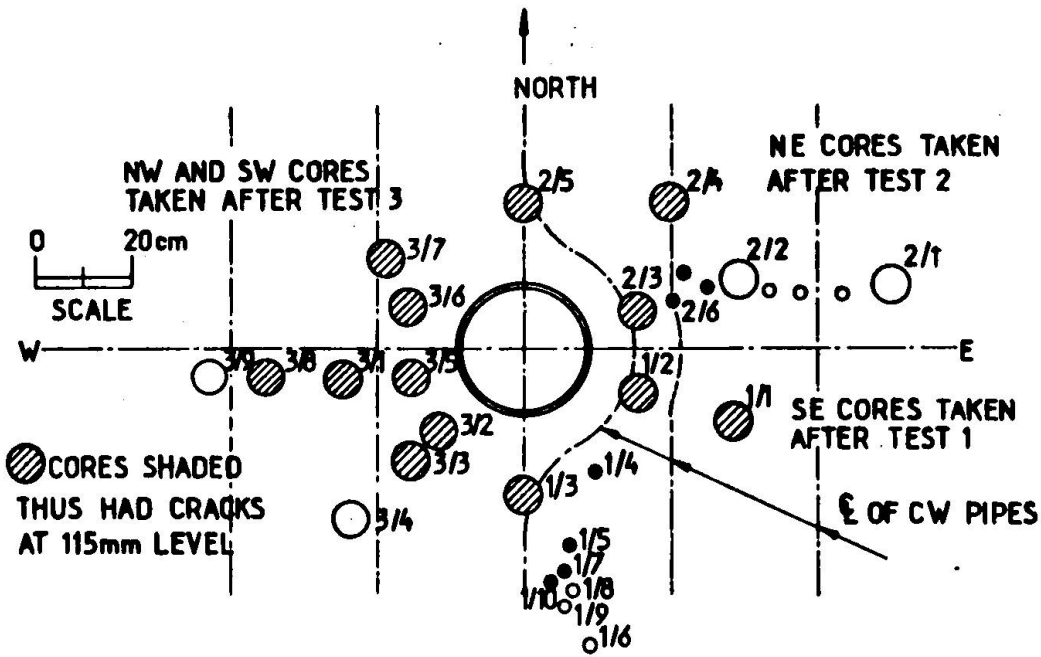
FIG.13 POSITIONS OF CORES TAKEN FROM MODEL

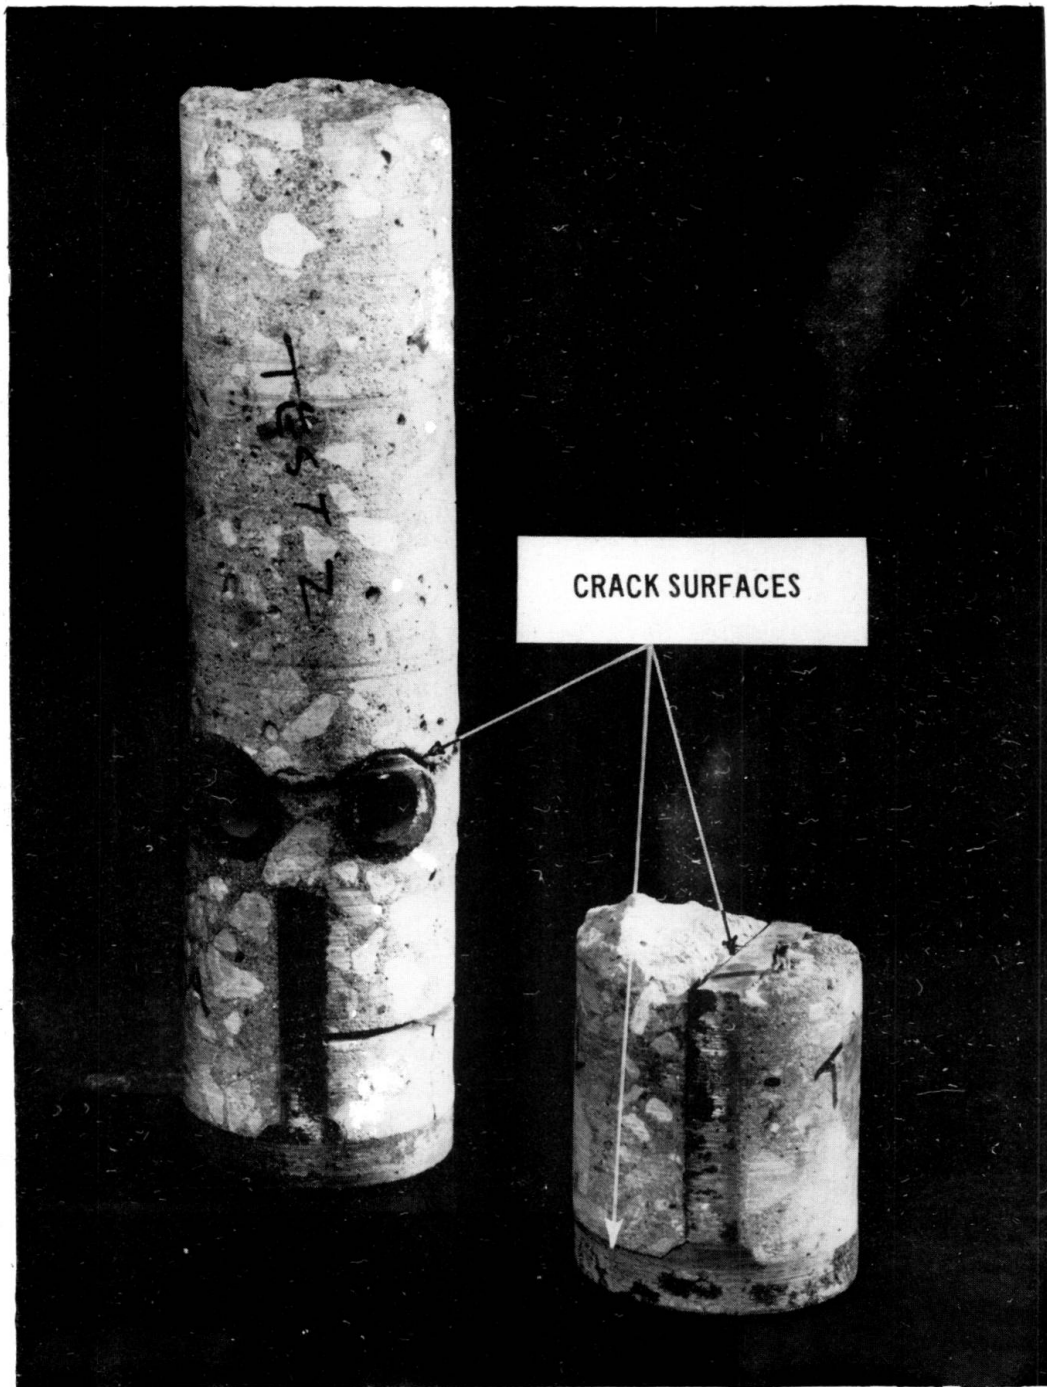
FIG. 14 CORES 1/3 (RIGHT) AND 2/5 SHOWING CRACK SURFACES

The cores taken after the test confirm the presence of the horizontal crack at a similar level to that found in test 1. This crack is clearly shown in Fig. 14. The extent of the crack in the NE quadrant after test 2 was similar to that in the SE quadrant in test 1. It is therefore considered that the original crack had not extended as a result of the thermal cycling. The presence of the hairline cracks in cores 2/3 and 2/5 is thought to be due to shrinkage induced by moisture movement.
