EFFECTS OF VRANCHA EARTHQUAKE OF 4 MARCH 1977 ON THE TERRITORY
OF BULGARIA

S. Sachanski - Dr. Eng. Head Dept. Seismic Mechanics, Bulgarian Academy of Sciences, Sofia, Bulgaria.

The spectral characteristics (predominant periods, Fourier transform spectra, response spectra) of Romanian earthquake on 4 March 1977 are analysed in respect to explain the causes of destruction of buildings located 200-500 km from epicentre.

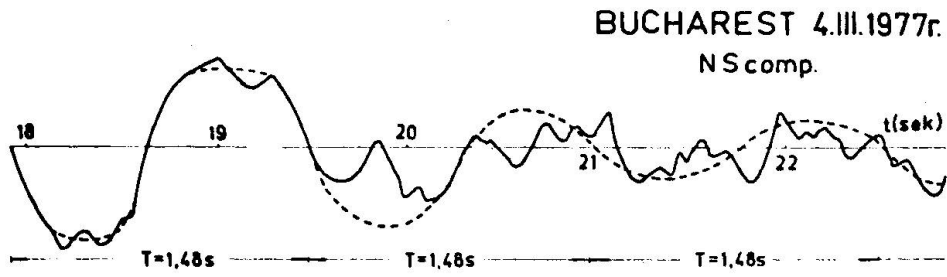
fig. 1

On the accelerograms recorded in Bucharest (INCERC), at distance 170 km from epicenter, can be seen typical sinusoidal character of the motion after 18 sec for both NS and EW components (fig.1). The accelerograms in Nish (453 km from epicenter) (fig.2) contain similar long period motion combined with short period waves specified by the geological conditions.

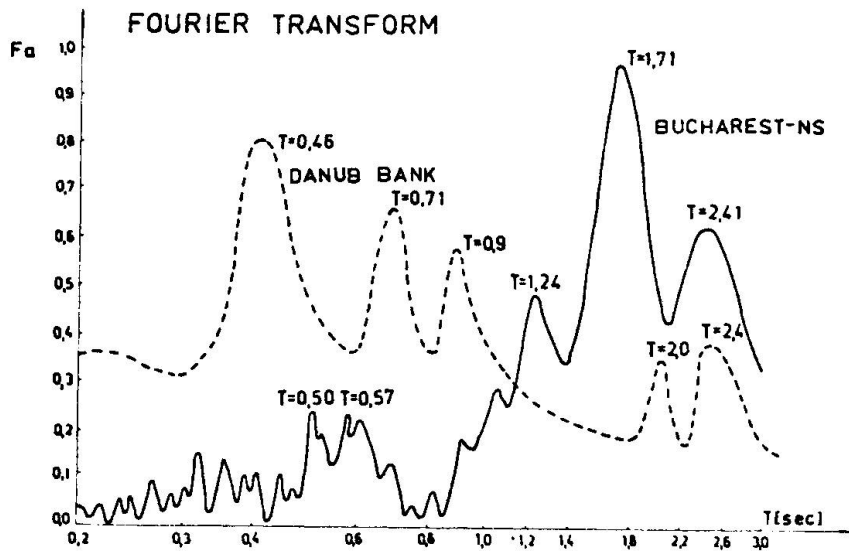
fig. 3

The Fourier transform spectra from Vrancha earthquake for Bucharest [1] and Nish [2] records and experimentally determined period [3] at right bank of Danube river (300 km from epicenter) are given on (fig.3). It is evident that specific deep geological conditions with short natural predominant periods for surface layers generate additional short motions (fig.2). Well known filtration of the short period waves with distance is not observed in this case. There are some regions on the territory of Bulgaria which generate short period motions and others one-long periods. This fact was confirmed by the behaviour of the structures with different natural periods located at different ground conditions.

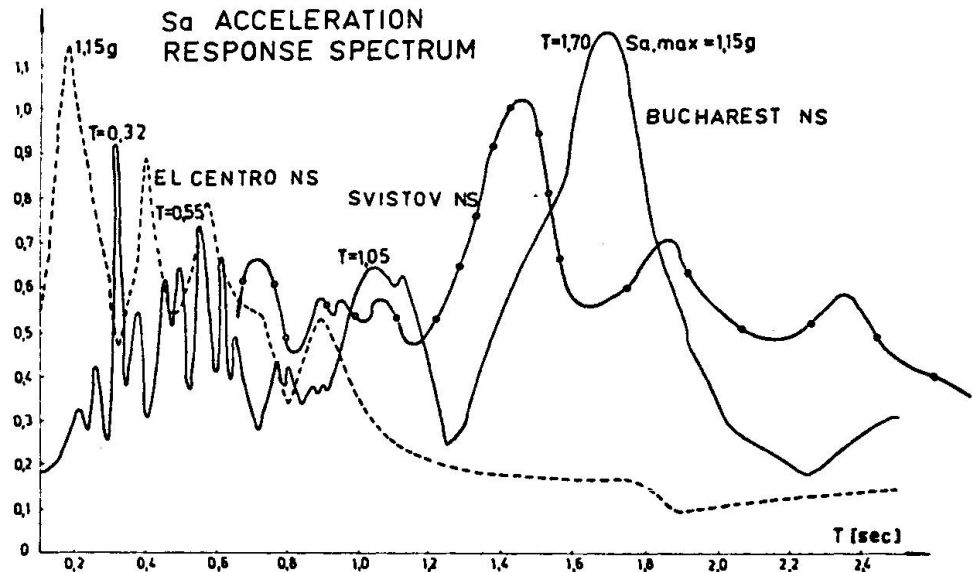
fig. 4

The response spectra for Bucharest record NS component, El Centro 1940 NS component and Svistov NS probable component at 0% critical damping are given on (fig.4). It is evident that Vrancha earthquake effect significantly the flexible structures with natural periods $T > 1$ sec. On this bases can be explained the large numbers of the damages in flexible structures. In some specific regions small buildings of one-two storeys had been heavily damaged

The most suprising effect of this earthquake was the total colaps of three reinforce concrete buildings without shear walls in first floor. This colapse can be explained by specific response spectra with maximum at $T > 1$ sec (fig. 4), sinusoidal exitation in both directions, large horizontal displacements and additional influence of P- Δ effect on the bending moments into the columns.

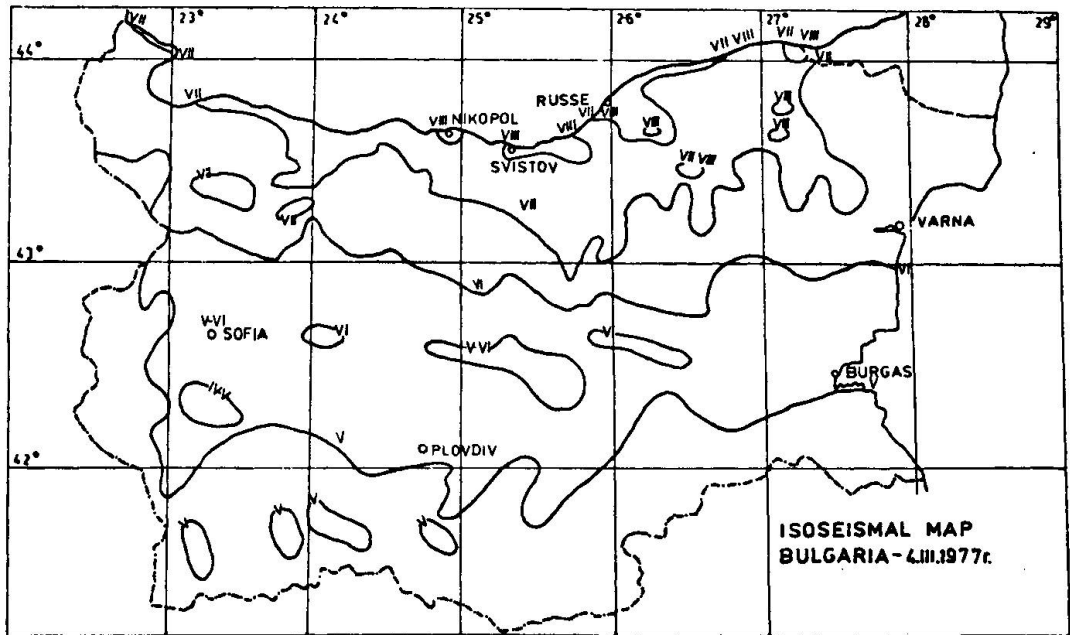
fig. 5

The isoseismal map of Vrancha earthquake on the territory of Bulgaria (fig.5) is influenced significantly by the geological conditions- specially on alluvial deposits at the rivers valley. The

most affected area—right bank of Danube is characterised by alluvial deposits and loessoidal surface layers of thickness 5 to 30 m.

In the most effected area—Svistov (point 1 on fig. 5) one storey brick masonry buildings did not get any cracks. Two storey very old buildings (fig. 6) with wooden floors did not suffered significantly. Some of them got small cracks (fig. 7) Some old buildings from last century (fig. 8) not designed for earthquakes but well built with steel connections between walls were damaged mainly in connections between timber roofs and masonry. In some other areas (point 2 on fig. 5) one and two storeys masonry buildings were heavy damaged. Those buildings had been built with low strength bricks and mortars (mud or lim-sand), timber floors and roofs non connected well with walls (fig. 9).

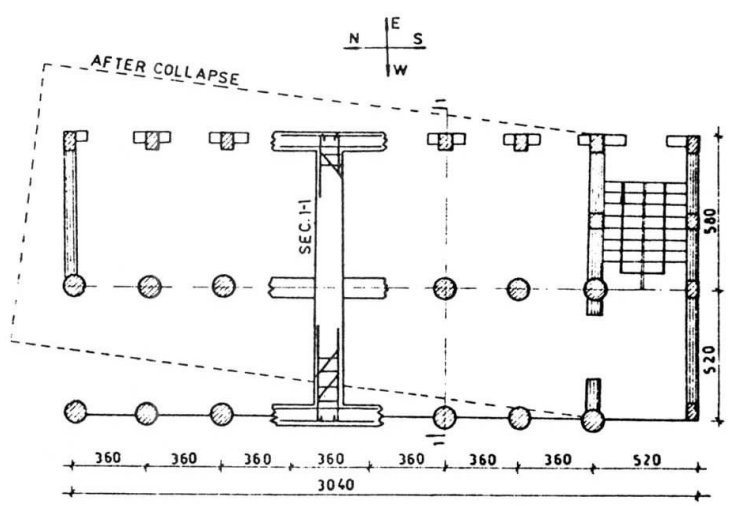
fig. 10

The fifth storey office building (fig. 10) is typical building with flexible first storey. The existing of shear walls at the stairs only develop additional rotational effects and reserve partly only first two storeys at the stairs (fig. 11). The cylindrical columns of the building are well designed (fig. 12) but connections between girders and columns did not forme space resisting frame for horizontal exitation. The small length of down girders steel bars into columns (fig. 10 b) was not capable to bear suficient bending moments from the earthquake. Similar construction had the sixt storeys public residential building wich was colapsed on the same way (fig. 13).

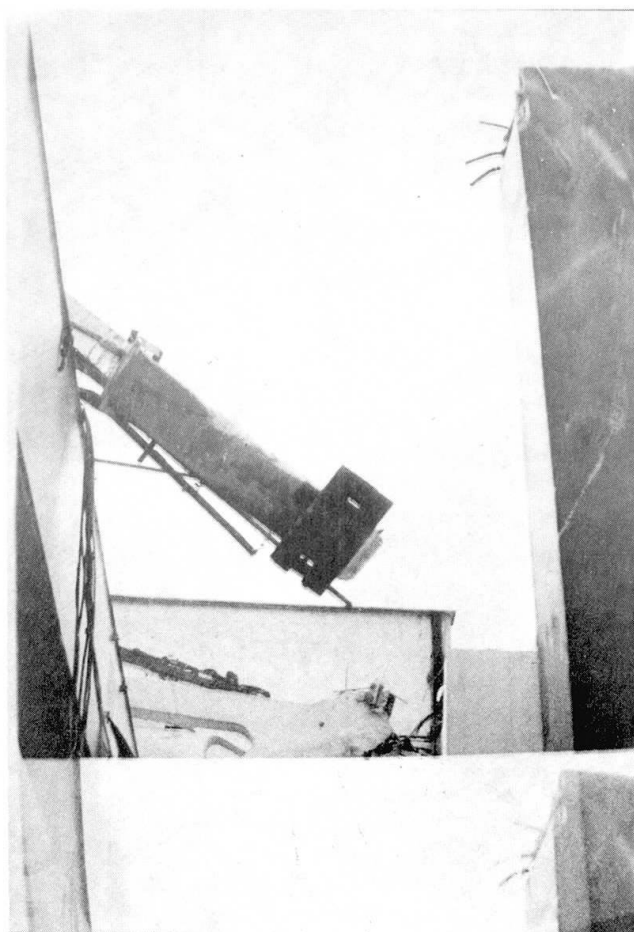
fig. 16

The damages in many industrial buildings were mainly from bed connections between roof trusses and columns (fig.16) between roof ,wall panels and columns.

Large panel and precast constructions non designed have resisted very well to this earthquake. Special attantion have to paid to the quality of realization on place of the joints between separate elements.
