# Session 1: Inspection, records and maintenance

## **SESSION 1**

**Inspection, Records and Maintenance**

## Conflict between Structurally Deficient and Historically Significant Bridges

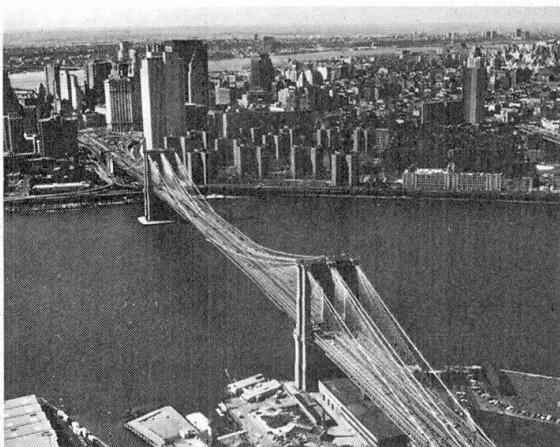
Fig.1. The Brooklyn Bridge, one of the most famous bridges in the world, celebrates its Centennial in 1983. Though no one would dream of replacing it, a cable corroded by pigeon dung snapped last year, killing a pedestrian; rehabilitation costs are estimated at \$105 million. Jack Boucher, HAER.

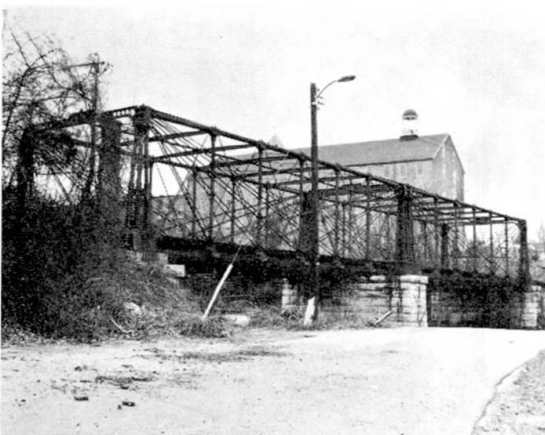
Fig.2. Bollman's Suspended & Trussed Bridge (1869) was relocated from a main line of the Baltimore & Ohio RR to service the mill at Savage, Maryland. It is the only known example of its type and facilitated the rapid expansion of early American railroads westward. Robert Vogel, Smithsonian Institution.

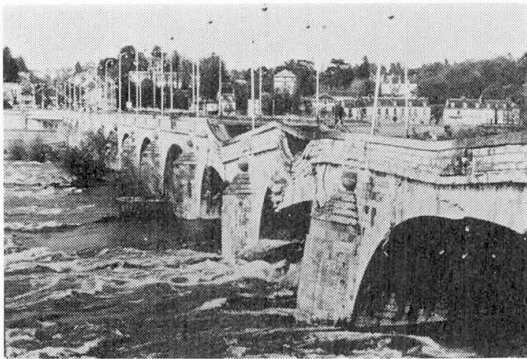
**Photographs 1 & 2 : The collapse of the bridge, on April 9th, 1978, at 4.02 p.m. (Photographs by Pierre Fitou – La Nouvelle République)**

Then on April 9th, 1978, at 9.27 a.m., pier 2 sinks and brings down the upstream-faced part of the 2nd arch. At 2.15 p.m., the upstream-faced part of the 3rd arch collapses in turn. At 4.02 p.m., pier 2 sinks by one metre, and arches 2, 3 and 4 crash down. On April 10th, pier 4 sinks downstream, spans 5 and 6 fall and pier 5 tilts down. Finally, on May 3rd, pier 1's collapse induces span 1's fall. Most fortunately, there was no victim.

The reason for this collapse was, once again, the removal of sand between the piers unprotected by adjoining wood piles, and the resulting transverse-force induced instability.

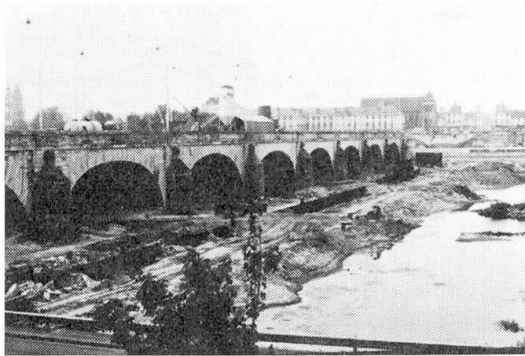
**Photograph 5 :** General view of cofferdam construction works.

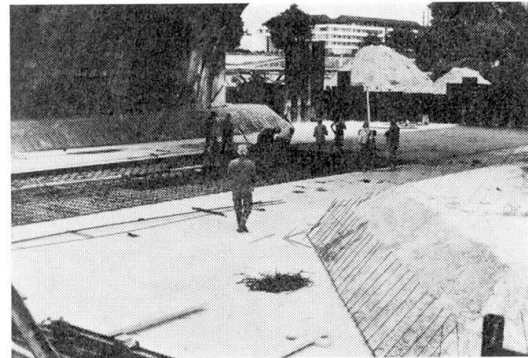
**Photograph 6 :** Slab casting.

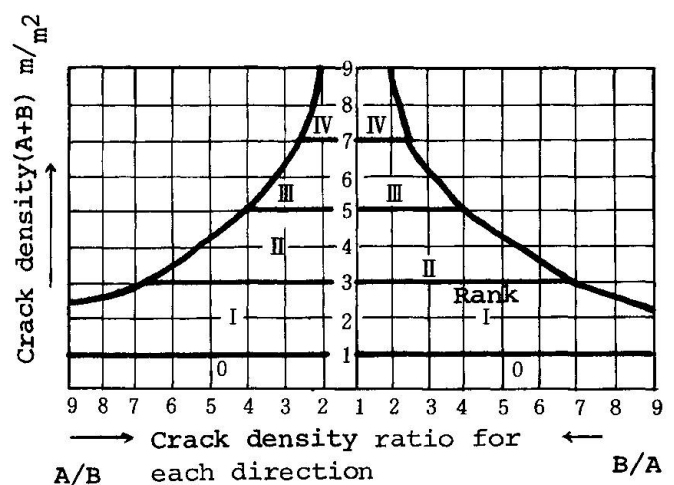
Fig 4. Crack density diagram (For crack's width larger than 0.1mm)

The criteria for damage ratings, as illustrated in Table 4, come from the crack density measured at the investigation.
