Preservation of Newly Built and Historical Buildings

Giorgio CROCI

This paper deals with the preservation of existing buildings. The main problem is the evaluation of the safety level, taking into account the crack patterns, the deterioration of materials, etc. As a result of this analysis, decisions can be taken about the opportunity and the criteria for intervention. The paper illustrates some cases, referring especially to historical buildings in Italy and Spain.

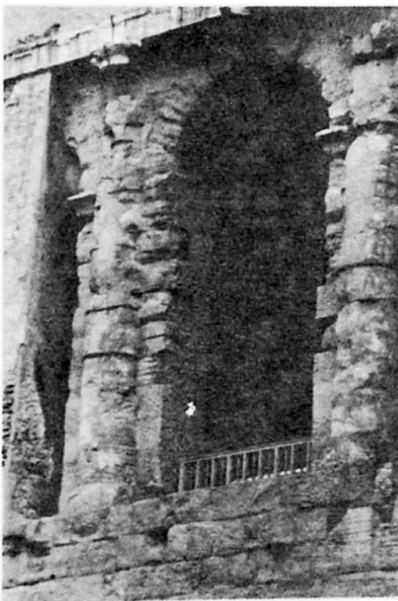
Pic.2: Alterations and deteriorations of Palazzo Senatorio

The first point to examine in the preservation of a structure is the analysis of the deterioration of the materials. This deterioration in the oldest buildings is linked not only to the chemical and physical phenomena, but also to the countless alterations, that, as in the case of Palazzo Senatorio in Campidoglio, Rome, (fig. 1) have occurred during the centuries (fig. 2), sometime stressed by incorret reinforcements (fig. 3).
