# Repair of the Todsburg Bridge (Fed. Rep. of Germany)

## 11. Repair of the Todsburg bridge (Fed. Rep. of Germany)

**Owner:** *Federal Republic of Germany*  
**Year of construction:** *1936/37*  
**Repairs carried out in:** *1983*  
**Under the supervision of:** *Heidenheim Motorway Authority*  
**Contractors:** *Weidle and Ludwig Fischer*

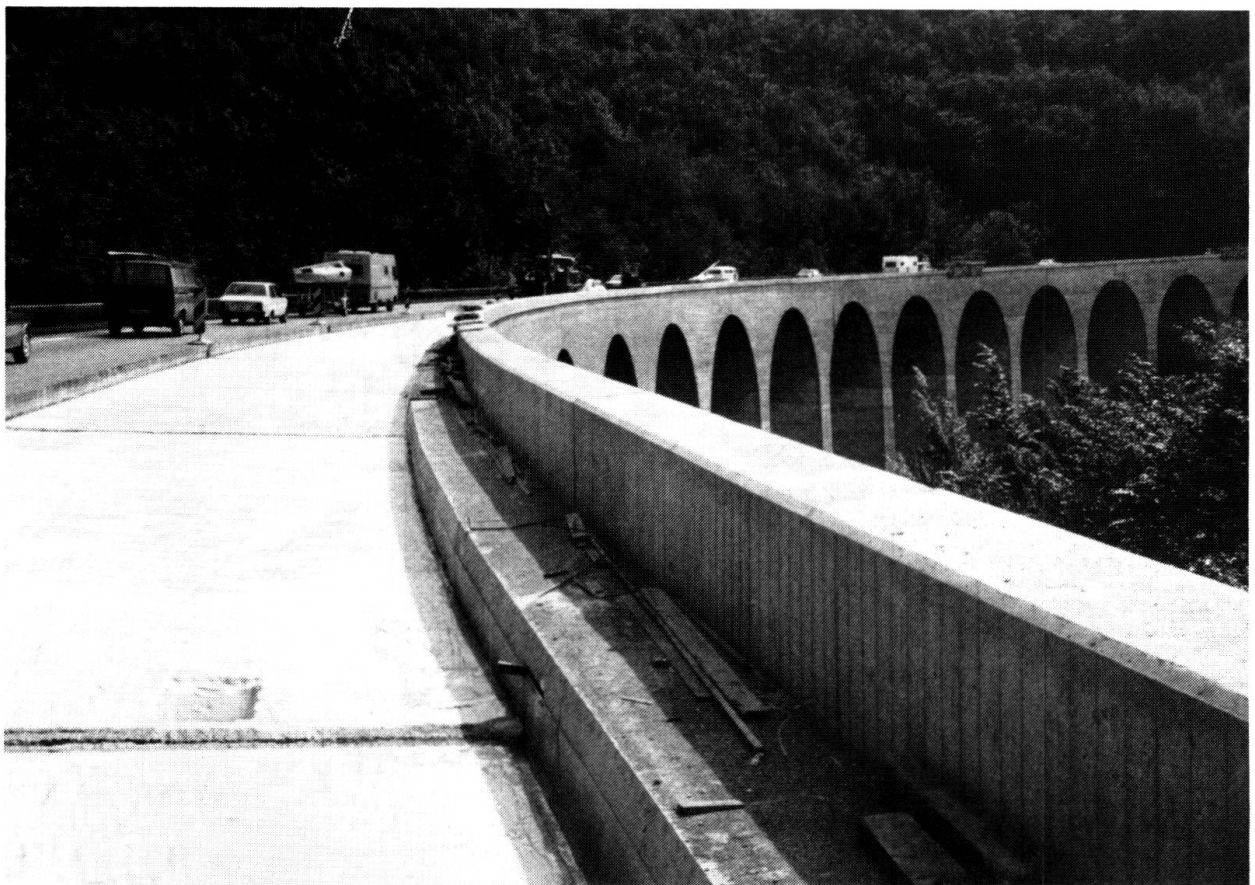
Fig. 1 The Todsburg bridge

The Todsburg bridge (Fig. 1) is located on the A 8 Autobahn between Stuttgart and Munich – one of the busiest sections of motorway in Germany. It stands between Stuttgart and Ulm at a point where the road climbs up into the Swabian Alb. For structural reasons, the two roadway sections are completely separate from each other. Some 30 000 vehicles pass over the bridge in each direction every day. By the beginning of the 1980's the concrete structure was in urgent need of repair – this stretch of motorway now being over 50 years old.

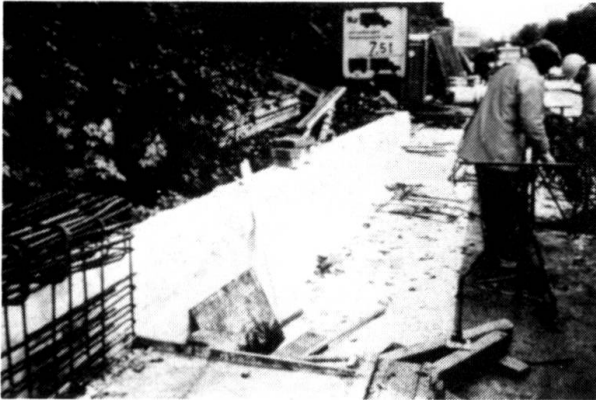
*Fig. 3 Working on reinforcements for the construction of the new parapet*
