**Artikel:** Built up roofs - wind uplift resistance  
**Autor:** Johansson, Germund  
**DOI:** <https://doi.org/10.5169/seals-38321>

## Built Up Roofs – Wind Uplift Resistance

### Germund JOHANSSON

Assist. Prof.  
Chalmers Univ. of Technology  
Göteborg, Sweden

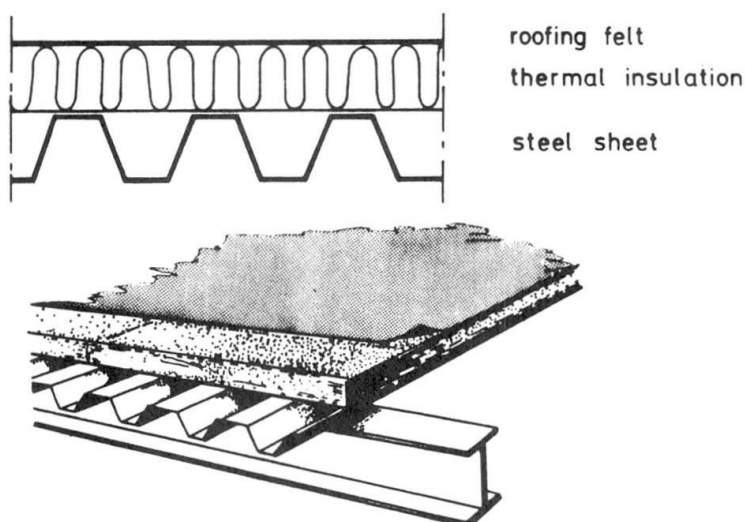
Fig.1 Built up roof

An externally insulated sheet metal roof consists of load-bearing trapezoidal metal sheet, thermal insulation and a covering surface. The insulation and the surface covering can be fixed to the sheet either by means of mechanical fasteners or by asphalt. Earlier the insulation were traditionally fixed to the sheet metal by bonding with warm asphalt. Nowadays often mechanical fasteners are used. In the case of mineral-wool insulated roofs the washers for these fixing devices are placed on the lower felt layer or, in certain cases, directly on the insulation.

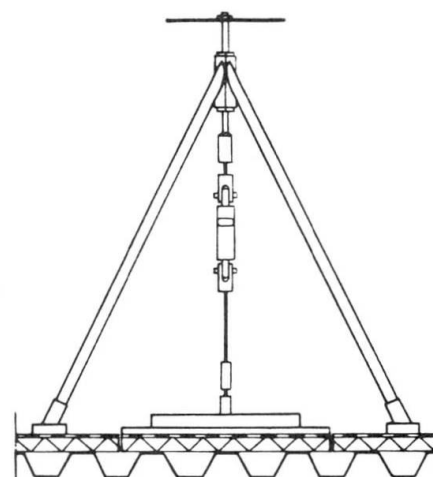
Fig.2 Test equipment for wind uplift testing

The test equipment used consists of three main parts – a stand with lift outfit, a frame to be attached to the specimen and a dynamometer between the stand and the frame, fig.2. The stand is made of aluminium and wood. The lifting force is achieved via screw in the top of the stand. A 22 mm thick slab of chipboard was bonded with hot asphalt to the surface of the roofing felt. The width of the chipboard slab is 500 mm and the length is governed by the pitch of the steel sheet. After having glued the board slab and screwed the frame to the slab, the insulation and the roofing felt were cut along the slab lines. The test method is easy to handle but it has some disadvantages – the test surface is disturbed by cutting and by gluing with hot asphalt. However, some test roofs which showed very low strength have later blown off during storms and the roofs with high values for the strength have not done so.

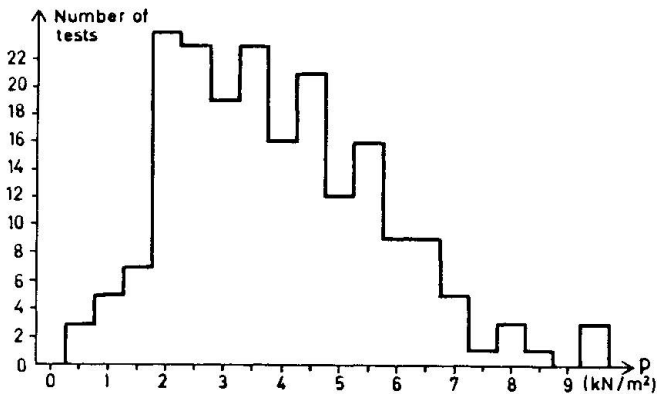
Fig.3 Measured strength of roofs with glass wool and mineral wool

In the middle of the 70's several roofs were tested with the equipment described. Twentyfive different roofs with insulation of fiber glass or mineral wool were tested with about ten specimens on each roof (200 in situ tests). The results showed a very large scatter, the maximum strength value obtained was more than twenty times the minimum value. The results are presented as a histogram in fig.3. The conclusion to be drawn is that the material quality and workmanship is not always what it ought to be. For instance, on one roof the lowest strength measured was  $0.4 \text{ kN/m}^2$  and the highest  $9.1 \text{ kN/m}^2$ , a difference as high as  $8.7 \text{ kN/m}^2$ .

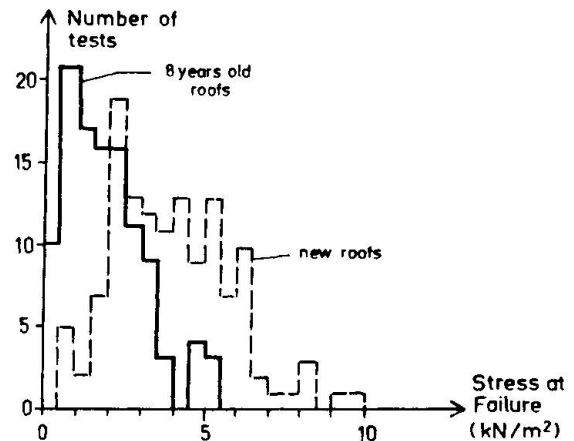
Fig.4 Measured strength of roofs with glass wool and mineral wool - comparison between old and new strength.

Eight years later, in the beginning of the 1980's, 13 of the roofs have been re-tested using the same equipment and the same technique. Some of the other roofs were "not available" for tests or they had blown off or they had been destroyed by fire. The results from the tests are a little bit frightening - there is a very large strength reduction. In table 1 some of the results are shown. After eight years the mean strength is reduced to about 50% of the original strength. The two histograms in fig.4 correspond to the measured strengths at all the roofs in table 1. The field tests show that for a new roof the fracture usually occur in the lower part of the insulation or between the insulation and the steel deck. Older roofs nearly always break in the upper part of the insulation just under the roofing felt.

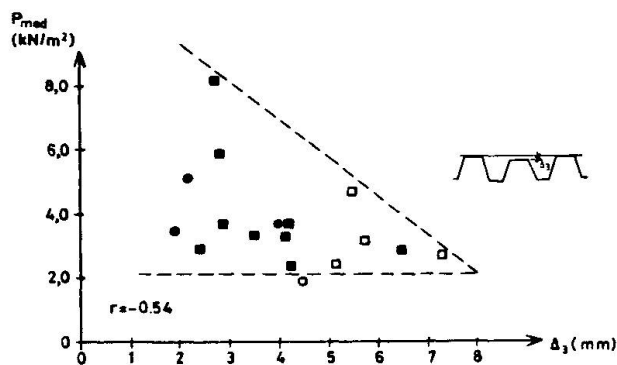
Fig.5 Relationship between measured strength (failure at sheeting - insulation interface) and measured flatness deviation  $\Delta_3$  for roofs insulated with mineral wool.

Unevenness of the sheeting surface has some effect on the strength. There does not seem to be a definite relationship, but approximate scatter range can be discerned. The relationship between strength and the measured deviation over three corrugations,  $\Delta_3$ , are plotted in fig.5 for 18 roofs. The conclusion which can be drawn from these figures is that a more even roof surface may increase the short-term strength, but need not necessarily do so.

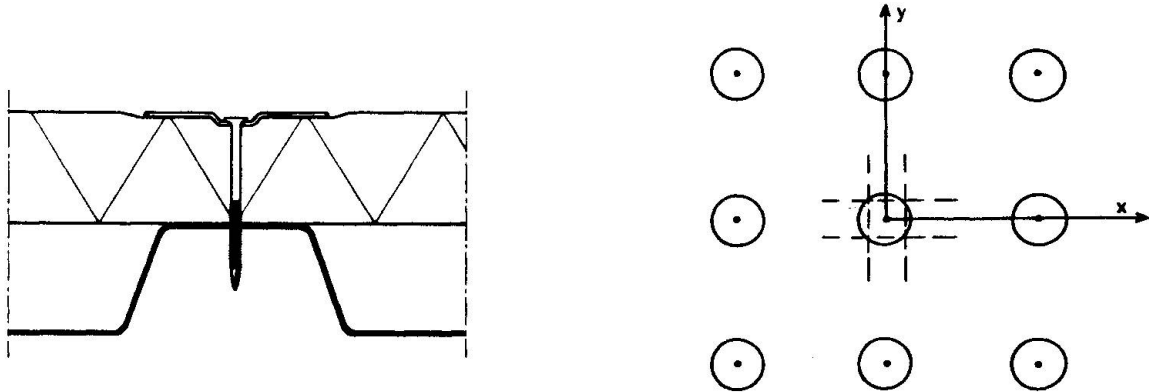
**Fig.7** Mechanical fasteners. Possible folding lines for the washers are indicated.

Storm damages due to the low strength have led to a new concept. Instead of using asphalt bonding most of the roofs nowadays have mechanical fasteners. This means that the requirements on the steel deck have been reduced and that the roof behaves in a different way. The use of mechanical fasteners on roofs have led to very few storm-damaged roofs. There are many different types but most of them consist of a screw and a washer. The fasteners are placed in a rectangular net, fig.7.

"Full scale tests" with suction box have shown that there is not linear relationship between the limit load and the number of screws  $\text{mer m}^2$  if fracture occurs in the attachment between the water proofing membrane and the fastener. Usually fracture appears to be a combination of bending in the washer and punching of the membrane. The washer and its perimeter can be divided in four different parts where

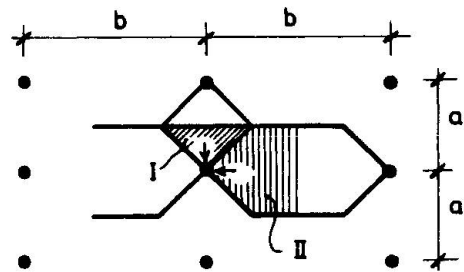
**Fig.9** Influence areas. Area I =  $a^2/4$

the boundary between the areas inclines  $45^\circ$  degrees to the attachment lines. The load on the screw, the total force, is the sum of all the loads on the different areas, I-IV, fig.8. The maximum load of the fastener occurs when the load on any of the perimeters I, II, III, IV reaches its maximum (fracture) level. If the exterior load is assumed to be carried the nearest way from the membrane to the fastener we get the influence areas shown in fig.9. When the external load  $q$  causes fracture in the fastener the load on perimeter II is

$$P_{II} = q \cdot \frac{a}{2} (b - \frac{a}{2}) \quad (1)$$

The corresponding load at perimeter I is

$$P_I = \frac{a/2}{(b-a/2)} P_{II} \quad (2)$$

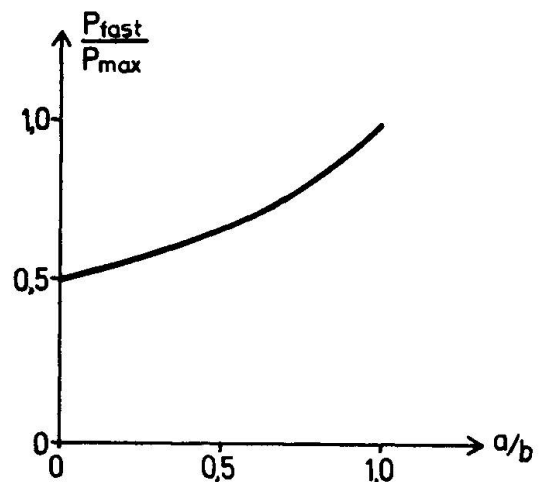
Fig.10 Maximum load in the fastener as a function of  $a/b$

The maximum load for the fastener is reached for  $a = b$  and  $P_{max}$  is  $4P_{II}$ . The ratio  $a/b$  is governing the maximum load in the fastener and in fig.10 the ratio  $P_{fast}/P_{max}$  is shown.

$$P_{fast}/P_{max} = 0.5 + 0.5/(2 b/a - 1) \quad (4)$$

From eq (4) you will find that doubling the number of fasteners by changing from a quadratic net  $a \times a$  to a rectangular net  $\frac{a}{2} \times a$  will raise the external load by 33%. ( $P_{fast}/P_{max}$  decreases from 1 to 0.67) There have been conducted tests [2] on
