# Construction of cable-stayed bridges in Honshu-Shikoku bridges project

Outline of Iwakurojima  
Cable-stayed Bridge  
Weight (Tower) 8,340ton  
(Cable) 2,230  
(Girder) 24,530  
Total 35,100

# CONSTRUCTION OF CABLE-STAYED BRIDGE

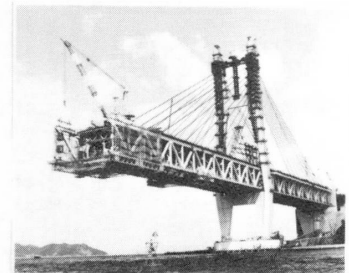
Erection of main truss

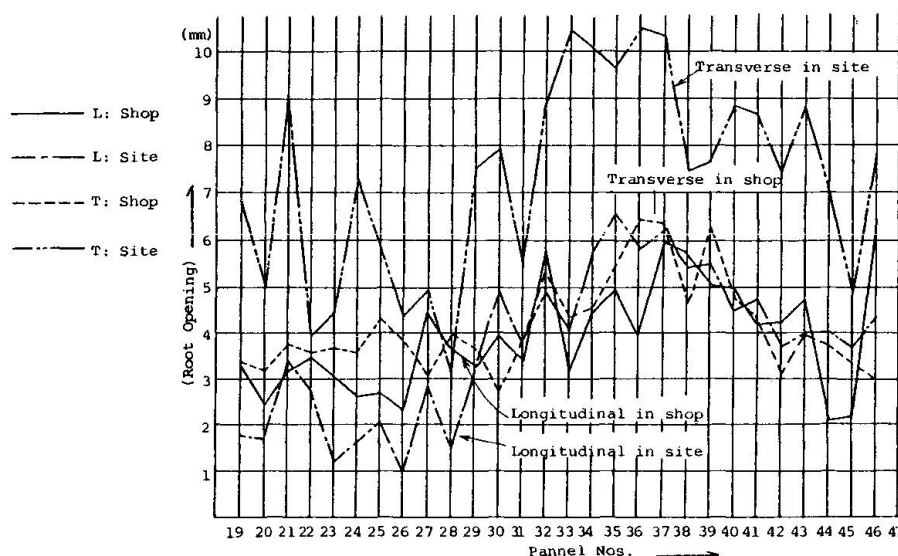
Fig. 1 Root Opening Difference between Shop Assembly and Construction Site

Fig-1 shows the root opening in the shop and on site.

Apparently the transverse root opening in the site bridge axis is larger than that in the shop. This is a result of the welding contraction, because the drift pins and the temporary bolts at the bolt joints between the main girder and the steel deckplate were removed, releasing the residual stress caused by welding. Therefore the main girder camber was not greatly affected by the contraction due to the welding.

The longitudinal root opening tends to be smaller at site than in the shop, although the difference is small.

Also the longitudinal root opening did not appear to have any effect on the width of the main girder because stress releasing was performed as in the case of the transverse opening, with the floor truss keeping the width of the main truss.

- (2) Quality of welds (Fig-1)

33 - 46 show larger root openings than 19 - 32. This is due to the fact that the standard values of the root opening differ depending on the method of welding (Submerged arc welding-CO<sub>2</sub> gas automatic arc welding).

The transverse root openings in the direction at right angles to the bridge axis were larger at the site, but the results of X-ray tests show that the quality of welding was satisfactory, presenting no problems.

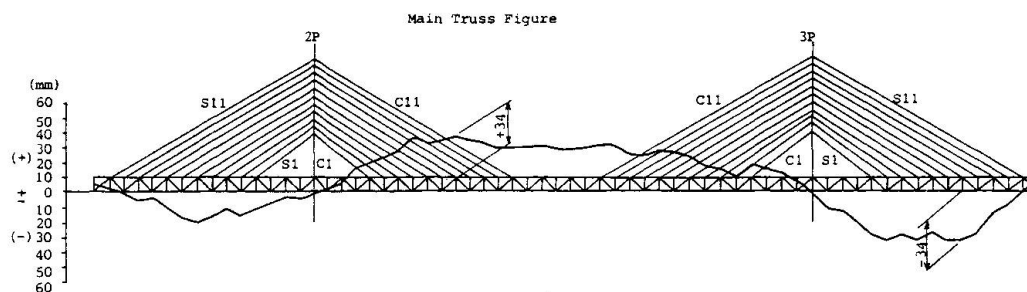
Fig.-2 Vertical error

Fig-2 shows errors between the planned values and the measured values at the time of closure of the girder. In the figure, the planned values were calculated according to the loading at the time. The error at the center of the central span is + 34 mm and that on the side spans is - 34 mm, and the tolerance on the central span being 118 mm and 59 mm on the side spans, respectively. These prove that the accuracy is satisfactory.

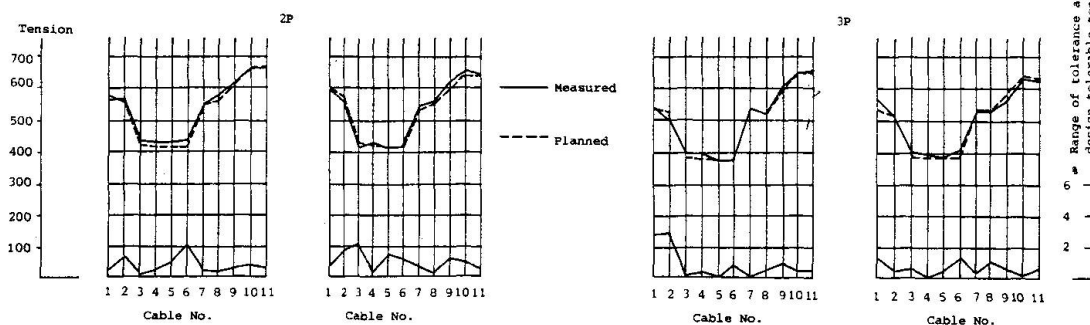
Fig. -3 Cable Tensions

Fig-3 shows cable tensions at each tier at the time of closure. The difference between the planned value and measured value according to the loading condition at the time was smaller than 5%, showing that the erection was performed with an extremely high accuracy.

However, as the allowed designed erection error was  $\pm 5\%$  of the allowable design tension at the time of completion, it is judged that the range of errors at this stage was to be made  $\pm 2.8\%$  of the allowable tension, taking into account the errors in the measurement. Therefore, shim plate adjustment was performed only on the cables at the 6th tier of the left side span, and at the 2nd tier and 1st tier on the right side of the center span.
