Effects of Length on Fatigue of Steel Wires in Service

Graham TILLY

Head of Struct. Group
Transp. Res. Laboratory
Crowthorne, UK

Practical issues in relation to the fatigue of 5 mm wires, 7-wire prestressing strand, and hanger cables, are discussed. Examples are given of failures taken from bridges in service.

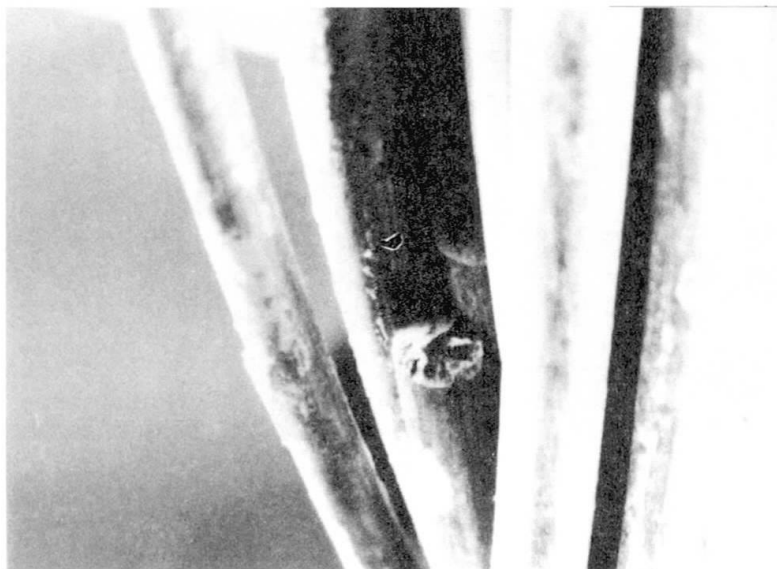
Fig 7 Fretting fatigue in 19-wire strand.

induced failures were identified in tests on the 19-wire strand - see fig 7. It was most dramatically exhibited on the larger cables tested in a specially designed bending regime as shown in fig 8, Tilly [13].

The nature of strands is such that when they are tested under tensile loads relative movements occur between the spirally wound outer wires and between the outer and inner wires. This causes fretting at the points of contact between the wires leading to earlier initiation of cracks and reduced fatigue lives as discussed for 7-wire strand by Cullimore [12]. In the present investigations fretting

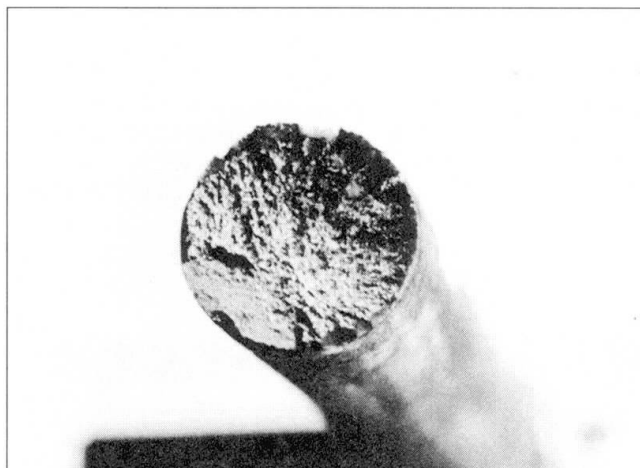
As described in section 3 corrosion causes up to 50 per cent reduction in remnant fatigue strength due to the presence of pits causing local stress concentrations. Examples of fatigue initiated from corrosion pits are given in figs 9 and 10. Here the pit depths were about 0.8mm and 0.34mm respectively and are fairly typical of the more severely corroded wires. Final fracture of the 8mm diameter wire shown in fig 10 is brittle type.

Fig 10 Initiation from corrosion pit in 8mm diameter wire.
