Diagnosis and strengthening of the Brunelleschi Dome

Autor(en): **Chiarugi, A. / Fanelli, M. / Giuseppetti, G.**

Diagnosis and Strengthening of the Brunelleschi Dome

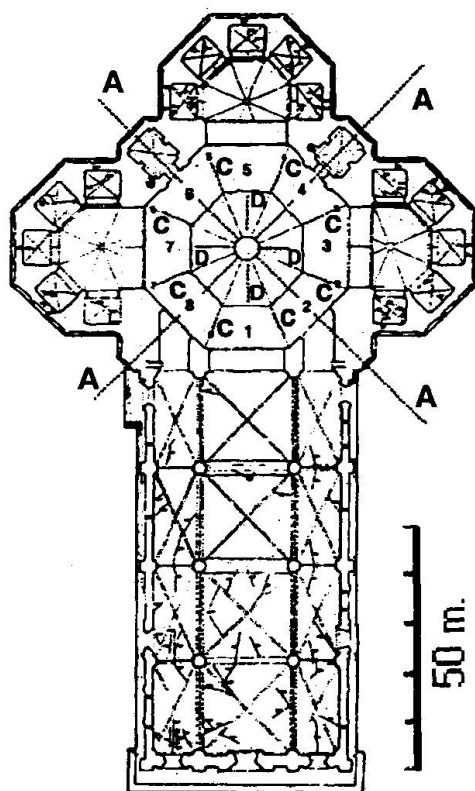
Fig. 1 Sides numbering and planar position of type "A, B, C and D" cracks.

After 1434 (the year in which Filippo Brunelleschi achieved the construction of the Dome of Santa Maria del Fiore), and after the erection of the skylight, carried out after Brunelleschi's death, no direct information is available until 1600 about mechanical problems in the Dome. Successively, several investigation campaigns are mounted concerning the cracks observed on some of the dome's panels, especially on the sides directly above the absidal pylons, and in particular in the South-East corner, panel n° 4; see figgs. 1 and 2.

- "type D" cracks, also penetrating only to a partial depth in the thickness, along the midline of the panels with odd numbering (see figgs. 1 and 2).

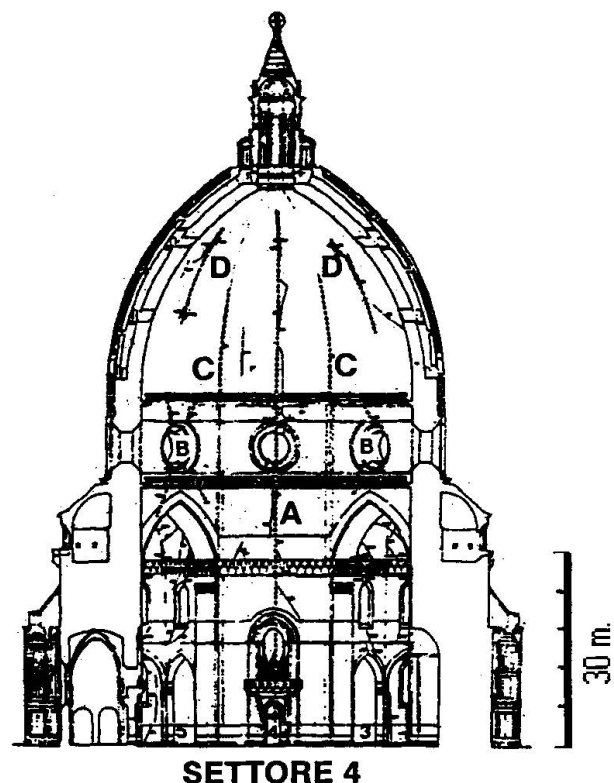
Fig. 2 Crack description summary with type "A, B, C and D" cracks.

- "type A" cracks, subvertical, through the whole thickness. (panels with even numbering);
- "type B" cracks, subvertical, through the whole thickness, in the panels with odd numbering;
- "type C" cracks, penetrating only to a partial depth in the thickness, in the edges between adjoining panels;

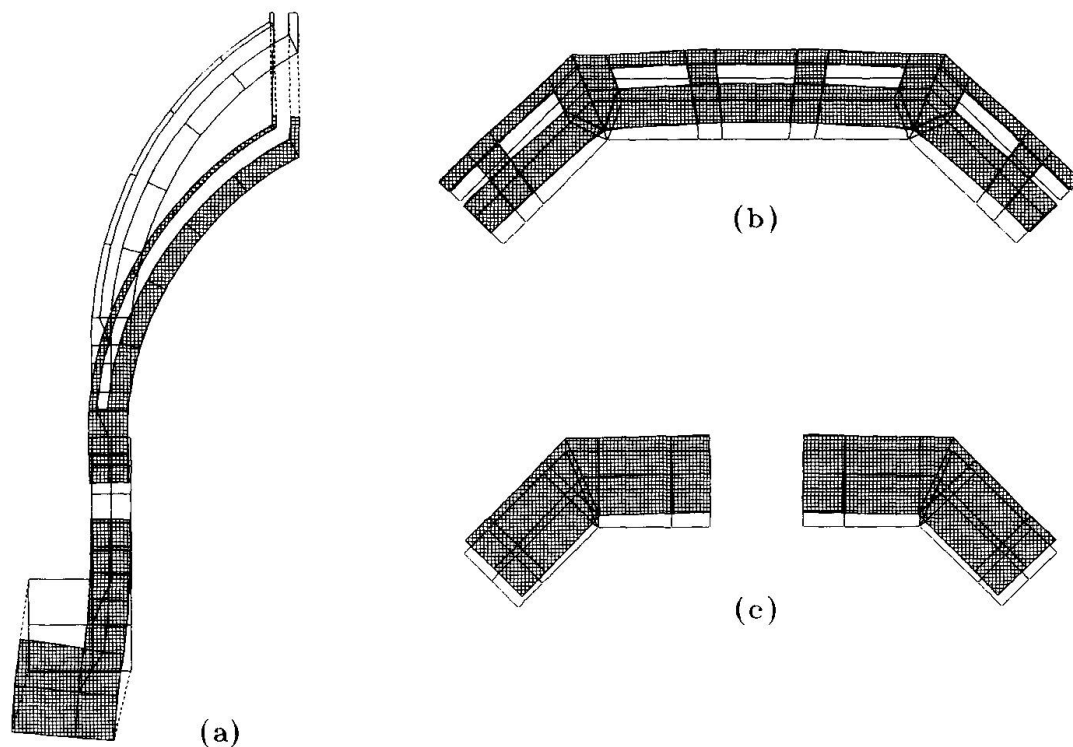
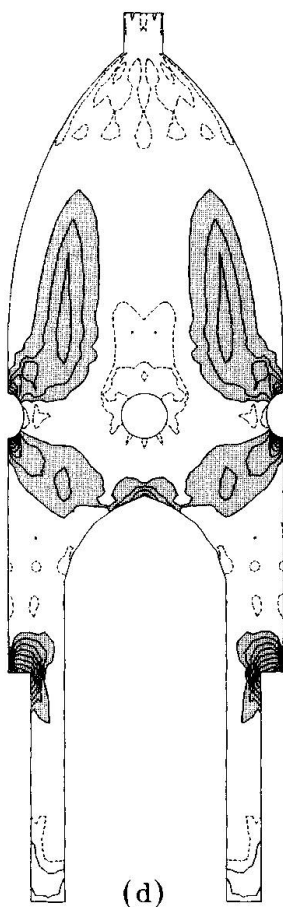
Fig. 3 "First virtual model" undamaged structure:

- (a) deformed line of vertical section in centerline on even-numbered panel;
- (b) deformed line of section 3-3 at 66 m level;
- (c) deformed line of horizontal section on circular centerline window (note ovalization of opening on even-numbered panel);
- (d) stress distribution σ horizontal on intrados face (note tension increase around the circular windows of even numbered panel and above the keystone of arch). Tension zone shaded.

- "First virtual model" characteristic:

n° nodes 3286

n° elements 569

isoparametric hexahedrons with 20 nodes

isoparametric pentahedrons with 15 nodes

modulus of elasticity: 50000 kg/cm²

Poisson's ratio : 0.1

Density : 0.0018 kg/cm³

A perusal of results clearly shows that the "parallels" just above the circular windows on the even-numbered panels undergo high levels of tensile stresses. Horizontal tensile stresses are found also in the drum, above the keystone of arches on the odd-numbered sides (see fig. 3 a, b, c, d).

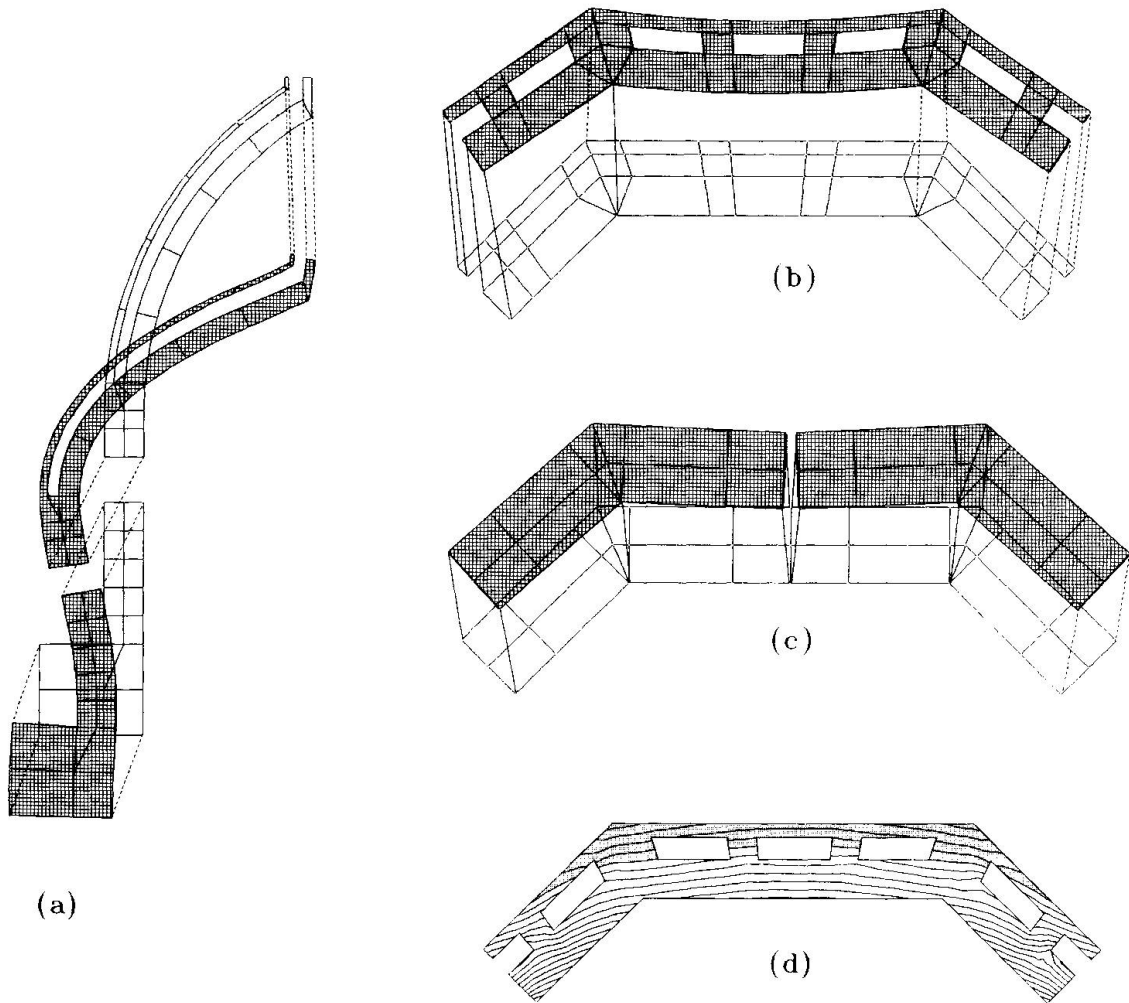
Fig. 4 "First identification model" with type A and B cracks:

- (a) deformed line of vertical section;
- (b) deformed line of section 3-3 at 66 m level
(note inflexion on the section plane);
- (c) deformed line of section under circular window
(note opening crack B);
- (d) stress distribution σ_z vertical in section 3-3
(note effects of bending with vertical tension
localized in external panels with odd numbering).
Tension zone shaded.

The results of the analysis carried out on this second model confirm the indications of the crack pattern, explaining in particular the origin of the cracks "type C and D". It is observed also that the external shell on the odd-numbered sides is subjected to vertical tensile stresses, whereas the highest level of vertical compressive stresses is found in the internal corners of cracks "type A".

This distribution of vertical stresses has been confirmed experimentally through another "continuous monitoring" operation using the flat jack technique (fig. 4 a, b, c, d; fig. 5 a, b, c).

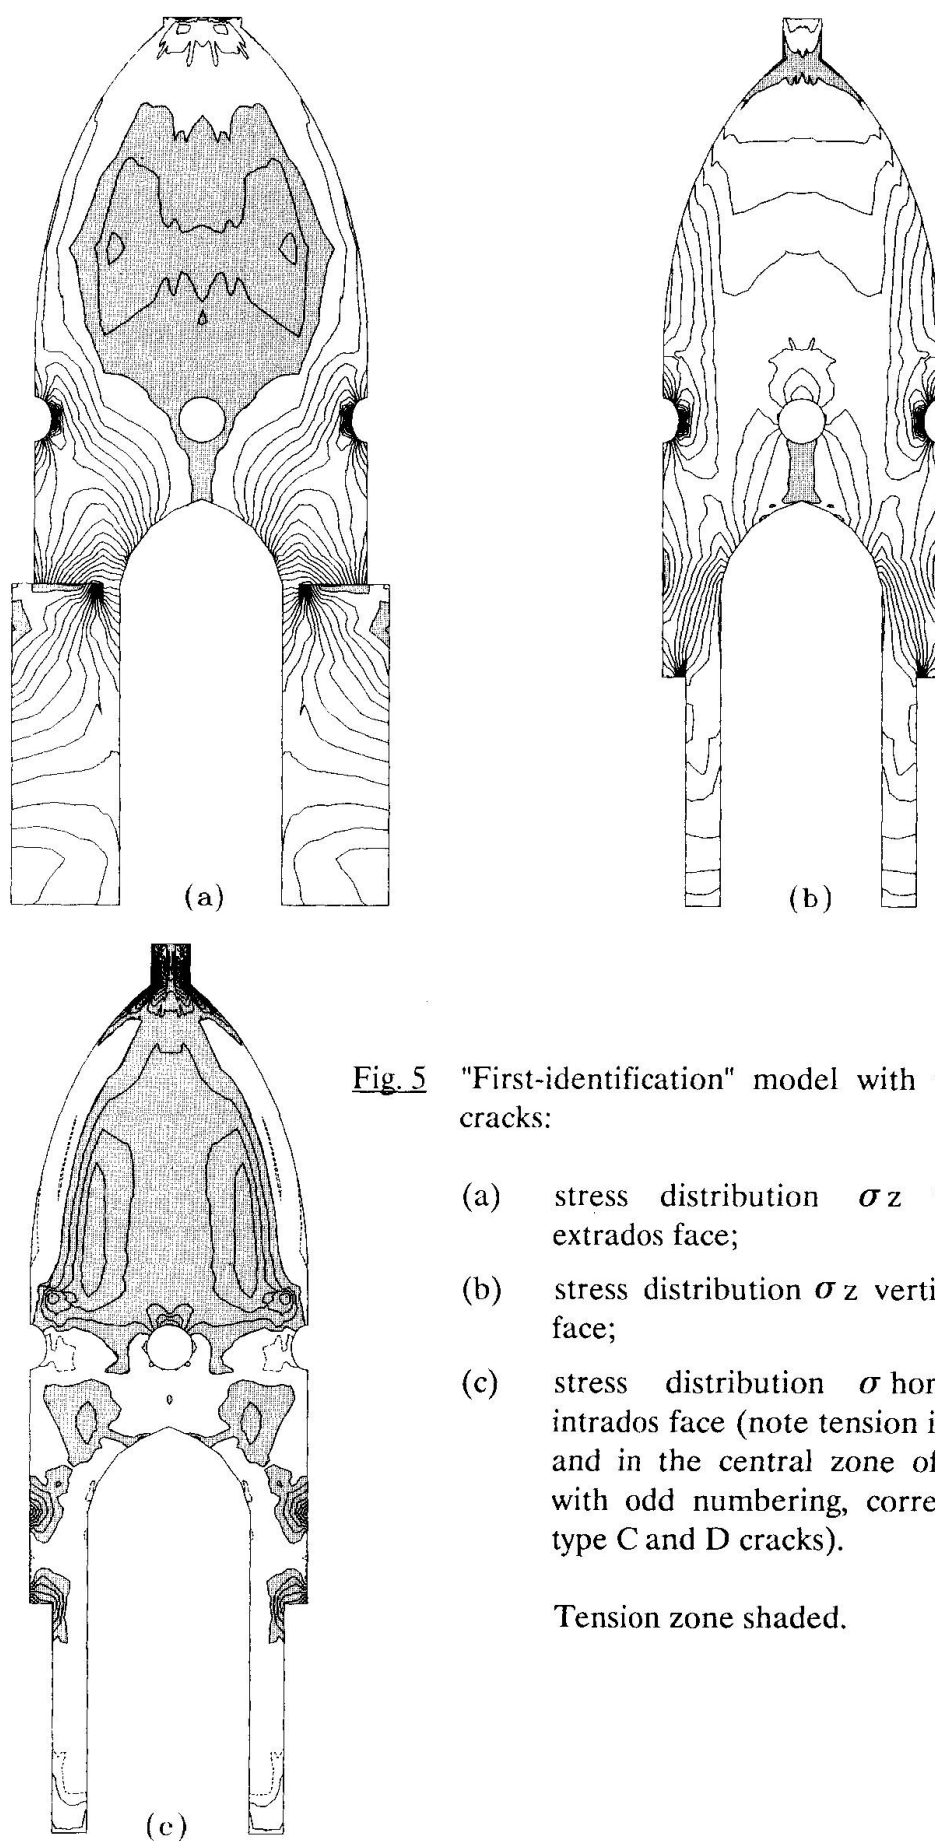
Fig. 5 "First-identification" model with type A and B cracks:

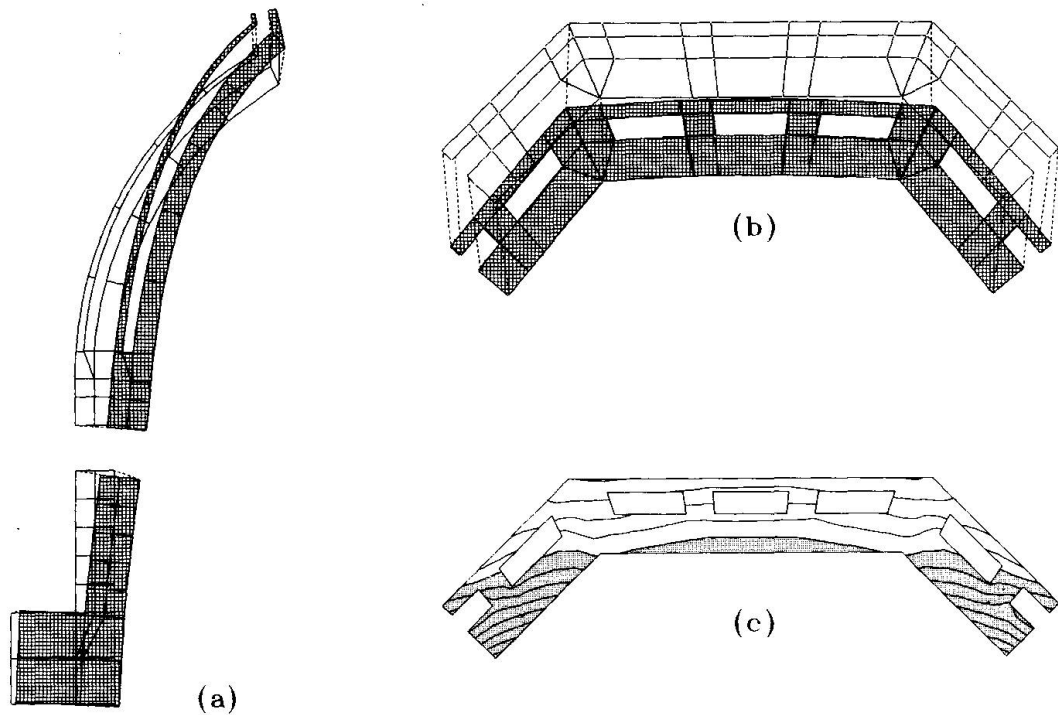
**Fig. 6**

"First identification model" under only strengthening effect:

- (a) deformed line of vertical section;
- (b) deformed line of section 3-3 at 66 m level;
- (c) stress distribution σ_z vertical in the section 3-3; with opponent distribution with respect to the dead-weight;
- (d) stress distribution σ_z vertical on intrados face;

Tension zone shaded.

The strengthening intervention could be effected through harmonic-steel cables placed at floor level in the first walking. The shape of these belts, pulled on at the midpoint of each side, would be octagonal; thus the interaction with the existing structure (apart from local effect) could be schematized by a system of radial forces, applied in the edges at the springing section of the dome.

Perusing the numerical simulation of this strengthening carried out on the "first-identification" model, one is surprised by the close- fitting antagonistic effect brought about by the intervention as against the dead-weight stress pattern (fig. 6 a, b, c, d).
