Artikel: Stress measurement and repair of a fatigue cracked box girder bridge
Autor: Yamada, Kentaro / Ojio, Tatsuya / Kainuma, Shigenobu
DOI: <https://doi.org/10.5169/seals-57469>

Stress Measurement and Repair of a Fatigue Cracked Box Girder Bridge

A three span continuous box girder bridge in Nagoya was subjected to very heavy traffic, amounting to over 55,000 vehicles per day on three lanes and with about 50 percent trucks. In 1988 fatigue cracks were observed at diaphragm corners after 20 years of service. The fatigue damaged diaphragm corners were repaired by high strength bolted splices. Truss members were also added to stiffen the diaphragms and the cross beams. In the summer and the fall of 1996 stress measurements were carried out to investigate a method for measuring truck axle weights and to carry out a fatigue assessment of the orthotropic steel decks and diaphragm corners. In this paper the case history of the box girder bridge is summarized and the preliminary results of stress measurement are presented.

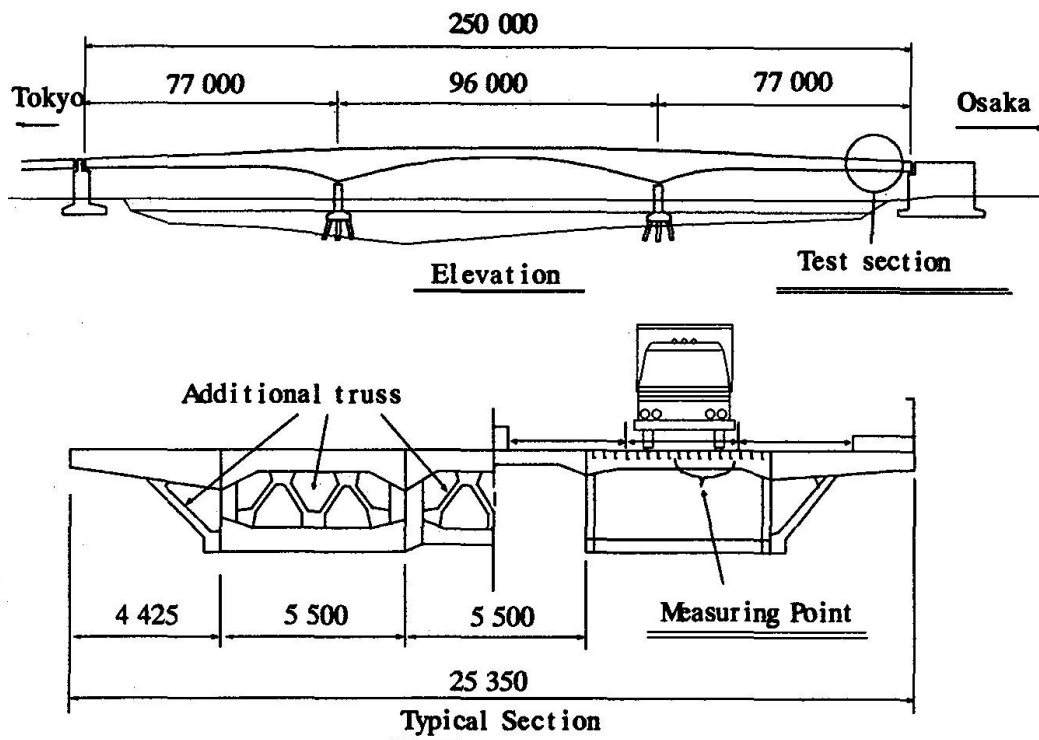
Fig. 1 Orthotropic steel deck bridge

After about 25 years in service, fatigue cracks were found at corners of diaphragms and at sole plates of supports. A committee (Chairman; Prof. Nishino) was formed to investigate the extent of the damage, causes of the cracks and ways to retrofit the bridge. Intensive investigations, such as stress and vibration measurements and structural analysis by the finite element method, were carried out to find the best possible ways to retrofit the bridge. Based on such investigations the cracked parts were strengthened by high strength bolted splices, and truss members were added

to stiffen all diaphragms and every other cross ribs. The rehabilitation scheme seemed successful, and no further fatigue damages were observed at these stiffened parts. However, recent inspection revealed that a few additional cracks were found at the diaphragm corners which were not retrofitted eight years ago, because no fatigue cracks were observed at that time.

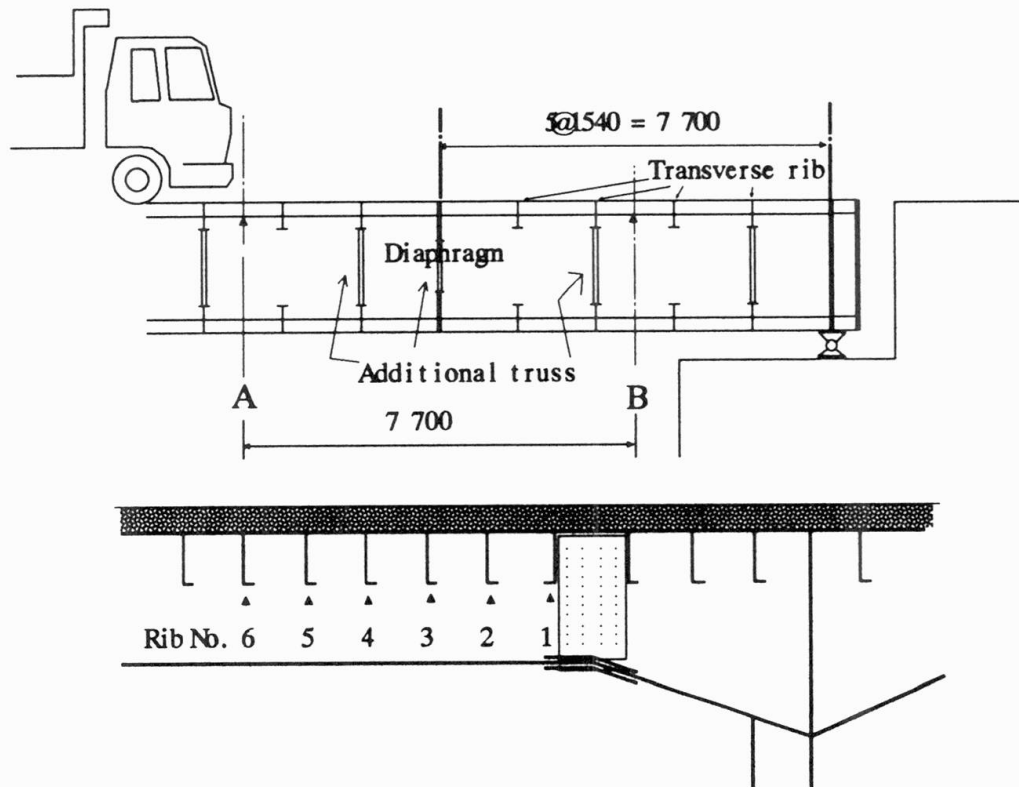
The orthotropic steel deck of the box girder bridge is schematically shown in Figure 2. It has a 12 mm thick deck plate, stiffened longitudinally at every 300 mm with bulb plates (open ribs) of 180 mm wide and 9.5 mm thick. About 80 mm thick asphalt pavement is placed over the deck plate. Diaphragms are placed at every 7.7 m with four cross beams of which are 1.54 m apart between the diaphragms. As mentioned previously, the truss members were added to all diaphragms and every other cross ribs in order to stiffen them in 1988/89 retrofitting.

Fig. 2 Orthotropic steel deck of test bridge

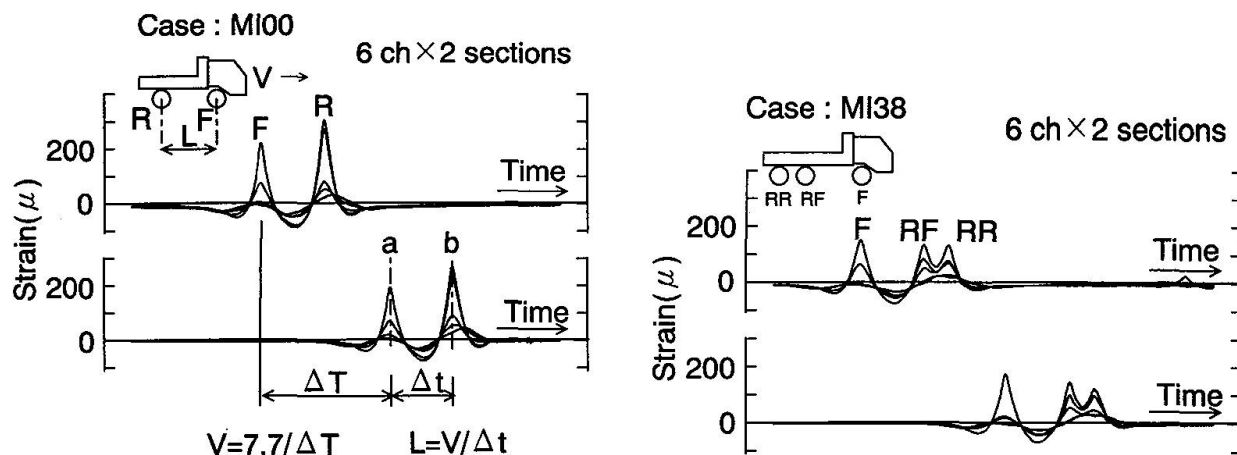
Fig. 3 Strain histories due to running of test trucks

- FEM analysis** : The finite element analysis was carried out for the orthotropic steel deck of interest to determine influence surfaces for all locations of strain gages, that were placed at the mid-span of the longitudinal ribs.
- Effect of tire loading** : Wheels with single tire and double tires with an unit weight were placed at different positions to calculate stress waves of the longitudinal ribs. Loading areas of the tires were determined according to JRA Specifications. Through such analysis it was determined to use six strain gages at two sections, A and B, near the supports, which were 7.7 m apart, as shown in Figure 2.
- Strain measurements** : Strain histories were recorded dynamically using Digital Data Recorder, and the data was transferred to a personal computer for further analyses. Typical strain recordings for 2-axle truck and 3-axle truck are shown in Figure 3.

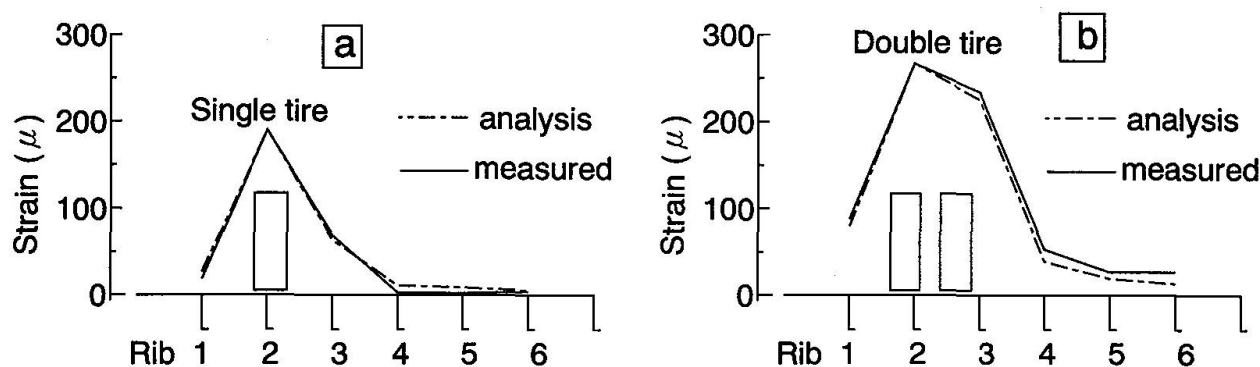
d) **Tire types and their positions** : From six strain recordings peak strains corresponding to wheels passing on the mid-span of the ribs were determined first. Then, three largest strain recordings were picked up, and tire position was determined. Single or double tires was also clarified from the shape of the strain waves, as shown in Figure 4.

Fig. 4 Stress distribution of six ribs at a and b

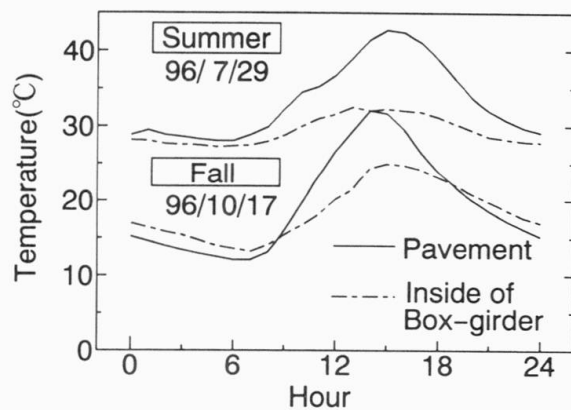
The first measurement was carried out in the end of July, 1996. It was the mid-summer in Nagoya and the temperature at the bottom of the asphalt pavement of the orthotropic deck was between 27 and 49, as shown in Figure 5. Two test trucks were used, as shown in Table 1. They were a 2-axle dump truck of 220 kN gross vehicle weight (GVW), and a 3-axle dump truck of 223 kN GVW. Drivers of the test trucks were asked to drive the trucks intentionally in the left, the center and the right sides of the mid-lane at different velocity. The test trucks ran with speed between 22 and 58 km/h over the test sections.

Fig. 5 Temperature of asphalt pavement

The measurement was once more carried out in the mid-October, 1996, when the temperature of the asphalt pavement was ranging between 12 and 32, as shown in Figure 5. A 3-axle truck of 199 kN, which ran over the test sections 12 times, was used to calibrate the results. The wheel loads of the test trucks were estimated using the same technique used in the summer experiments. The results are plotted in Figure 9. The average estimated wheel loads were about 5 percent more than the actual wheel loads

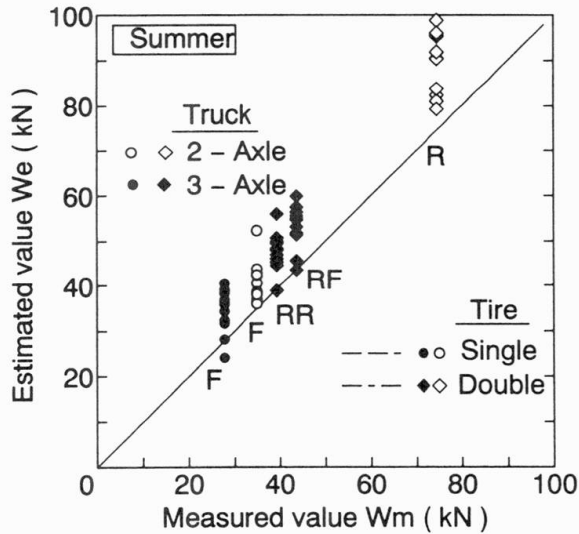
From the recorded strains the wheel loads were estimated. The estimated wheel loads, W_e , are plotted against actual wheel loads, W_a , measured statically at a weigh station in Figure 6. It was found that W_e for the front and rear wheels were about 20 percent higher in average than W_a . The scatter of the estimated wheel loads was also observed owing to the scatter in the measured strain recording, which probably came from the vibration of the truck during the passage over the test sections.

Fig. 6 Comparison of measured and estimated wheel loads of test trucks

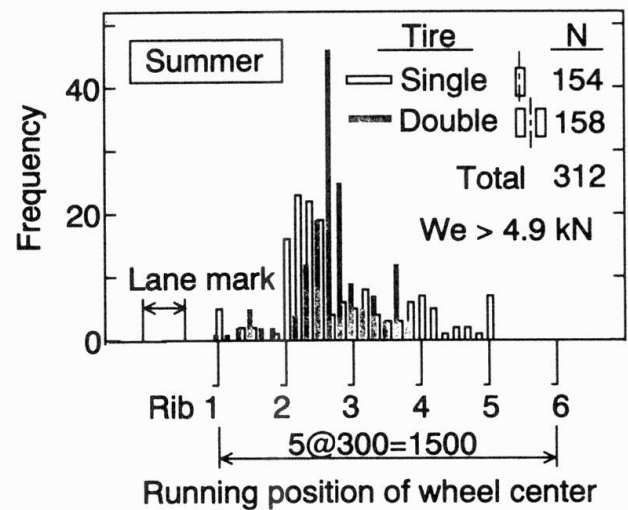
Fig. 8 Frequency of estimated wheel

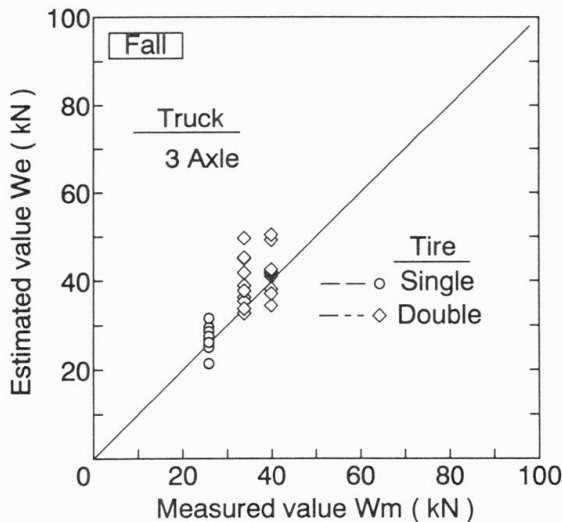
Fig. 9 The comparison of measured and estimates wheel loads of test trucks

The difference in the ratio of the average estimated wheel loads to the statically measured ones between the summer and the fall experiments was about 15 points. In this period supports near the section B was temporarily jacked up for replacement works from metal shoes to rubber ones. The effect of such change in structural details on the test results is unknown at this moment. The increase in the stiffness of the asphalt pavement above the orthotropic deck may also attribute to the

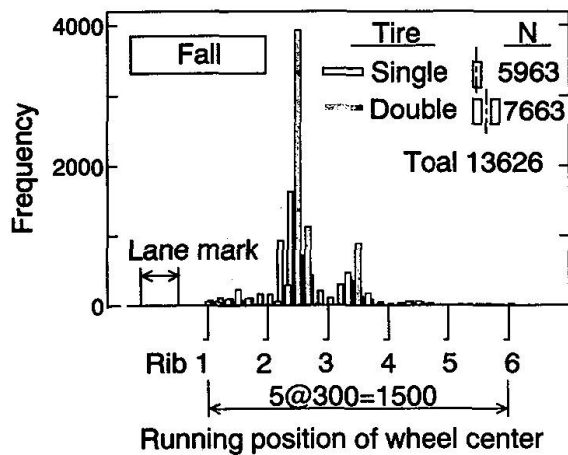
The running position of all wheels are plotted in Figure 11. The majority of the wheels passed between ribs 2 and 3, and some passed between ribs 3 and 4. In these areas ruts were observed, and the trucks seemed to run along such ruts.

Fig. 11 Frequency of estimated wheel position

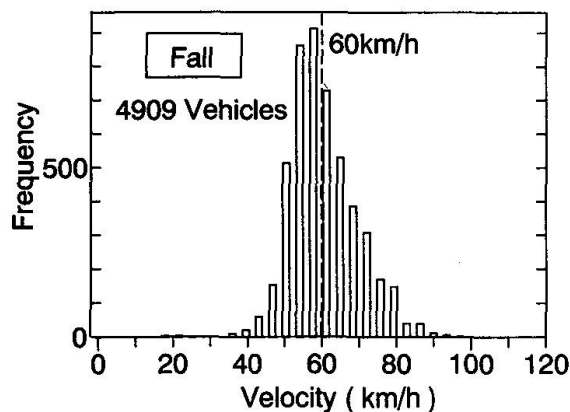
Fig.12 Frequency of vehicle velocity

The velocity of each truck in service was also computed. The distribution of the velocity is plotted in Figure 12. The average speed was about 57 km/h. Approximately 50 percent of the trucks ran with speeds over 60 km/h, while speed limit of this road was 60 km/h.

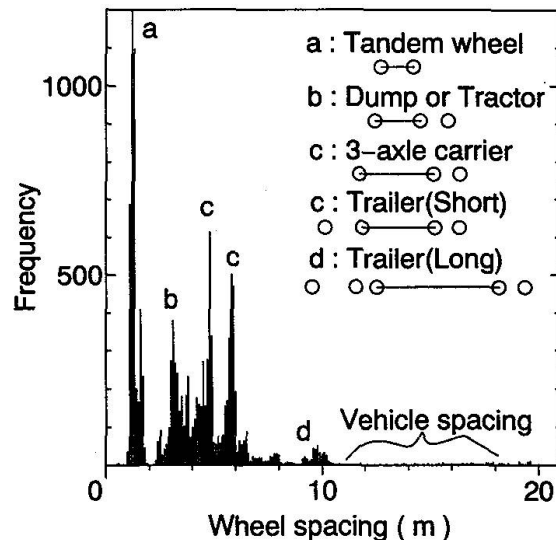
Once the speed of each truck was known, one can compute the wheel spacing. The distribution of the computed wheel spacing is shown in Figure 13. There are several groups of wheel spacing. Compared with the configuration of the trucks currently used in Japan, the wheel spacing seems to correspond to (a) tandem wheels (about 1.3 m), (b) main spacing of dump trucks or tractors, (c) main spacing of 3-axle trucks or short trailer trucks, and (d) main spacing of long trailer trucks.

Fig.13 Frequency of estimated wheel spacing
