**Artikel:** Structural connections of prefabricated concrete units - some matters of current concern  
**Autor:** Bernander, K.G.  
**DOI:** <https://doi.org/10.5169/seals-73114>

## Structural connections of prefabricated concrete units – some matters of current concern

By K. G. Bernander, Stockholm

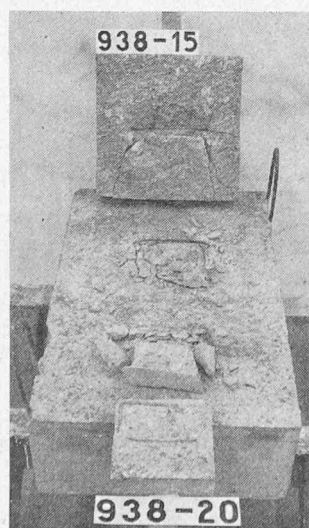
Fig. 10. Types of anchor rupture of stirrups cast into a thin concrete topping. Note the difference in type of rupture for smaller ( $15 \times 15 \text{ cm}^2$ ) and larger ( $30 \times 30 \text{ cm}^2$ ) surfaces. When size was  $(61.5 \times 61.5 \text{ cm}^2)$  the rupture was a pure tension cone around the stirrup

Fig. 10 shows the mode of failure. In all cases here presented the anchor of the stirrup in the topping became critical, however, often at displacements beyond the maximum load.

Where small contact surface the anchor failure was due to splitting of the topping. Where large contact surface the failure in the topping formed a tensile rupture cone around the stirrup.
