Ground improving injections underneath historical buildings: five case histories as an overview of a technique

Valentina Berengo¹

Abstract

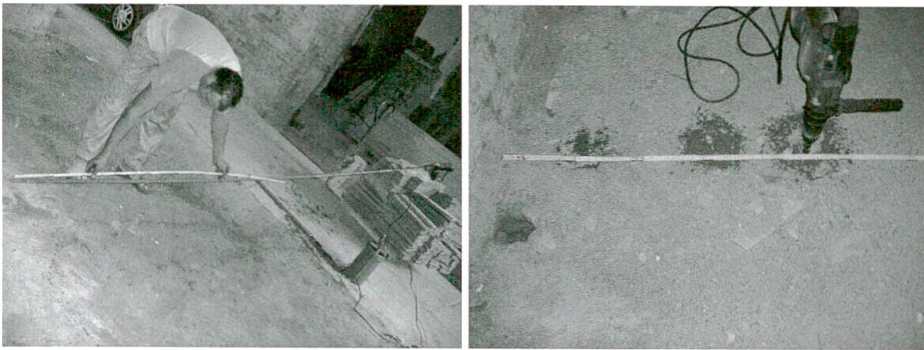
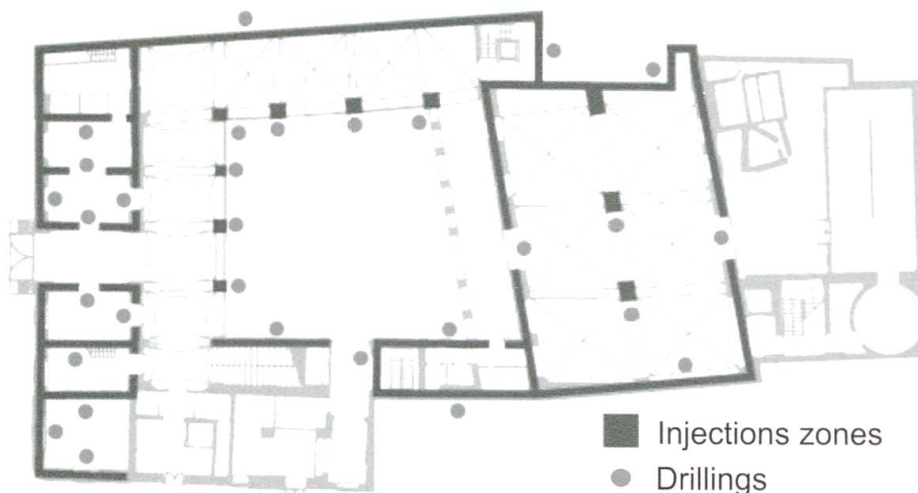
Fig. 2: Above: foundation survey at Palatium Vetus. Below: survey and intervention map.

bished and enlarged so many times that the soil stress state has changed under the foundation system. The final configuration is constituted by only one body with two levels, lying on several types of foundations. To investigate the foundation system a series of drillings were performed. A manual boring machine was used (max energy per bump: 12–14 Joule, frequency: 1.200–2.800 bumps per minute), making holes of 26 mm diameter (Fig. 2). Drillings were performed along-

Fourteen different areas around the entire building were investigated (Fig. 2): walls were found to be constituted by bricks and binder with no discontinuities, the foundation base level varies from 0.5 m to 3.2 m depth and a 10–15 cm layer of crushed stones lies under the foundation system.

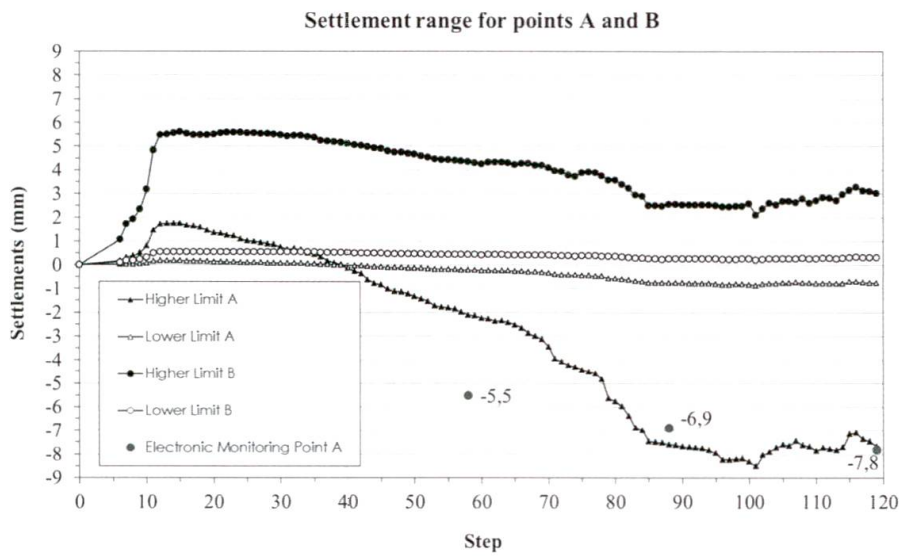
Fig. 6: Time-settlement calculated curves and real measurements at Città di Castello tower.

All throughout the work a real time electronic monitoring was operating. Fig. 6 shows how slight the differences are between the calculated time/settlement curve and the real settlement measurements after every injection phase, thus confirming the reliability of a numerical analysis that reproduces the resin injections.

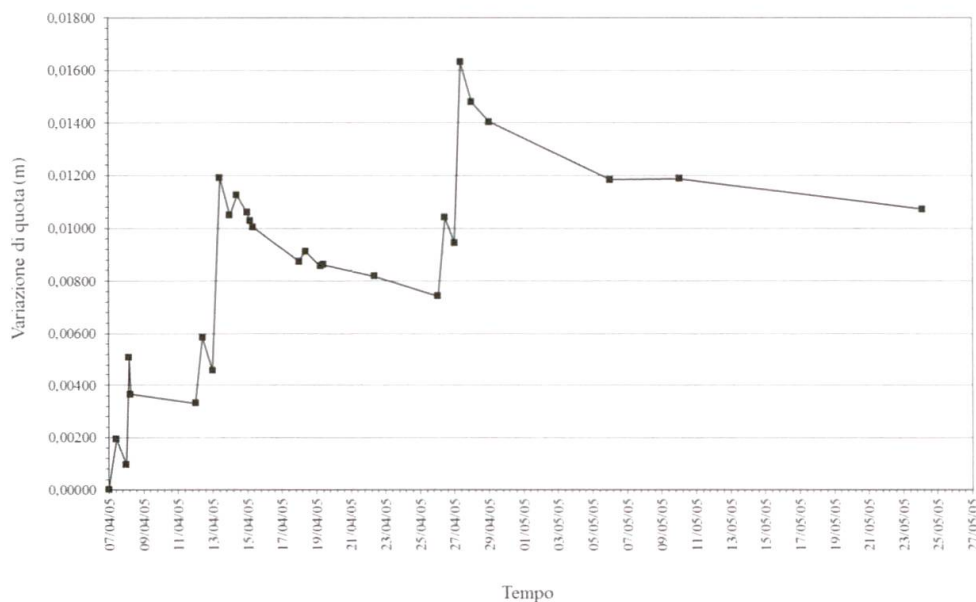
Fig. 9: Time-displacement measured curve for «point 17» [x-axis: date, y-axis: displacement rates in m].

Fig. 9 shows the time-displacement curve of the check point «17», close to the SL15

anchorage, on the «Canal Grande» side. The recovery is evident for each intervention phase.

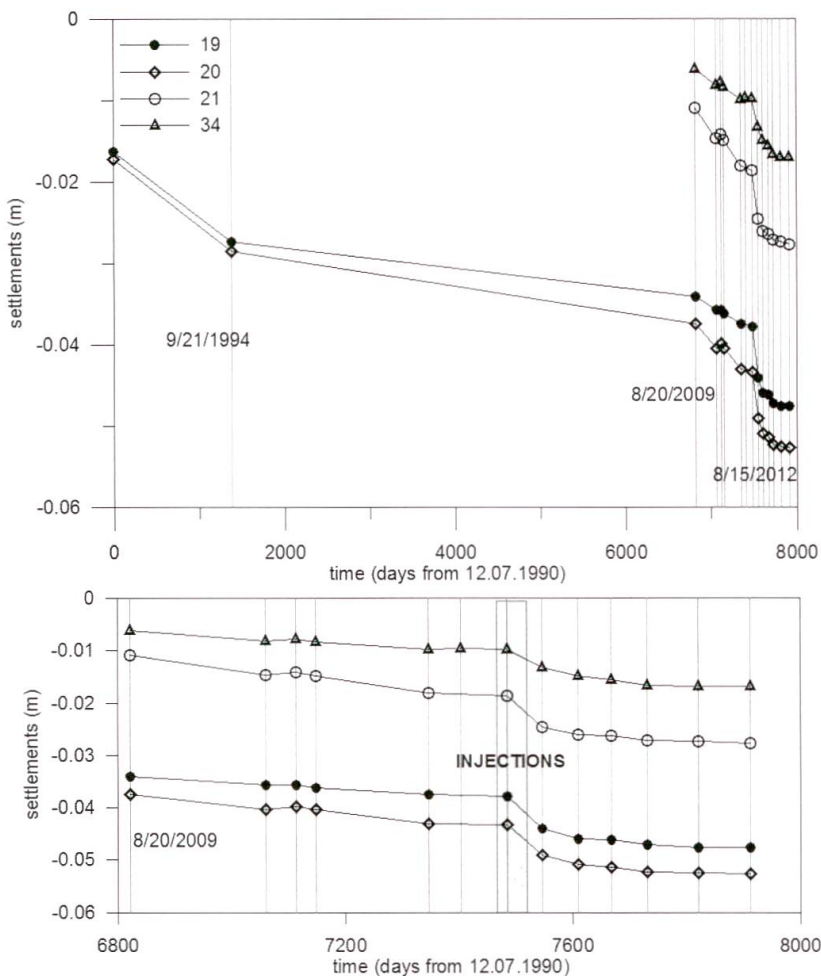
Fig. 14: Above: time-settlement curves of several anchorages. Below: enlargement of the measurements just before and after intervention.

ment, led to the decision of using the Urettek Deep Injections® technology. The injections were performed at different levels for an extension of 280 m long in order to fill the voids and, as it is usual, to improve the soil mechanical properties. In Fig. 14 the settlement trend is plotted over

time in correspondence to fixed control points. It is clear that the settlement stabilized after the injection procedure. The injections cause a slight localized settlement due to the procedure itself, but the graph shows that the settlements which were increasing over time prior to the intervention have almost stopped. After the intervention a monitoring system called Easy Crack Monitor System® was installed in order to check the crack stabilization. The system allows for the automated and continuous reading of any relative displacement between two lips of a lesion and/or two buildings and/or two structural elements, along two orthogonal directions. It is composed of one or more reading devices in correspondence of the lesions to be monitored and by a central acquisition and transmission of data (Fig. 15). The reading device, rigidly connected to the masonry, detects the relative displacement

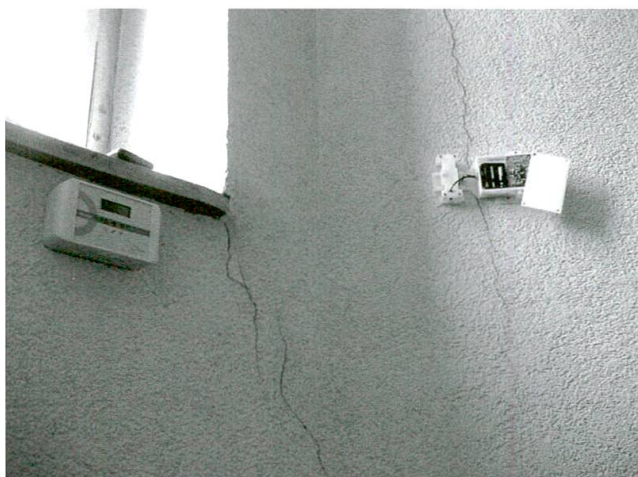
Fig. 15: Easy Crack Monitor System®.

between two stiff portions along two orthogonal directions at regular time intervals. The reading of the movements is made at the same point for both directions, with a precision not greater than 0.5 mm. Each system is also equipped with a temperature sensor. The control unit has the function of collecting data from several reading devices and to transmit them by means of GPRS protocol, at regular intervals, to a server for storage and display.
