Ground improving injections underneath historical buildings: five case histories as an overview of a technique

Valentina Berengo¹

1 Resin injections technology applied to historical buildings restoring

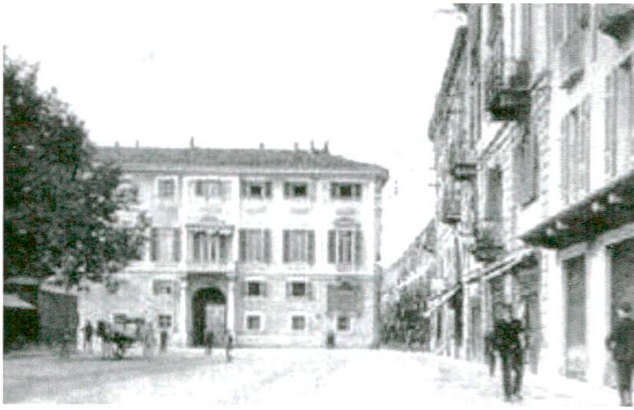
Fig. 1: Palatium Vetus in Alessandria (historic photograph).

Palatium Vetus (Fig. 1) is in fact the oldest building in Alessandria: it was built in 1170 in the heart of the town and has been refur-

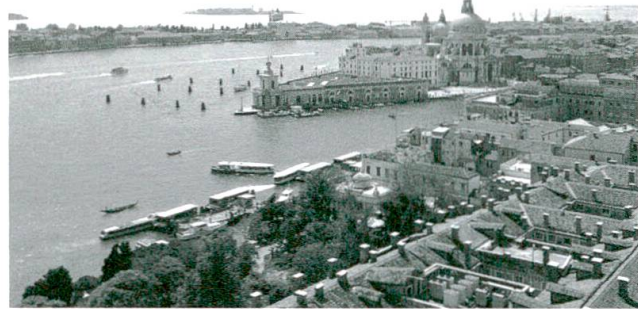
The main building has a width that varies from 16 m to 75 m and floors lie on ten brick walls, parallel to one another, as described in Fig. 7. Foundations are constituted by bricks and binder walls laying on four different substrates: directly on the soil, on a rigid shelf laid on the ground, on a shelf that lies on wooden piles or on the foundations of an existing tower. The foundation base level varies from 0.69 m to 2.84 m depending on the position.

Fig. 7: Punta della Dogana view (above), map (below).

«Punta della Dogana» is a historical place in Venice where trade occurred. The trapezium-shaped buildings were built in 1677 on the basis of the design of the architect Giuseppe Benoni (Fig. 7).

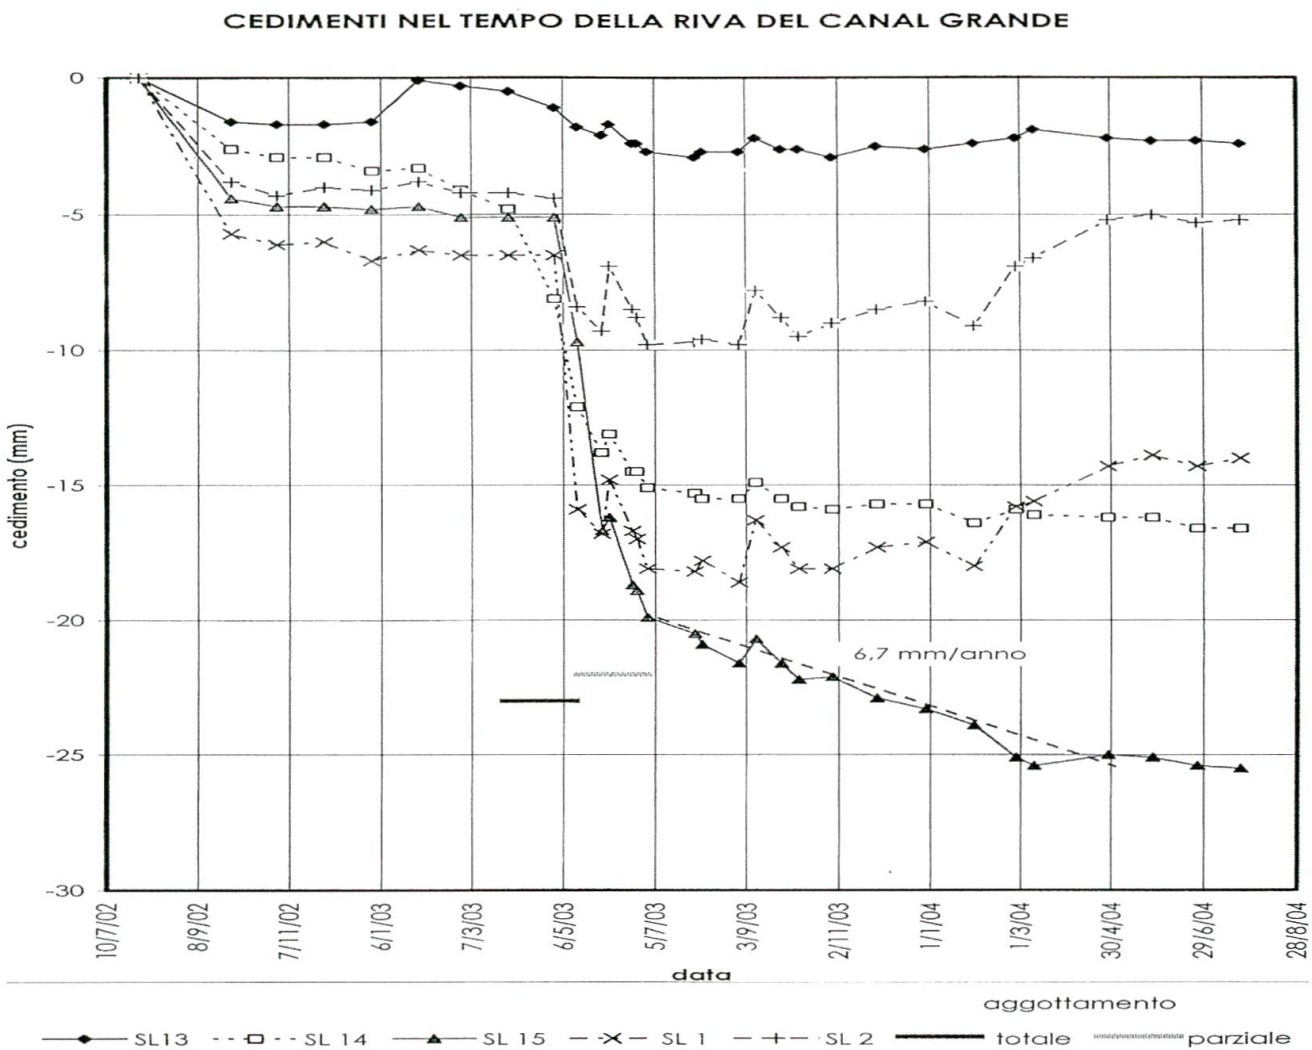
Fig. 8: Time-settlement curves of several anchorages (x-axis: date, y-axis: settlement in mm).

create a sort of retaining structure for the following injections. The second and the third phases were performed the following year and were less invasive. The detailed description is given in Gabassi et al. (2011). The structure response was monitored twice a day from the end of the first phase, during the injections phase, and every 15 days between the two phases. What occurred was a temporary rise in the pressured water inside the injection pipes as a consequence of the resin expansion, especially during the first phase. The pore pressure increase and the consequent dissipation caused settlements to occur but in the following phases the phenomenon decreased and this trend inverted, showing also a small settlement recovery.

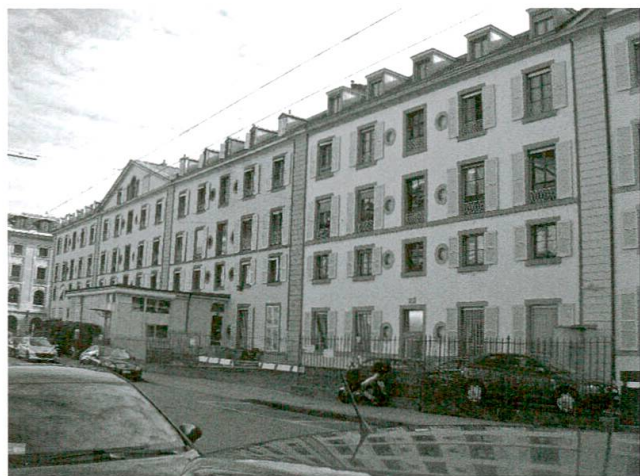
The building subject to intervention in Geneva (Fig. 12) was affected by very long and deep cracks worsening over time. It is a residential complex constituted by nine independent parts, whose origins date back to 1828. It was built on the foundations of the city's old fortification walls. Only one side of the building, however, lays on the foundation walls, while the other side, instead, lays on an old replenishment layer. This is the cause for the cracks.

Fig. 12: The building subject to intervention in Geneva.
