Artikel: Welding experiences at the construction of the newest Danube and Tisza bridges in Hungary

Welding experiences at the construction of the newest Danube and Tisza bridges in Hungary

Dr CH. SZÉCHY
Chief engineer, Highway-bridge Department in Hungary

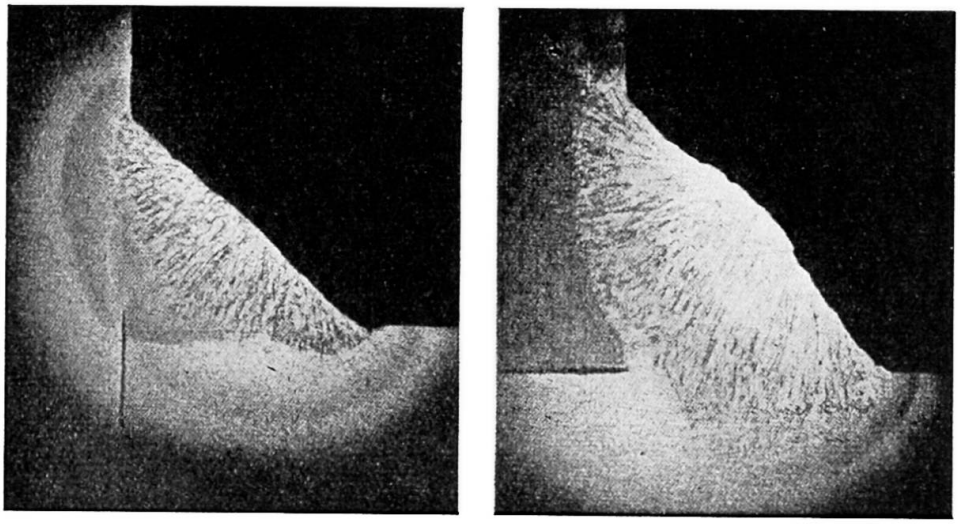
The texture of the weld, made by the Hafergut-process was uniformly more coarse-grained as that of the hand-weld; the first layers of this latter one have naturally undergone subsequent heat treatment, resulting in some recristallisation and a fine-grained texture in the underlying layers (fig. 3).

Consequently some deterioration of the fatigue-strength might be feared of, but the tests however did not prove so.

Fig. 3. Typical macro-structure of a fillet weld made :
a) By usual hand welding,
b) By the « Hafergut » process.

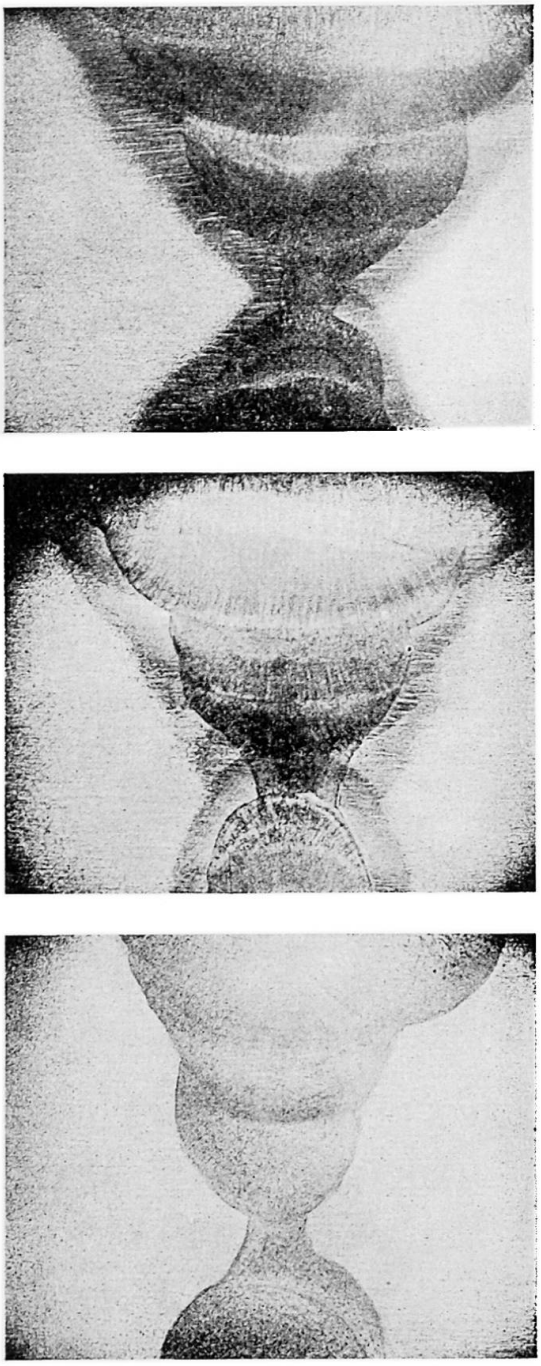
Fig. 7. Macrostructure of X-welds of the test specimens :

a) As rolled condition;
b) Stress relieving heat treatment (730° C);
c) Normalising heat treatment (930° C).

Annealing of the welds is raising considerably their ductility (by 200 %) and results in a considerable inner stress relief between the differently hard transition-zones. Annealing to 930° C (1 600° F) makes disappear entirely all difference in the microstructure of the transition-zone

These results are to be seen from figure 7, *a*, *b*, *c*, showing the macrostructure and from figure 8, *a*, *b*, *c*, showing the microstructure of the welds.

This latter has got a purely ferritic structure differing from the transition-zone in the size of the crystals only. The microscopic checks have revealed however no internal crack or harmful internal structural change whatever.

Considering that any heat treatment over the lower critical-temperature (730° C = 1 250° F) may bring about some changes in the metal's internal microstructure (ferrite $\longrightarrow$ austenite) practically a stress-relieving heat-treatment was advisable only, which would produce a very substantial raise of the weld's ductility. All other mechanical properties being entirely satisfactory in the as-rolled state already.

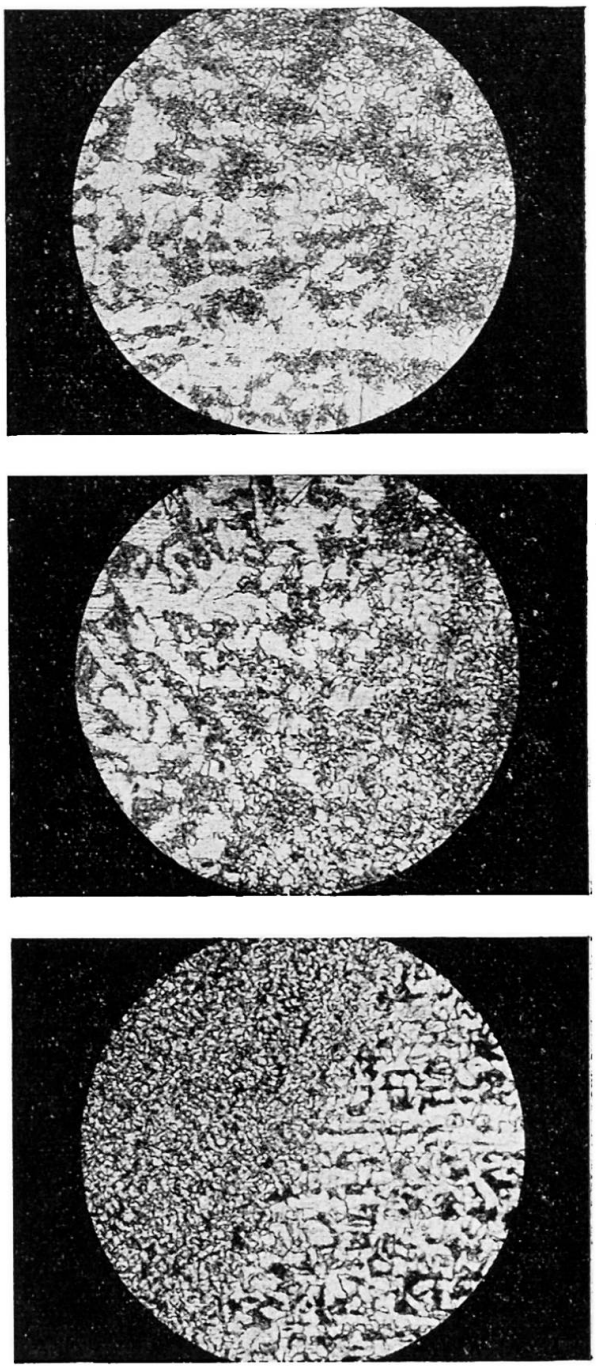
Fig. 8. Microstructures of the same welds (transition zone) :

a) As rolled;
b) Stress-relieved;
c) Normalised.

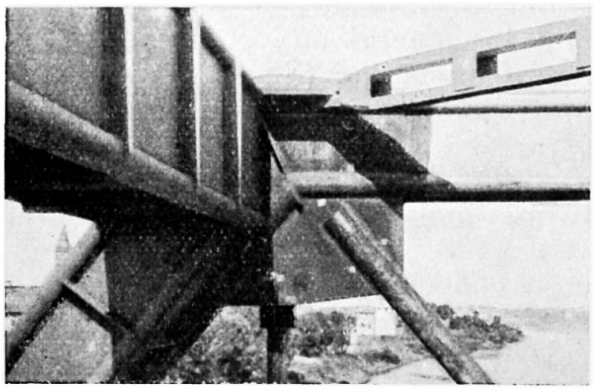
Fig. 12. Upper chord junction showing a double tube diagonal, joined to a double chord by a gusset plate welded by fillet weld.

We were quite aware that from the point of view of stress-transmission these solutions had some defects, but they made at the other hand a rather easy and quick fabrication and simple and reliable field welding possible and this latter ought to be the decisive factor. Any inaccuracy in fabrication could be easily repaired — when it became a trouble in the assembly — by simple widening or lengthening of the notches or by a slight increase of the strength of the filled welds.

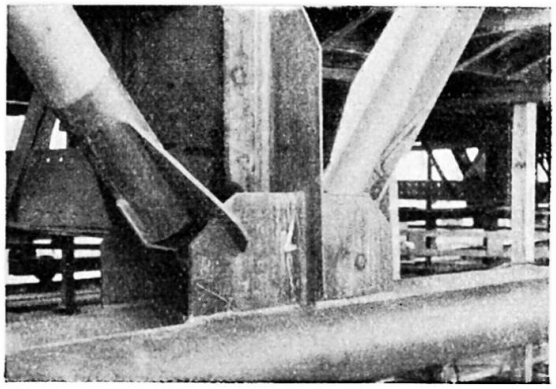
Fig. 13. Lower chord junction showing a single tube diagonal, joined to a double tube chord by a notched transversal plate welded to the gusset plates again by fillet weld.

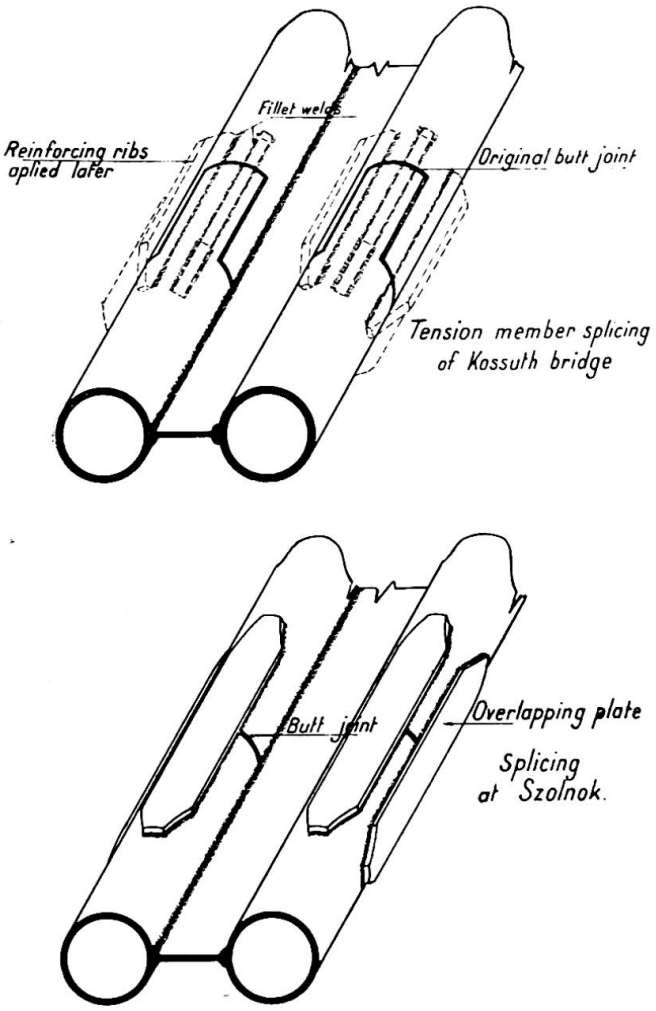
Fig. 14. Welded splicings :

a) At Kossuth bridges : the original tongue and grove butt weld showing reinforced ribs (dotted) applied subsequently.
b) At Szolnok a simple butt joint with welded cover plates.

In order to assure a uniform joint and to avoid the application of any overlapping plates and fillet welds and in general any combined joint where the questionable cooperation of butt-welds and fillet-welds of different elastic qualities ought to be taken into account, a « tongue and groove » shaped butt joint was specified (fig. 14).

But even this great precaution did not prove adequate enough. The difference of ductility of longitudinal and transversal welds was still bigger and owing to their much greater rigidity these latter had to transmit the whole tension alone before any of the longitudinal welds could come into action at all.

In itself this would not have been of major importance, considering that nowadays the resistance of butt-welds is at least equal to that of the parent metal, but the bad quality of these welds did not allow to rely on the joints as they were.

Under such circumstances the decision was made, that all splicings of the tension members must be thoroughly repaired in the way that regardless to the reliability of the transversal butt-welds overlapping plates were specified to transmit all tension by their fillet welds. In order to reduce the extent of the hardened transition zone, narrow rib like plates were applied for overlapping, with gradual bevelled transition at both their endings (fig. 14, *a*, dotted line). All fillet-welds were much easier to make and in the given case, when a subsequent rewelding of the root from the back was impossible and the occurrence of excessive rootopenings was very great, they proved altogether more reliable.

2. The second improvement was the alteration of the tension member splicing. The tongue-groove type was abandoned for a simple butt joint covered with regular overlapping plates (fig. 14, *b*).

These latter and their fillet-welds were dimensioned to transmit all tension force, the first class quality of the butt welds not being granted in advance.

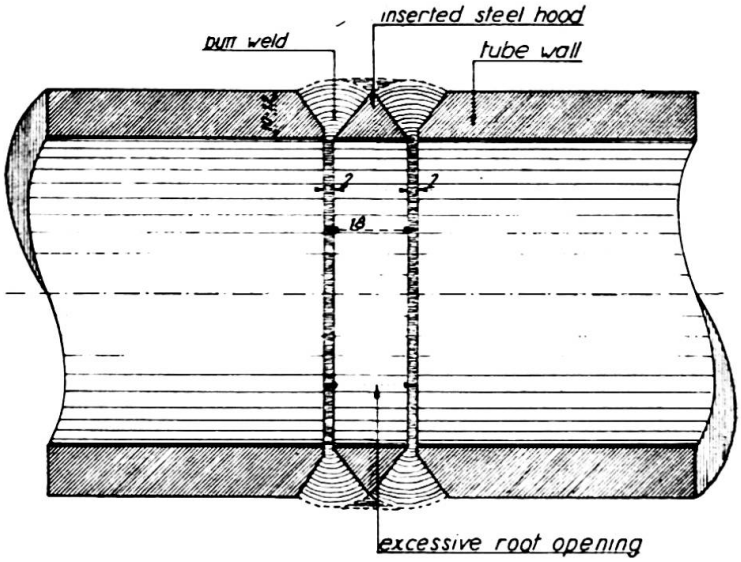
Fig. 15. Welding scheme at excessive root openings.

b) *The defective accuracy* in steel work fabrication which resulted sometimes in root openings of 12-18 mm in the field joints. In order to establish the necessary magnetic circumstances we were compelled to insert a small triangular steel hood into the root-opening thus creating two weld

roots and a very difficult weld to make, with fairly large and brittle transition zones (fig. 15).

5. A more accurate fabrication has put an end to excessive root-openings, which were primarily responsible for defective fusion at the root section.
