Zeitschrift: IABSE congress report = Rapport du congrès AIPC = IVBH Kongressbericht

Artikel: Side face crack control for large concrete girders

Autor: Breen, John E. / Frantz, Gregory C.

Side Face Crack Control for Large Concrete Girders

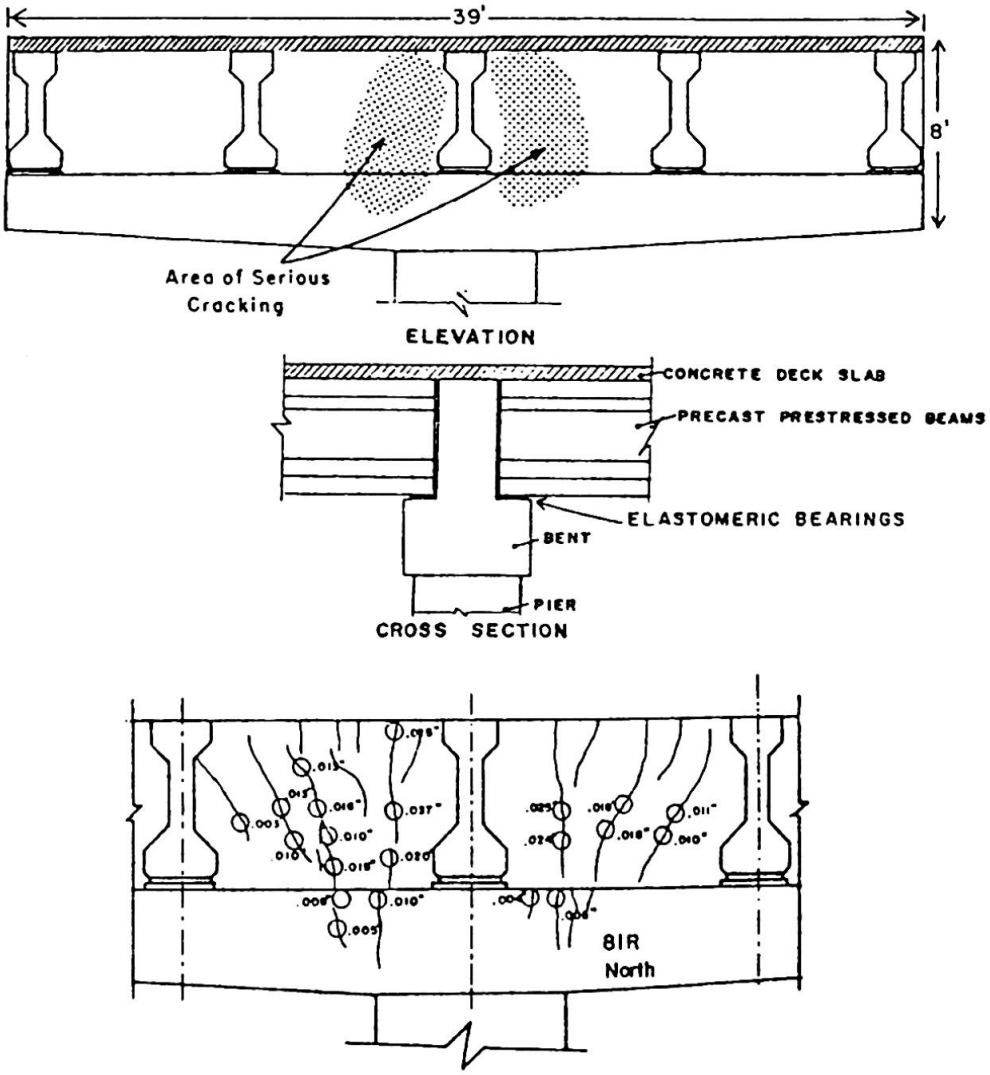
This paper summarizes a detailed investigation of several large reinforced concrete highway bent cap girders which were found to have very wide cracks near middepth on the side faces (see Fig. 1). Although the crack width at the level of main reinforcement was acceptable, the side face cracks near middepth were up to three times as wide, indicating potential durability problems. [1]

Fig. 1 Crack patterns and crack widths in the bent caps

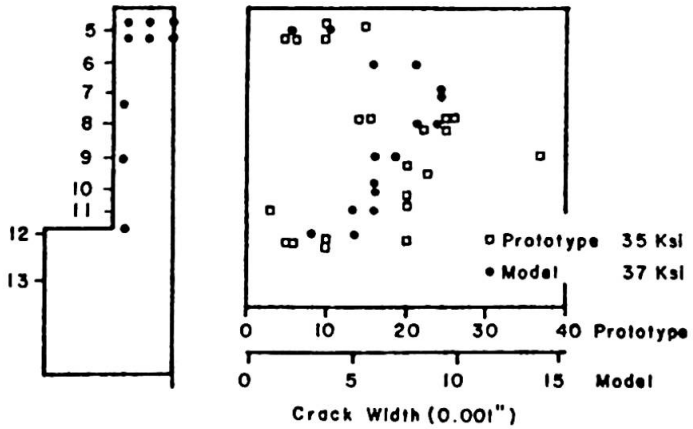
Laboratory models accurately reproduced the crack pattern and crack widths to scale, as shown in Fig. 2. From this figure, the crack width near midheight of the web can be seen to be approximately three times that at the level of the main (top) reinforcement. A series of 44 specimens was used to investigate variables such as amount and distribution of side face reinforcement, cover, web width, and beam depth. The major effect of the skin reinforcement in controlling the width of side face cracking is in encouraging the distribution of closely spaced deep cracks, such as shown in Fig. 3 (a), which can be contrasted to the relatively few deep cracks and large number of branching cracks shown in Fig. 3(b), in a similar specimen with no skin reinforcement. The effectiveness of skin reinforcement in controlling the wide cracking was dramatically shown in Fig. 4, in which a modest amount of skin reinforcement decreases the crack magnification ratio (the ratio of maximum crack width on the side face to crack width at the main reinforcement level) from approximately 4.0 to approximately 1.8.

Fig. 2 Comparison of crack widths in prototype and model bent caps, scaled to S_L

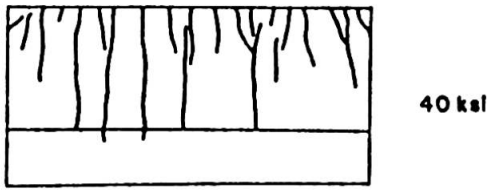
Fig. 3(a) Crack pattern development of A-5 (skin reinforcement = eight #3 bars)

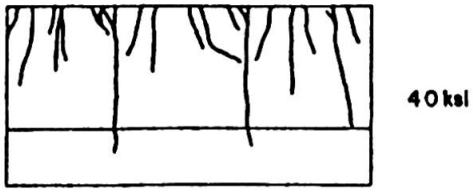
(4) Without any skin reinforcement a "tree branch" crack pattern developed where several of the cracks originating on the extreme tension face curved and joined together to form one wide crack extending into the web. As the area of skin reinforcement increased, this crack pattern gradually changed to one where more cracks remained vertical and extended further down into the web, resulting in smaller crack widths near middepth. Modification of the crack pattern is one of the principal benefits from using skin reinforcement.

Fig. 3(b) Crack pattern development of A-2-0 (no skin reinforcement)

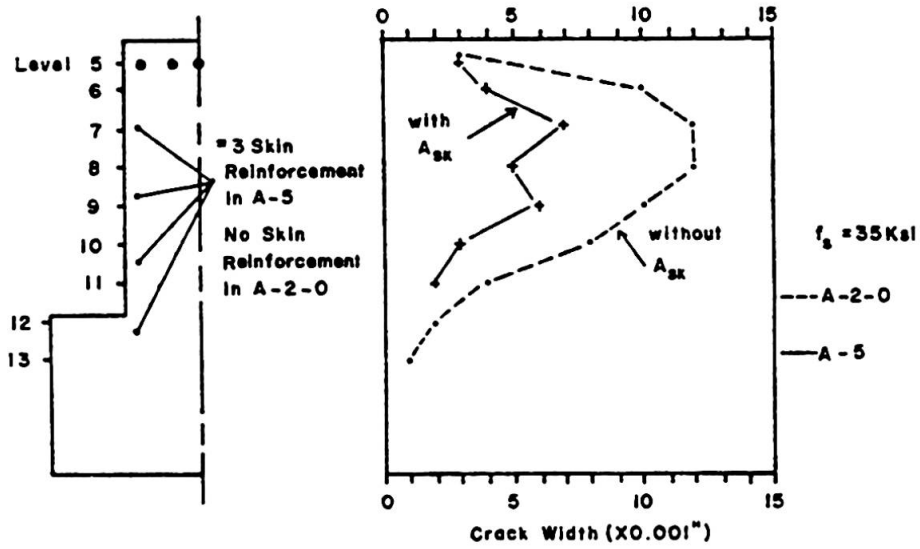
Fig. 4 Crack profile of a single crack in A-2-0 and A-5

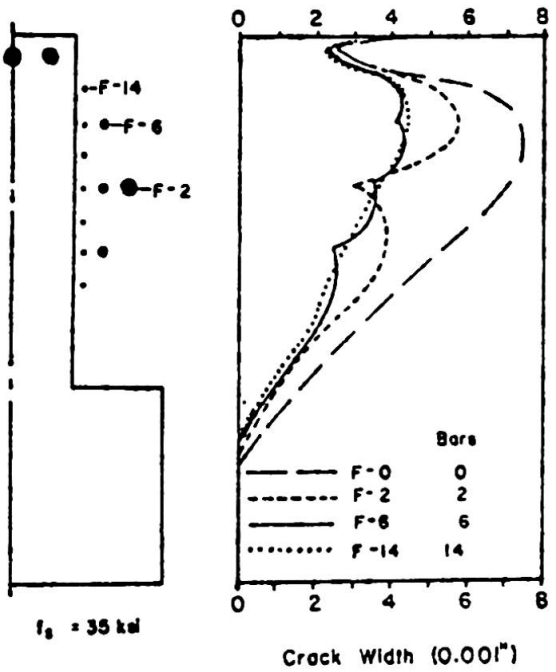
A relatively simple two-dimensional finite element analysis was developed and the results of this study generally confirm the laboratory results. This analysis was used for studies such as looking at the effect of skin reinforcement distribution in a given cross section (see Fig. 5).

Fig. 5 Effect of skin reinforcement distribution with constant A_{sk} (0.88 sq. in.)

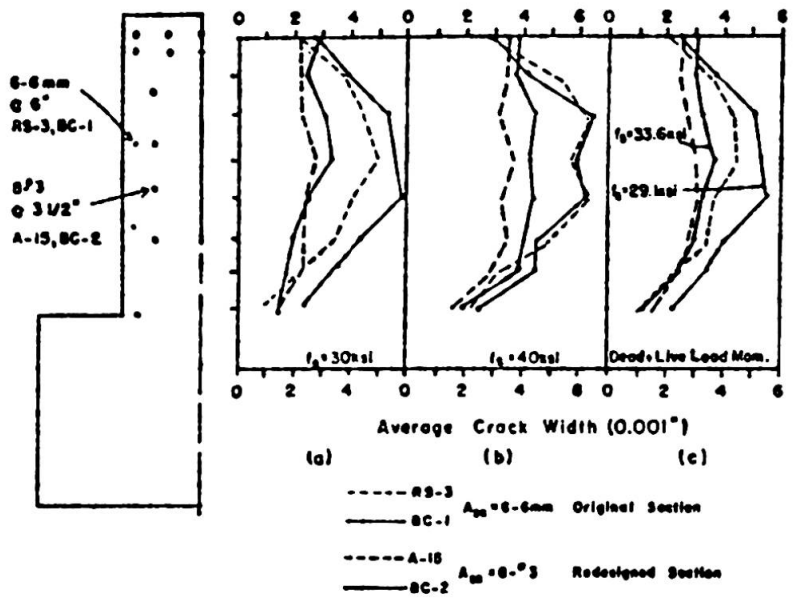
Fig. 6 Crack profiles--original and redesigned model bent caps

Based on the test results and analytical studies, a new design procedure was developed to control side face crack widths and was simplified for code usage. To verify the new design procedure, the original model bent cap which had experienced a serious side face cracking problem was redesigned and tested. This test indicated that the new design procedure worked quite well, as shown in Fig. 6. The crack magnification ratio was reduced from approximately 2.5 in the original design to a value of 1.2 in the redesign. This was done with usage of the same amount of reinforcement in the two specimens, but with improved distribution.
