Plenary Session 2

Structural Contribution to Natural Disaster Reduction

THE PROSPECTS OF NATURAL DISASTER REDUCTION THROUGH IMPROVEMENTS OF STRUCTURAL QUALITY

Earthquake Hazard Mitigation in New and Existing Structures

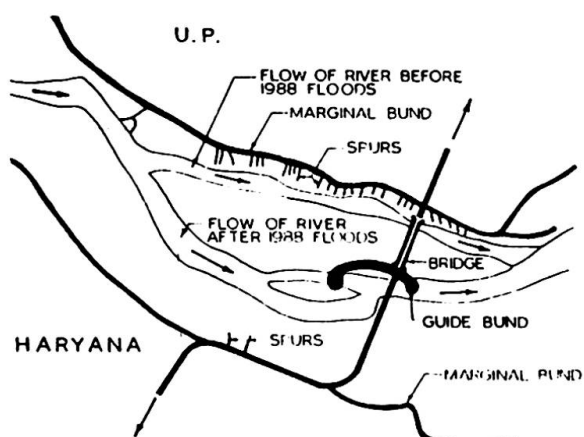
3.3.3 For the past many years the river was flowing with its main channel hugging the left bank.   However, during the floods of 1988 when the work on the foundations of the bridge was already in progress, the river suddenly changed course, shifted by more than 1200 m towards the right and started flowing behind the location of the proposed guide bund.   The question of increasing the length of the bridge to cover the new channel of the river was then considered, but it was finally decided to train the river and go ahead with the construction of the guide bund at its originally proposed location (refer Fig. 11)

FIG.11. POSITION OF FLOW OF RIVER

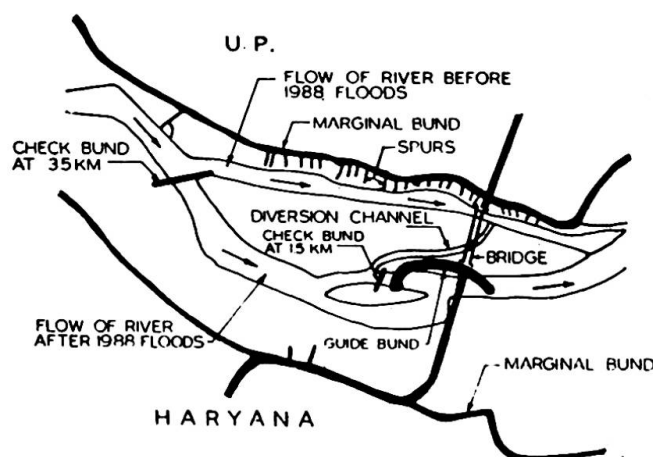
FIG.12 REMEDIAL MEASURES ADOPTED
TO DIVERT THE FLOW OF RIVER

3.3.4 During the dry period, a diversion channel was cut in the bed of the river to guide the dry weather flow under the bridge.   To achieve this, the flow in the main channel was blocked by construction of a 'check bund' or embankment.   The first such 'check bund' constructed about 3.5 Kms. upstream of the bridge site was not successful in diverting the flow and a second check bund about 1.5 Kms. upstream of the bridge site had to be constructed. (refer Fig. 12)

3.3.5 This proved entirely successful in diverting and channelising the flow under the bridge.   Thereafter the work of the guide bund and the connecting approach embankment was taken up on a war footing and completed in phases before the advent of the next floods.   The behaviour of the river has been well controlled since then and the work on the bridge is now proceeding according to schedule.

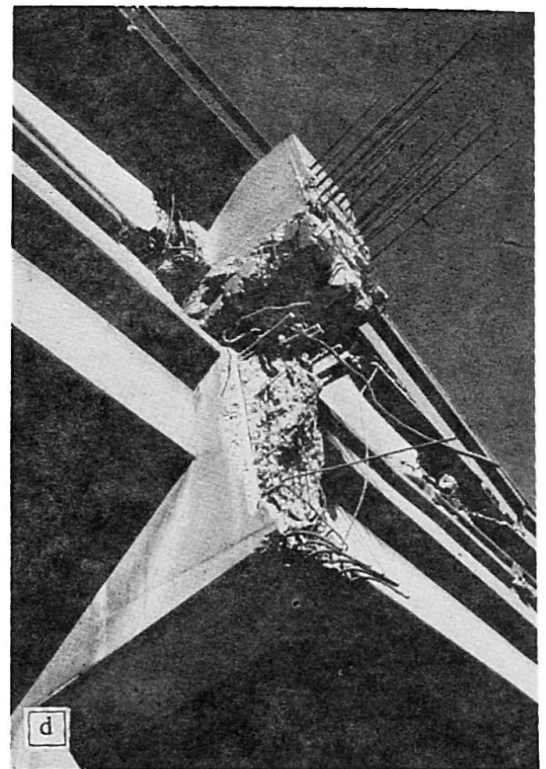
I-880
Oakland, CA
October 1989

FIG 1. Bridge Damage During the 1989 Loma Prieta Earthquake

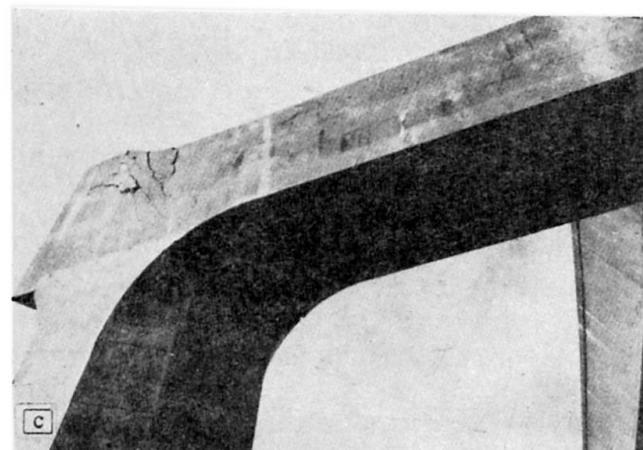
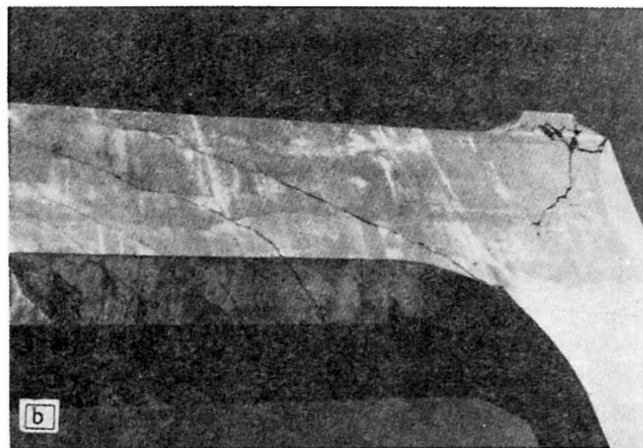
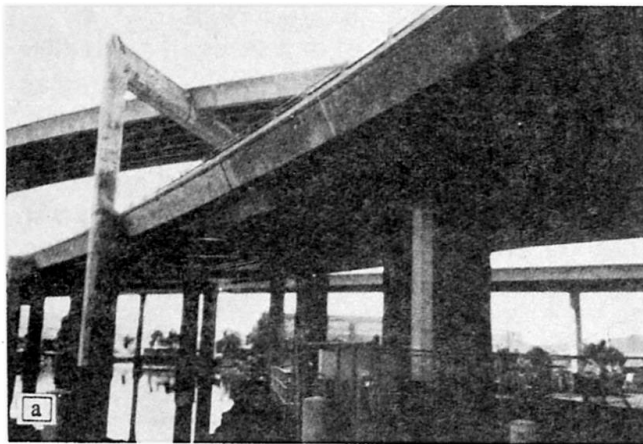
FIG 5. Earthquake Damage, Loma Prieta 89,
China Basin Viaduct

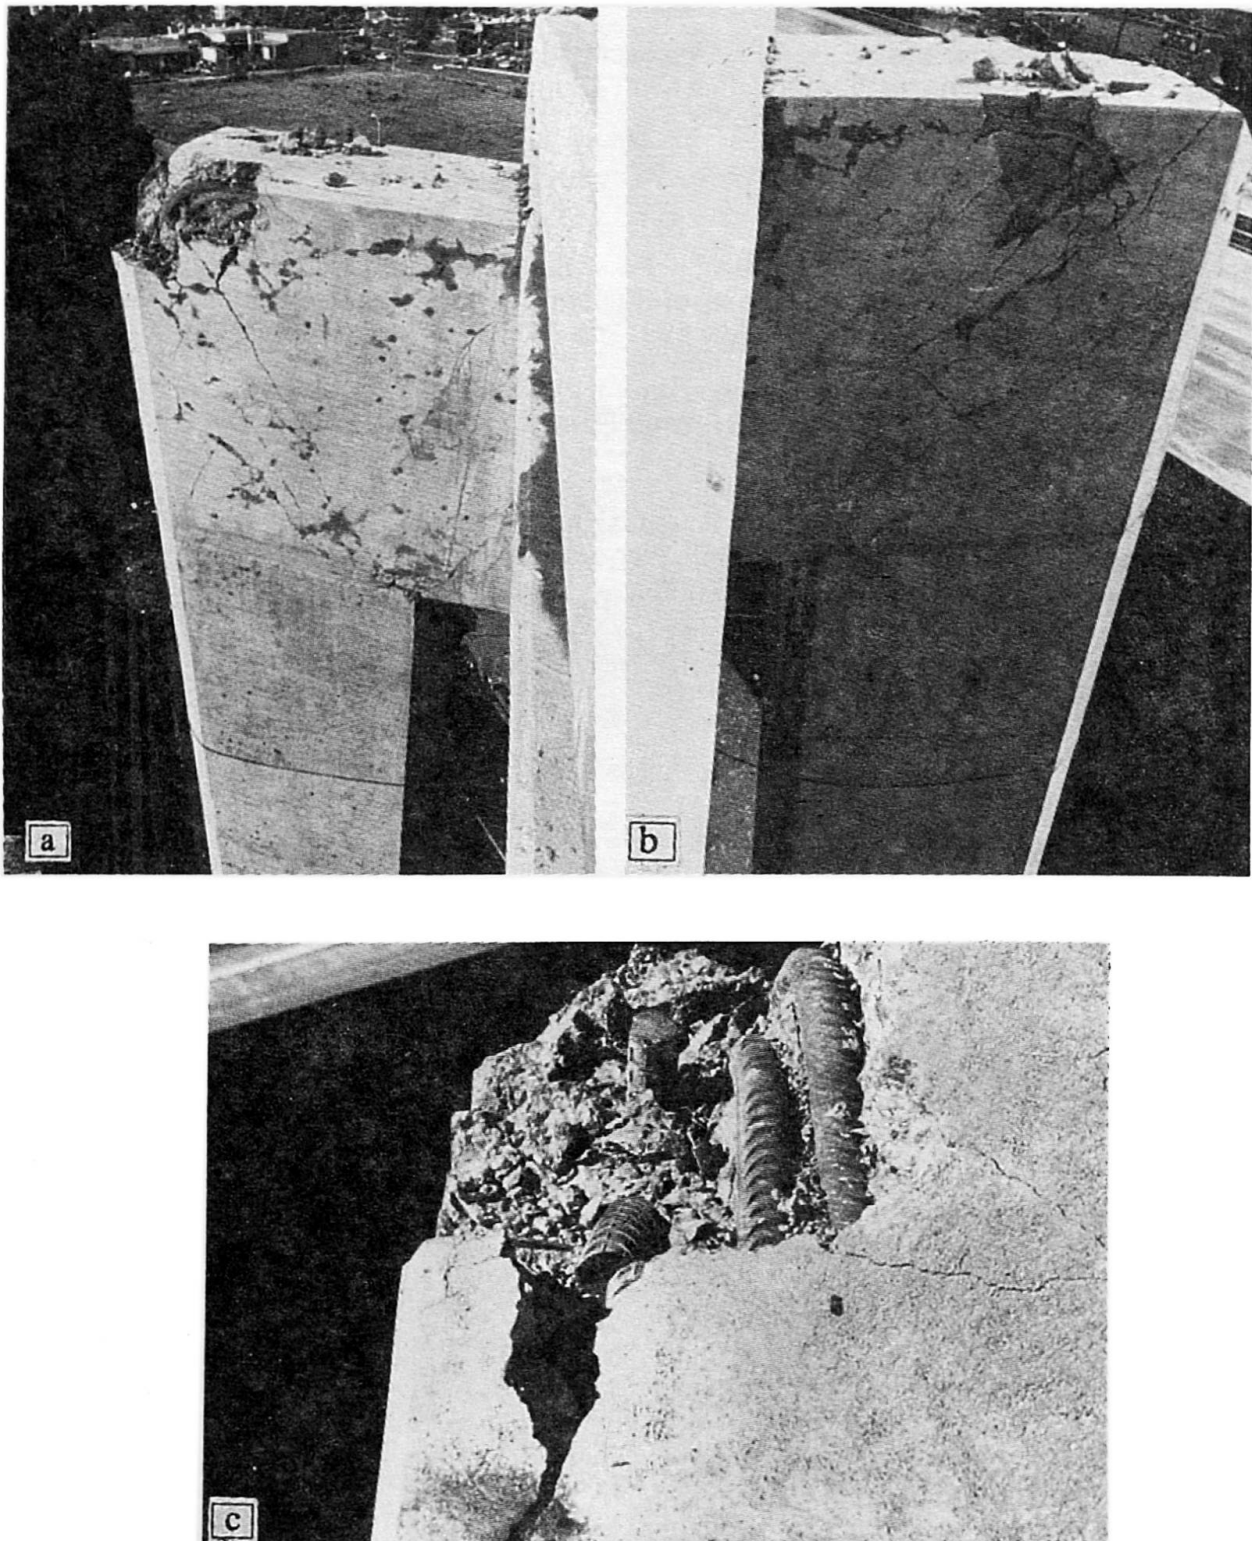
The second outrigger bent assessment example from the 89 Loma Prieta earthquake was performed for bent #38 on the I-980 southbound connector in Oakland, CA. Reinforcement details and dimensions of the critical knee joint are shown in Fig. 8. Based on capacity checks for both cap beam and columns, as outlined above, and from subsequent sequential failure mechanism analyses [1], the joint shear stress levels in the knee joint at the collapse limit state were found to be in excess of $0.5\sqrt{f_c}$ and $0.35\sqrt{f_c}$ [MPa] for closing and opening knee joint moments, respectively. Thus, joint shear damage can be expected prior to the development of any flexural ductile beam or column mechanism as demonstrated by the encountered distress patterns during the Loma Prieta earthquake, depicted in Fig. 9. Since existing beam and column capacities and reinforcement detailing were satisfactory to allow limited ductile performance, repair and retrofitting of the joint was performed by complete removal of the joint concrete, added joint shear reinforcement and an increased joint size.

FIG 9. I-980 Oakland, CA, Encountered Damage Patterns
