Load and Destruction Test of 160-Ft. Girder Designed for First Prestressed Concrete Bridge in U. S. A.

M. Fornerod, Chief Engineer, Preload Enterprises, Inc., New York, N. Y.

5. Loading and Destruction Test of 160-Ft. Prestressed Girder

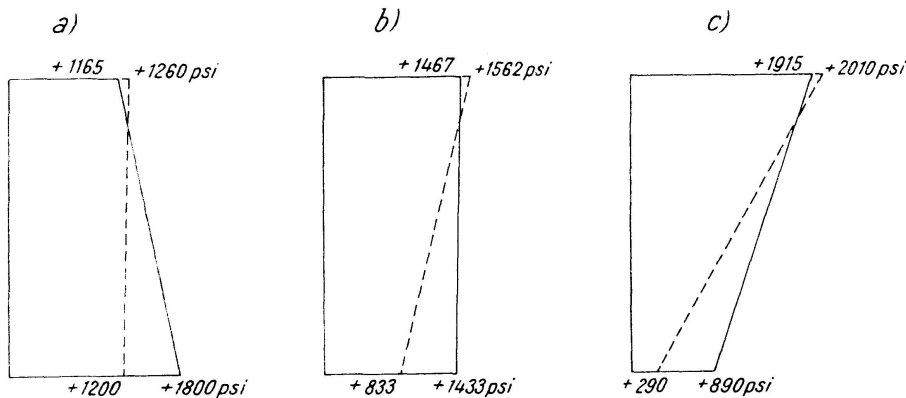
Fig. 7. Typical Stress Diagrams for Midspan Section
Full lines: „Initial" condition   Dotted lines: „Ultimate" condition
Positive stress indicates compression

Typical calculated stress diagrams at midspan for the 3 loading stages a) to c) inclusive are shown in Fig. 7 in full lines for "initial" condition and in dotted lines for the "ultimate" condition as described above.

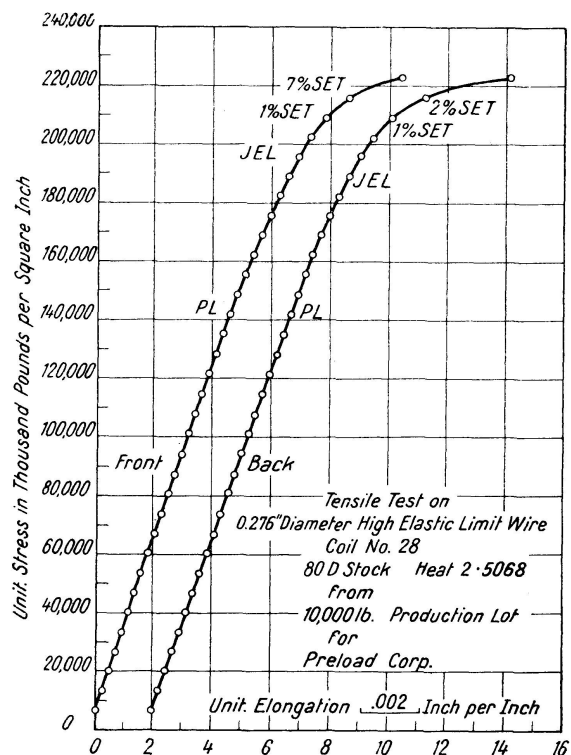
Fig. 8
Stress Strain Curve of Roebling 0,276" Wire

is approximately 245 000 psi. The fact that the design was made for a lower quality wire than the one actually furnished by the contractor is the reason the test girder failed due to crushing of the concrete rather than due to breaking of the wire.

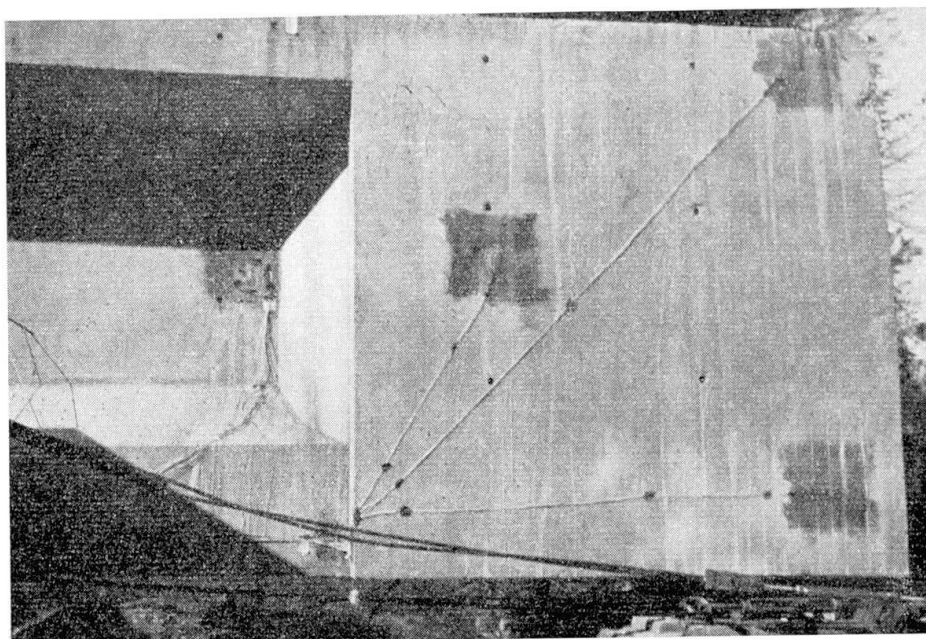
Fig. 9. Strain Gages and Leads at End of Test Girder
East end of girder, looking north, showing strain gage installation on concrete

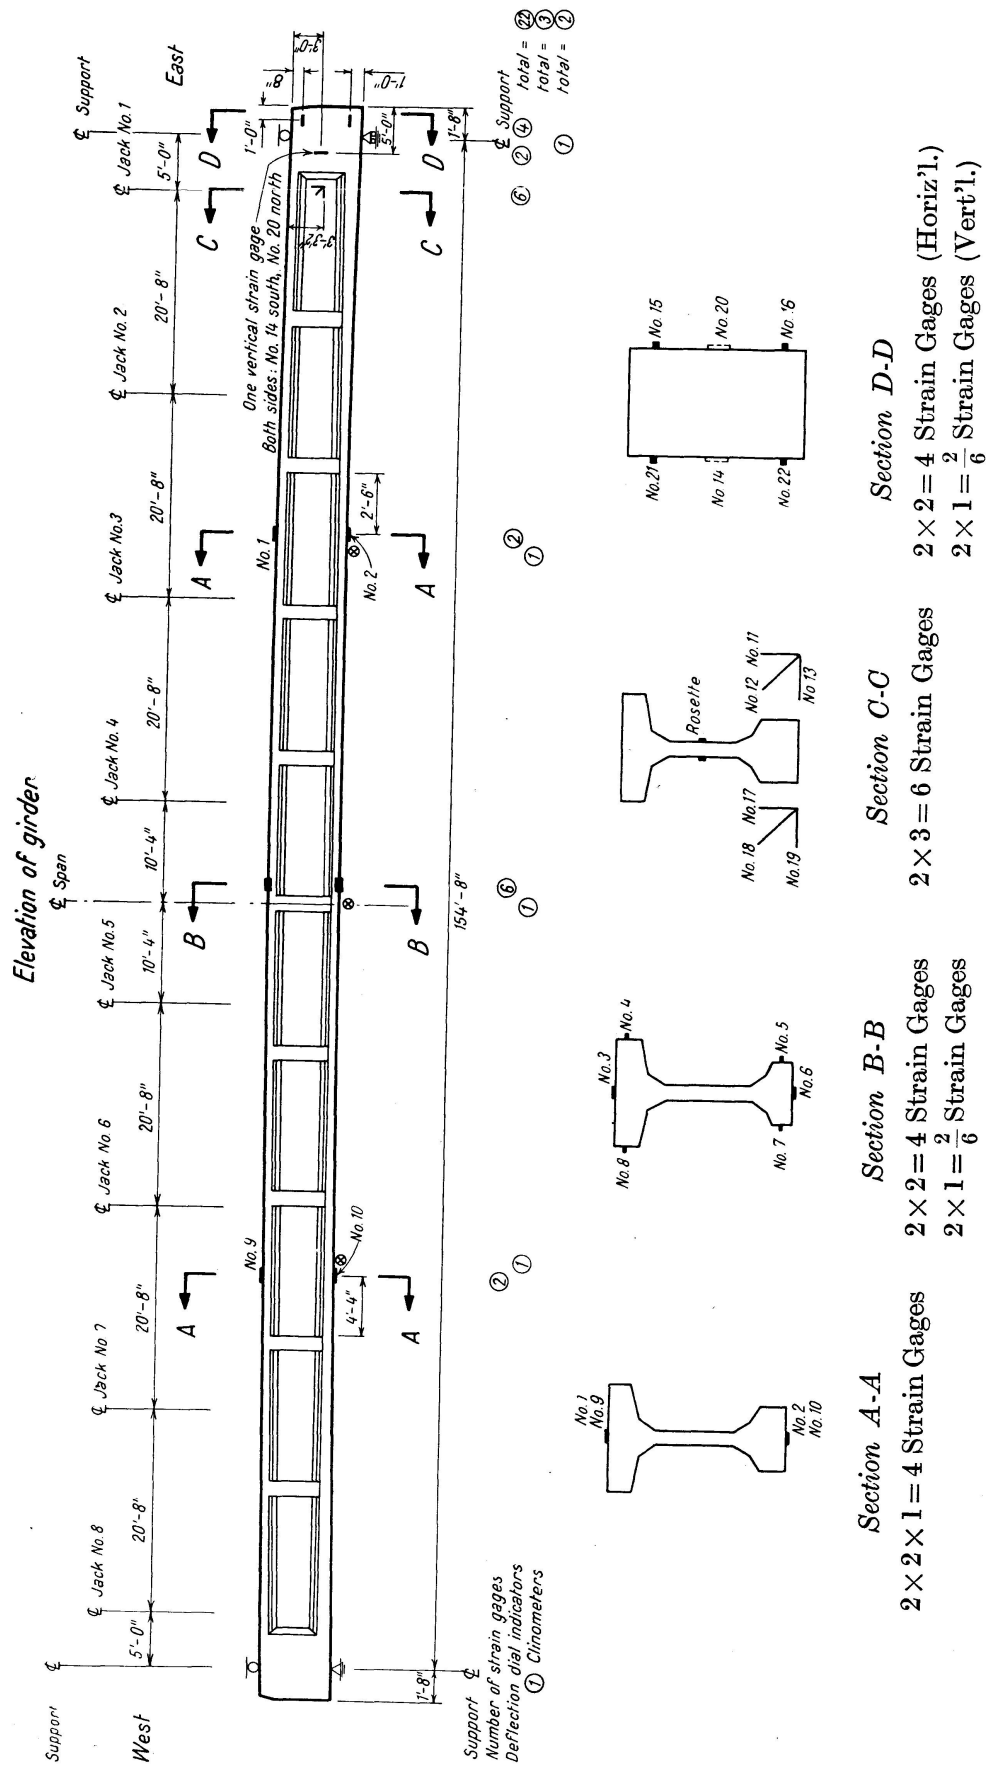
Fig. 10. Test Girder Details and Strain Gage Locations

A total of 22 external electric strain gages Type SR 4 (Baldwin) were attached to the girder and waterproofed (Fig. 9) at locations as shown in Fig. 10. All strain gages were connected by separate leads to two Anderson Model 301 Strainmeters housed in a special instrument shelter. This shelter also contained a concrete test cylinder with a compensator gage for the elimination of temperature influences. (Fig. 11). This arrangement permitted the recording of concrete strains in 10^{-6} units or micro inches per inch.

The test load was applied to the girder by means of 8 hydraulic jacks spaced as shown on Fig. 10 and 12 and operating against a steel frame and the weight of steel ingots suspended on hangers at each loading frame. The jacks were spaced in such a way as to produce the same bending moment as a uniformly distributed live load. A total of approximately 400 tons of steel ingots was available. The force exerted by each jack was determined by a load cell on top of each jack consisting of a short 2″ diameter steel bar with a pair of strain gages mounted on opposite sides of the bar. These load cells were calibrated to permit the jacks to be pumped up to definite and accurate testing loads producing known bending moments in the girder together with the dead load of the girder and the weight of the steel frames.

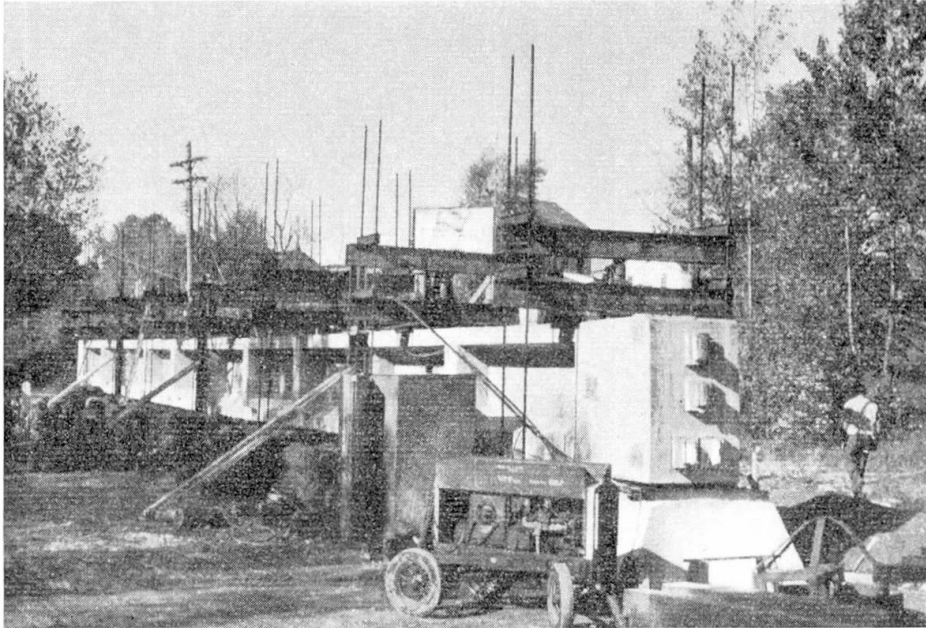
Unfortunately the use of the load cells above the jacks had to be abandoned at a load corresponding to 1400 lbs. per foot. At this stage the tilting of the load frames became excessive and for the remainder of the test jacking loads were determined from the hydraulic pressure gages in the jacks.

Fig. 12. View of Test Girder and Loading Arrangement
Looking northwest, after loading up to 3000 lbs. per foot. Instrument shelter in the foreground

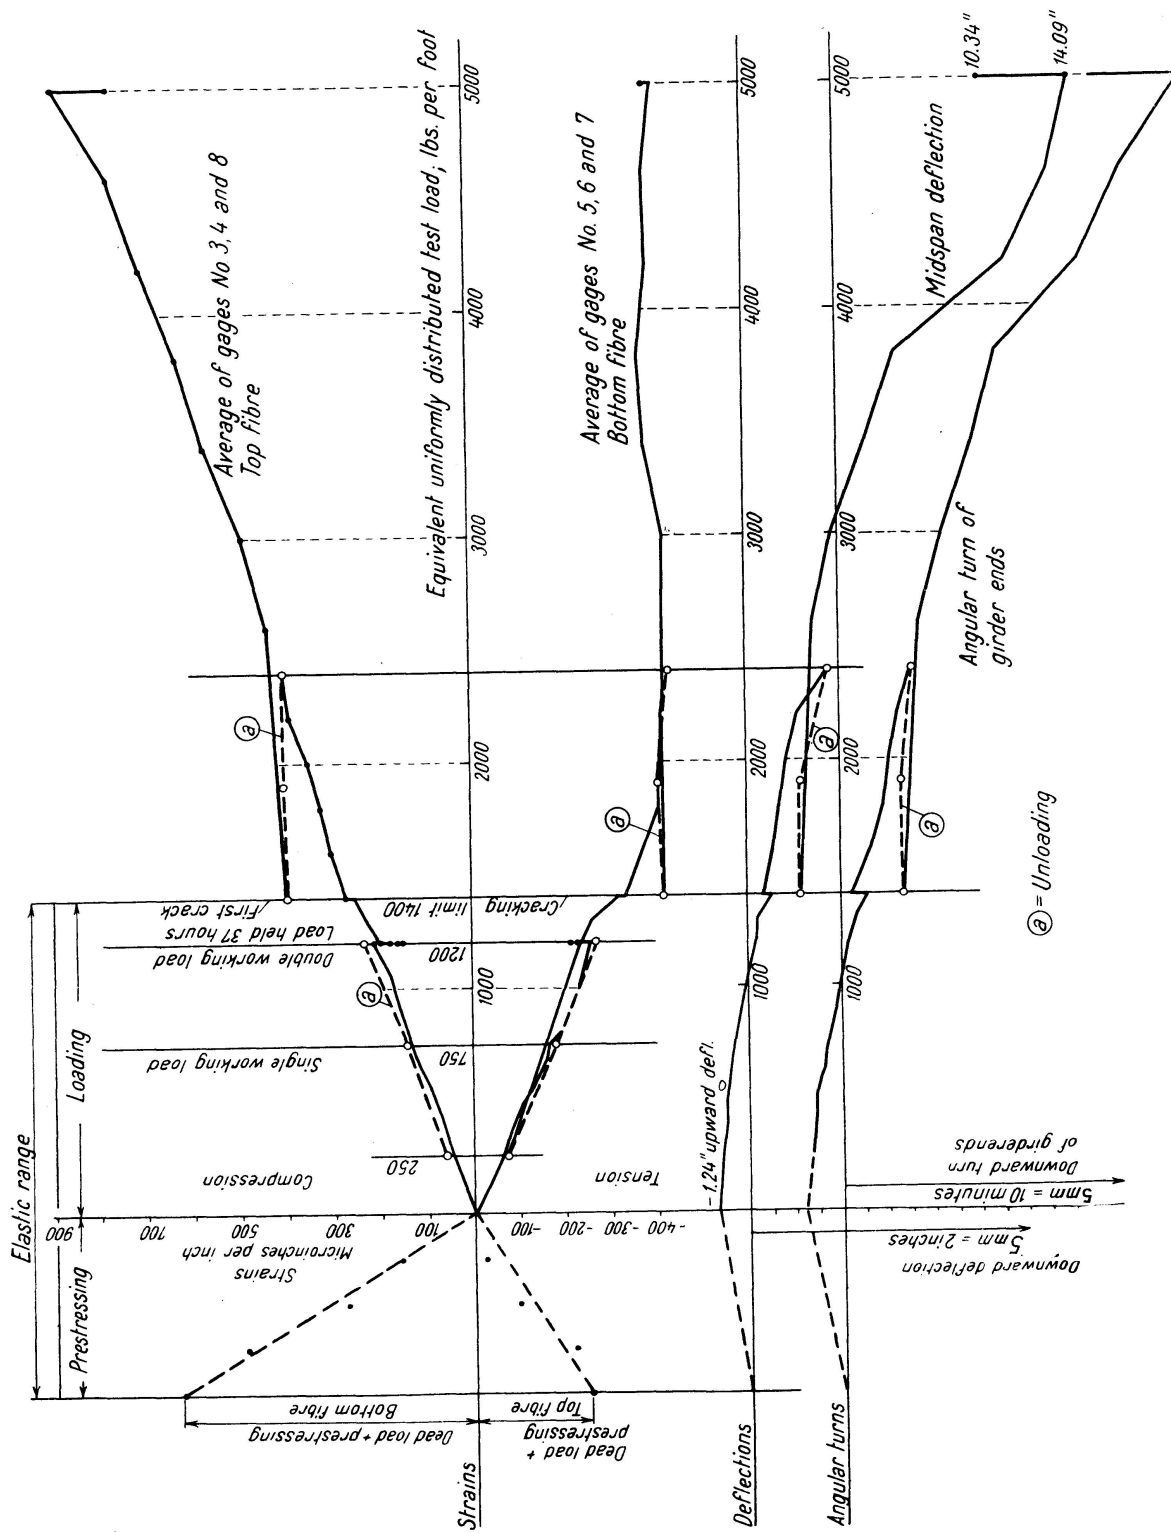
In Fig. 13 a series of graphs show the variation of strains for top and bottom at center of span and the variations of center deflection and of the angular turn of the girder ends. A tabulation of these values is given in Table I.

The strains measured with the Rosette type strain gages near the ends of the girder web (gages No. 11, 17, 13, 19 and 12, 18) were not very significant and up to a load of 2600 lbs. per ft. ($3^1/_2$ times working load) did not exceed 90 micro inches per inch or approximately 590 psi compression. Only gage No. 17 showed tensile strains after a loading exceeding 3000 lbs. per ft. However, in view of the corroborating results from the other 5 gages in the rosettes, gage No. 17 must be considered an unreliable record.

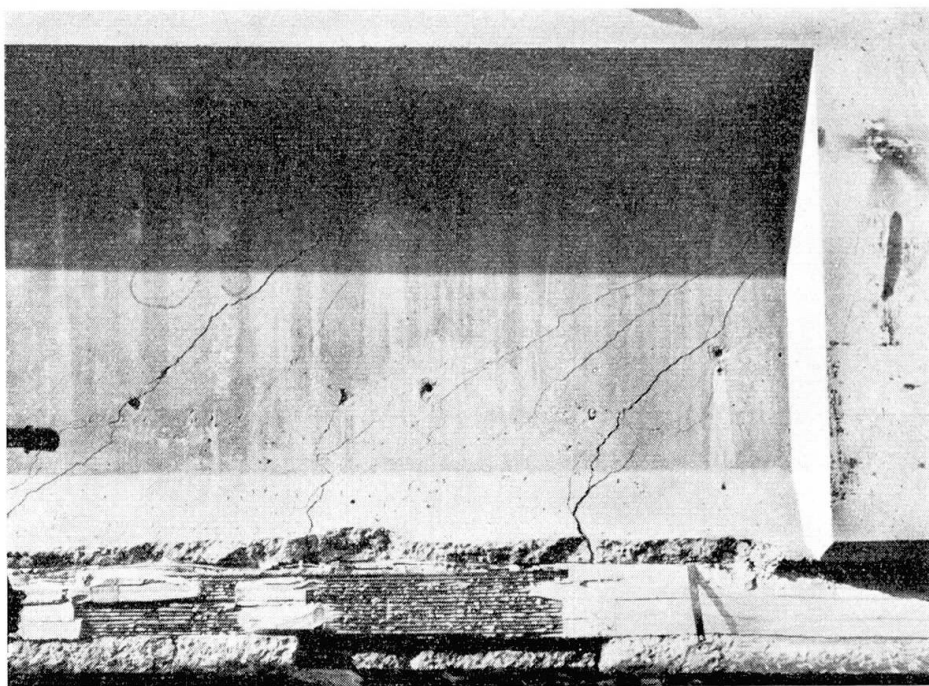
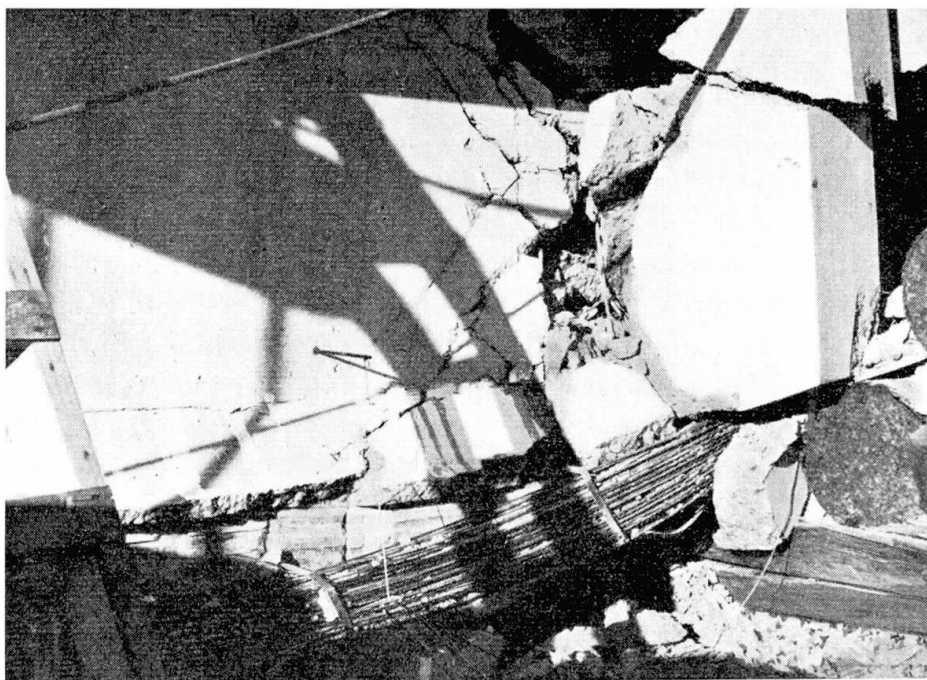
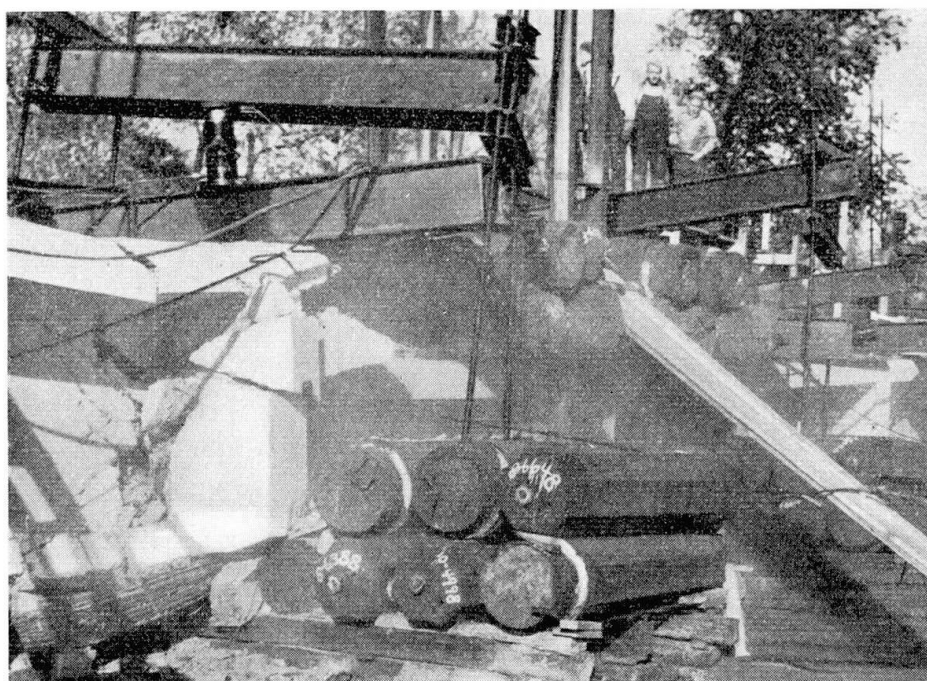
Fig. 16. Failure Cracks and View of Girder After Failure

Subsequent cracking patterns are shown on Fig. 14. It is significant that up to a test load (1200 lbs./ft.) which corresponds to twice the working load in the bridge, no cracks due to loading could be observed. The midspan deflection increment due to this test load was 1,7″ or a little less than $1/1000$ of the span length. For a single working load (750 lbs./ft.) this deflection ratio is only $1/2000$ of the span length. For a depth to span ratio of 1 to 24, as in this instance, the total deflection at working load is therefore $2^1/_2$ times less than what is commonly allowed by the A.A.S.H.O. Code for steel plate girders ($1/800$ of span length).

Failure took place at a total midspan moment of 20 800 000 ft. lbs. which is 2,75 times the total working load moment. Since the dead load portion of the working load is permanent and not subject to variation, it is the excess of the failure load over and above the dead load which gives a measure of safety against occasional overload. The failure test demonstrated that the bridge could be loaded with eleven times the standard live load before failure occurs.
