Zeitschrift: IABSE reports of the working commissions = Rapports des commissions de travail AIPC = IVBH Berichte der Arbeitskommissionen

DISKUSSIONSBEITRAG ZUM THEMA III (DÜNNE FAHRBAHNBELÄGE)

Contribution to the discussion
on Theme III (Thin Wearing Surfaces)

LABORATORY AND FIELD EVALUATIONS OF THIN WEARING SURFACES FOR ORTHOTROPIC STEEL DECK BRIDGES

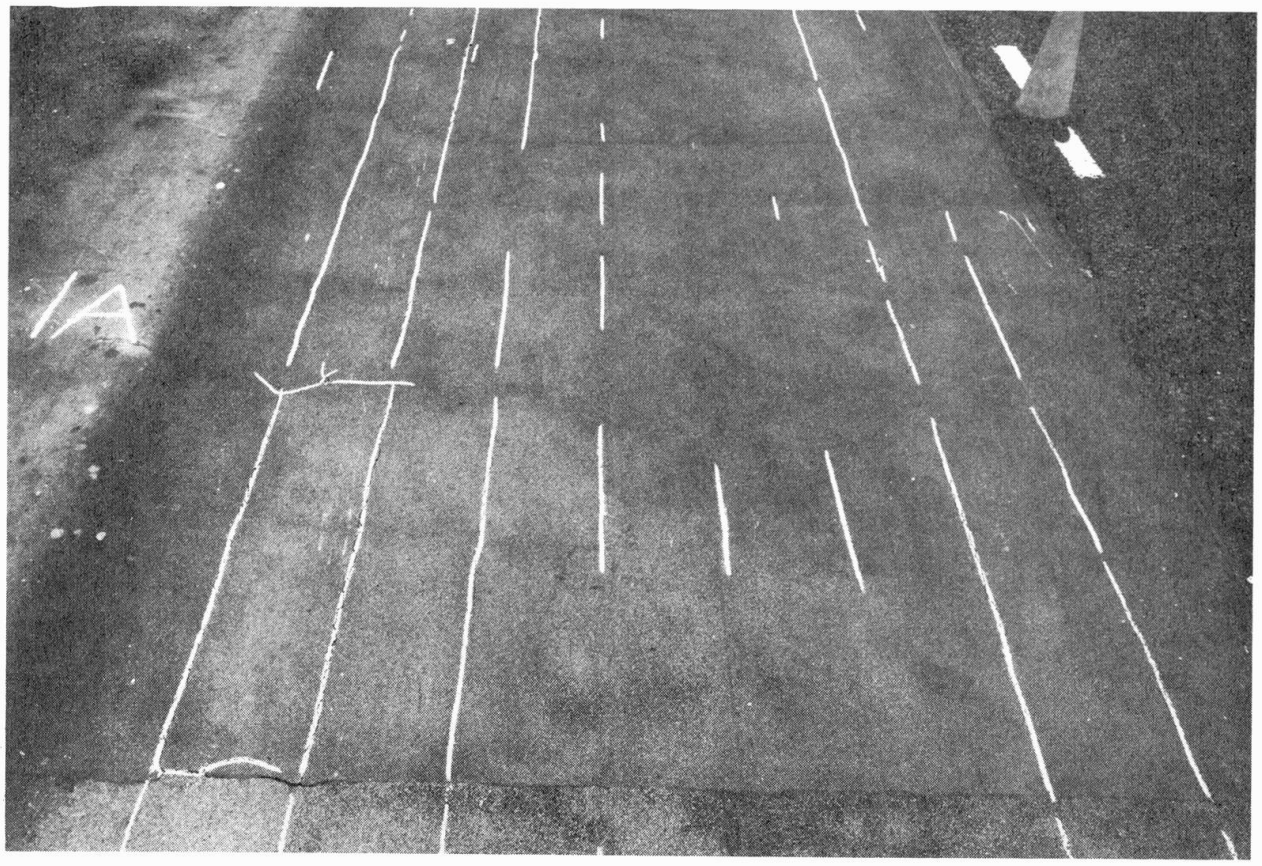
The panels were opened to traffic in November 1963. The first cracks appeared over the stiffeners in the wheel tracks on Sections 1A and 1D, early in 1964. Subsequently, there was a rapid deterioration of the condition of Section 1A, probably due to a defective constituent in the resin, and it was replaced in October 1964. The replacement was made with a fresh batch of the material to the same specification. It was more durable than the previous batch, but it deteriorated in a similar manner and was removed in April 1968. Cracks have developed in the "Estercrete" on Section 1D over all the stiffeners, but they have not widened appreciably and the material still firmly adheres to the steel.

FIG. 3 CRACKING IN EPOXY RESIN SURFACING ON SECTION 1A, NOVEMBER, 1967

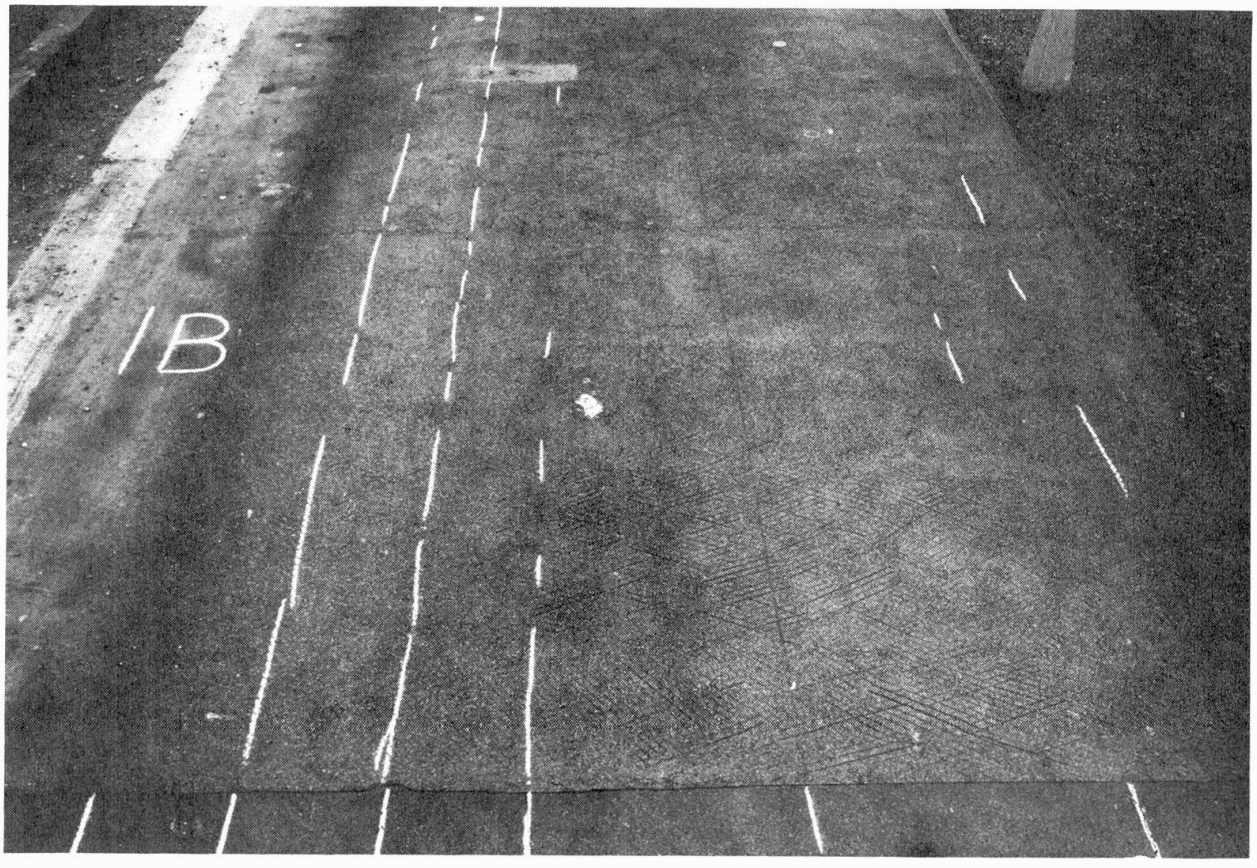
On Sections 1B and 1C the surfacing was in good condition until the beginning of 1965. Then one crack appeared over the stiffener in the nearside wheel track. Since then additional cracks have developed in both the wheel tracks, but the materials still adhere firmly to the deck between cracks. The condition of the four resin surfacings in November 1967 is shown in Figs. 3-6. As reported in a previous paper the mastic asphalt laid at the same time is still uncracked and hasvindicated its selection for the deck of the Severn Bridge in 1966.

The resin on Sections 1B, 1C and 1D would still be regarded as providing a good running surface with a good skidding resistance. However, they are not adequately protecting the steel in a region where a small amount of corrosion could have a serious effect on both the ultimate and fatigue strength of the bridge deck.

FIG. 4. CRACKING IN EPOXY RESIN SURFACING ON SECTION 1B, NOVEMBER, 1967

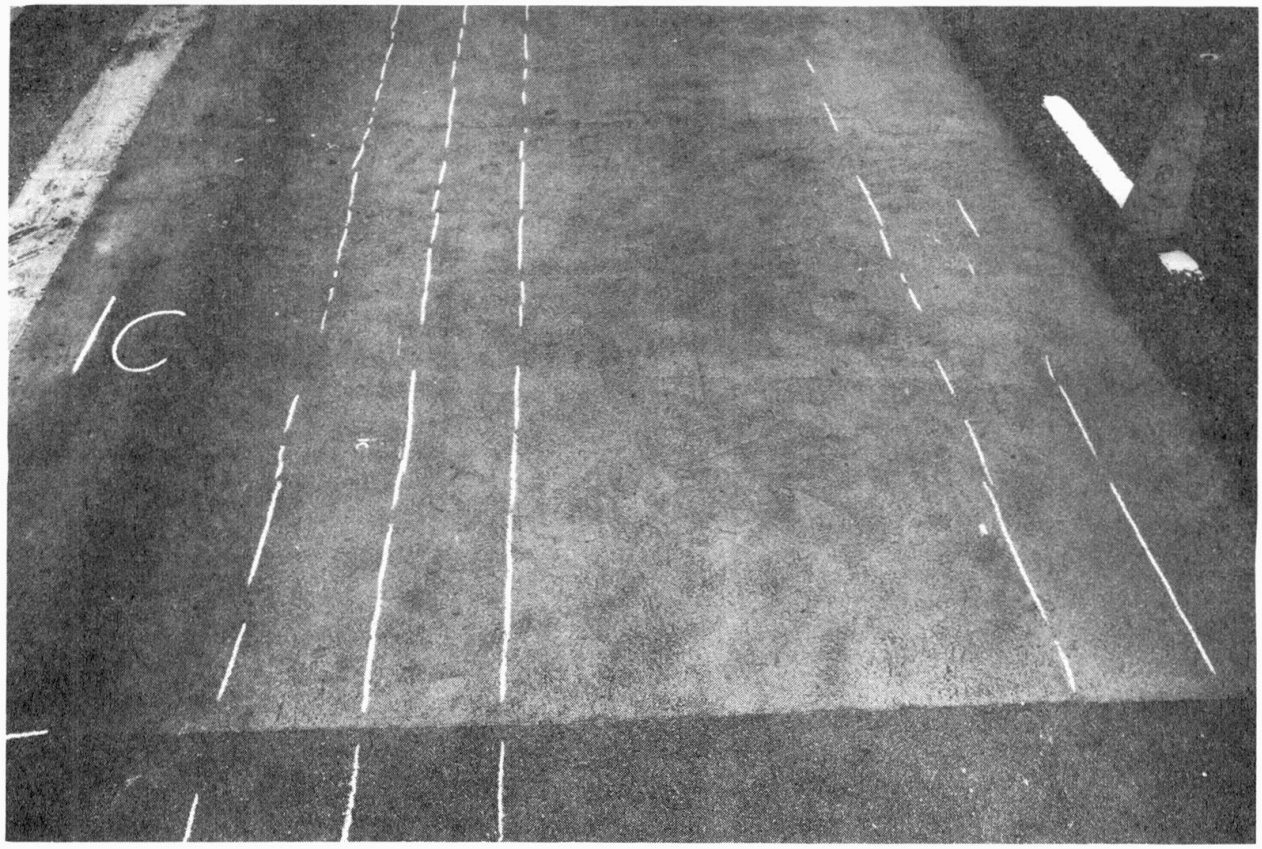
FIG. 5 CRACKING IN EPOXY RESIN SURFACING ON SECTION 1C, NOVEMBER, 1967

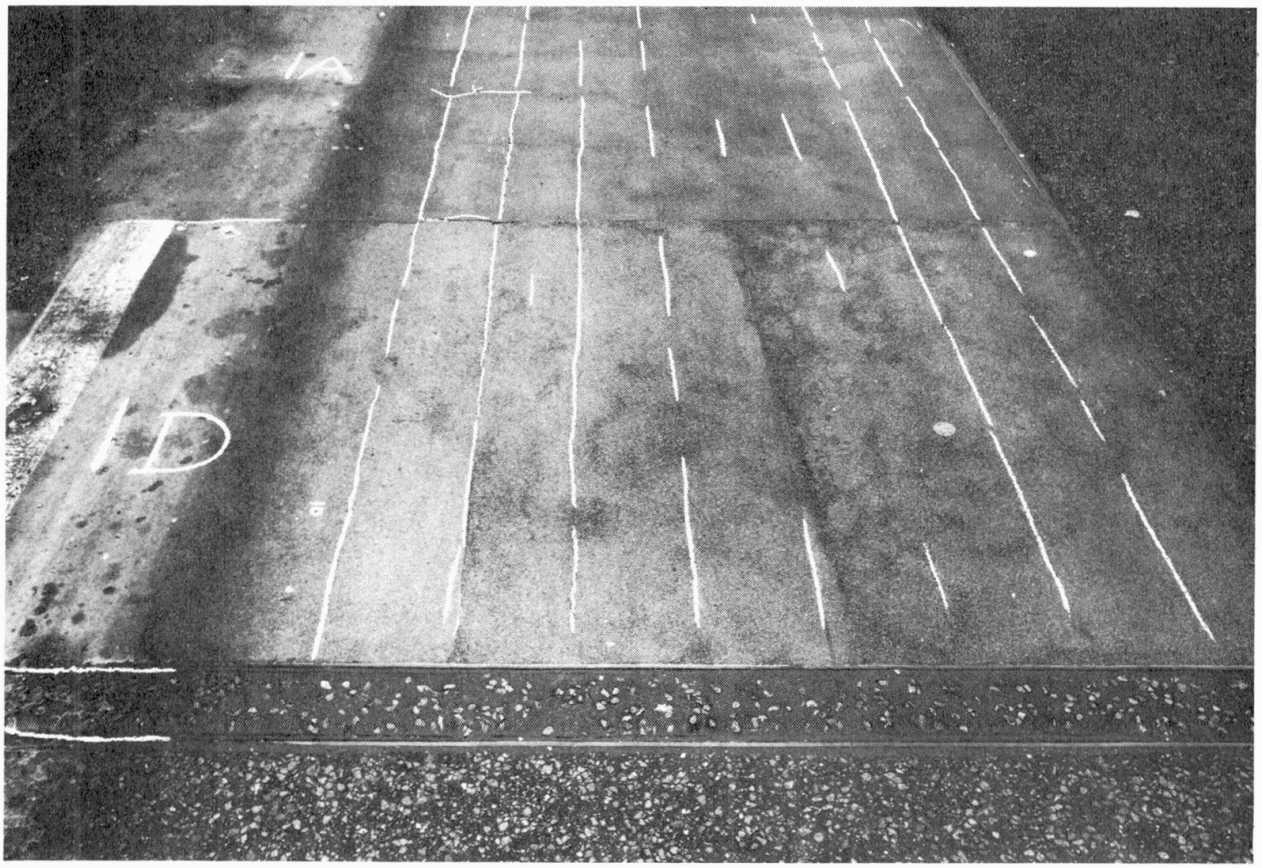
FIG. 6 CRACKING IN "ESTERCRETE" SURFACING ON SECTION 1D, NOVEMBER, 1967
