Artikel: Behaviour of brick masonry buildings during earthquakes

BEHAVIOUR OF BRICK MASONRY BUILDINGS DURING EARTHQUAKES

Nejat BAYÜLKE

Chief of Structural Division
Earthquake Research Institute
Ministry of Reconstruction and Resettlement
Ankara-TURKEY

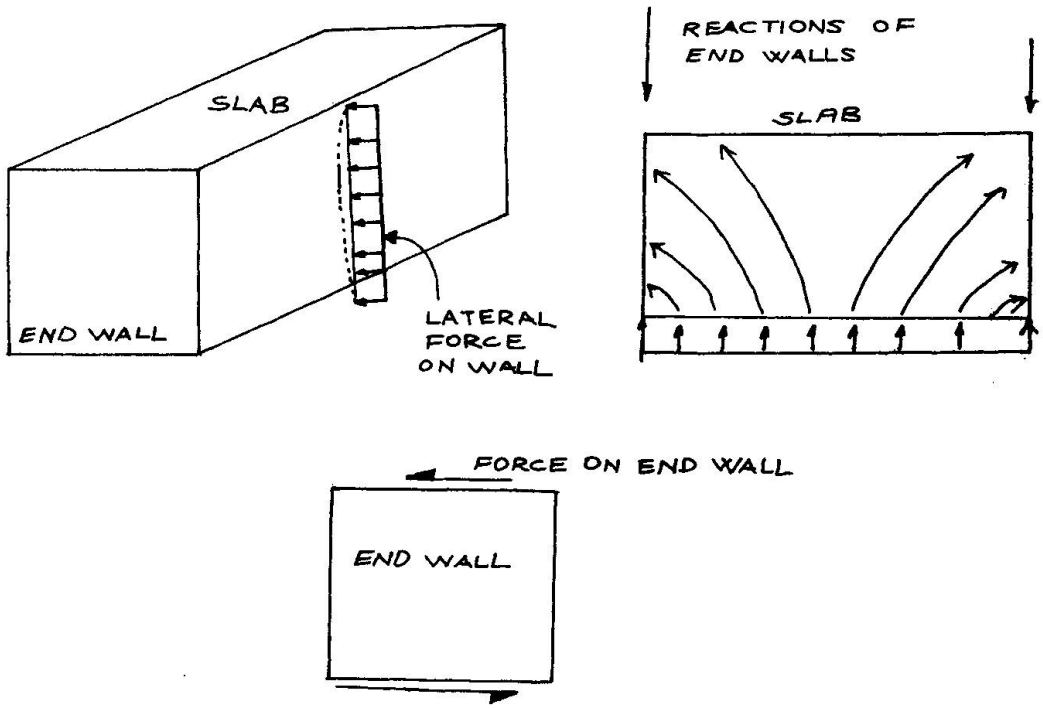
Under the action of lateral forces (wind and earthquake) the longitudonal walls will transfer the lateral loads to the roof or floor slab (if there is one) or to the roof truss and this element will in turn transfer the loads to end walls. Figure-1. Thus the end walls will be subjected to shear forces and when the shear stress exceeds the shear strength of the wall, failure in the form of diagonal tension cracks occurs. These cracks will make an angle of 45 degrees with the horizontal.

Figure-1 State of Loading on Brick Walls Due to Lateral Forces

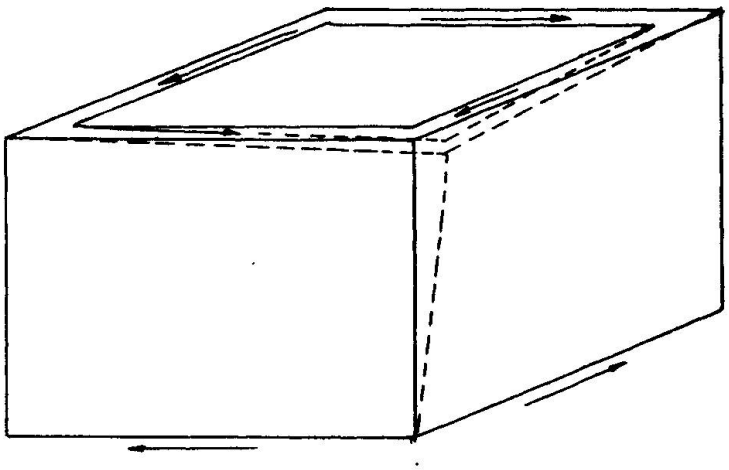
Since the earthquake forces will act in the two principal directions of the building, the corners of the building will be very critical. Figure-2

In fact such kinds of corner failures have been observed many times in Turkey. Figure-3. In case when there are no slabs of reinforced concrete or the roof truss is not rigid enough to hold the two cross walls together this form of damage should be expected.

Figure-2 Corner Behaviour of Masonry Buildings.

Figure-3 Corner Damage due to Earthquake

Another critical condition occurs at the corners of external walls, under the action of earthquake forces, the cross walls tend to displace each other outwards at the corners. This could be prevented by providing vertical reinforced concrete columns at the corners. This detail is widely followed and commonly executed in Turkey even in one story high houses. Presence of reinforced concrete slabs at floor and roof levels will prevent outward displacement of corners by exerting a vertical restraint.

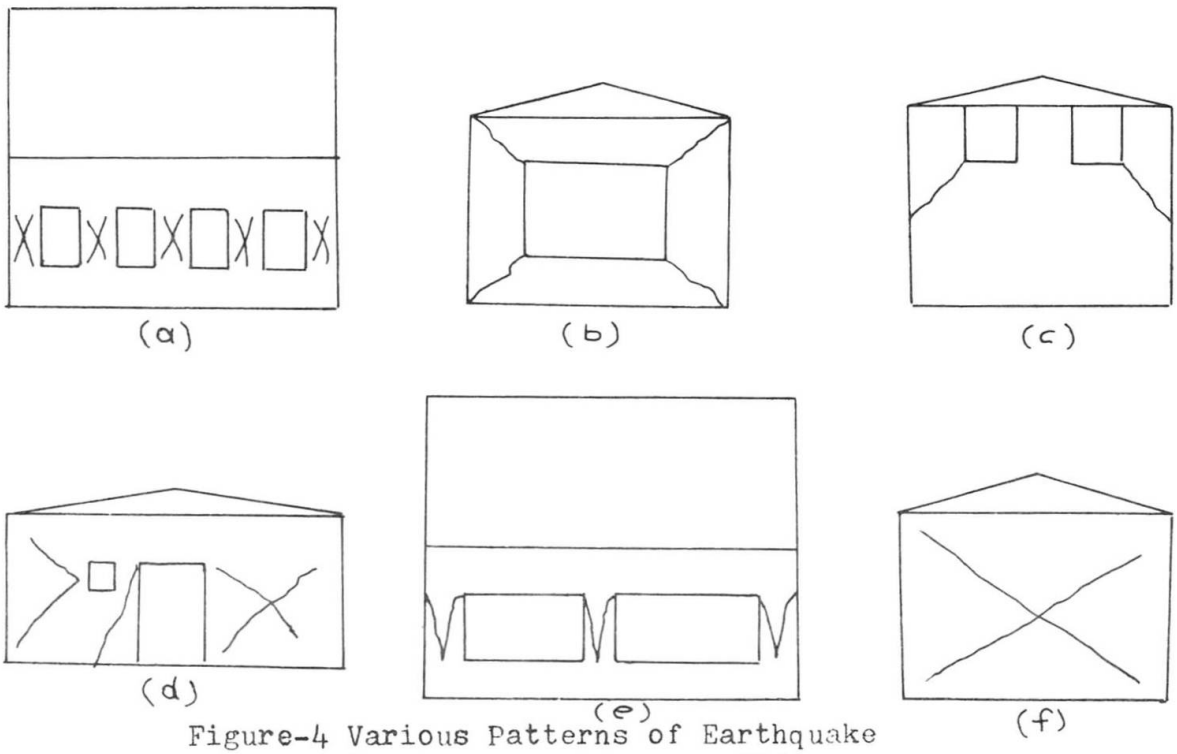
Due to action of shearing forces on the walls of brick masonry, various forms of diagonal tension failures occur. However the walls are also subject to compressive stresses due to the weight of the wall and weight of upper stories. Thus the diagonal tension cracks will deviate from 45° and the angle between the cracks and vertical direction will be smaller than 45° degrees. Apart from the angle of cracks, the extension of the

Figure-4 Various Patterns of Earthquake Cracking in Masonry Buildings

of the cracks will be influenced by the height to width ratio of the wall and location and size of the window and door openings. Figure-4.

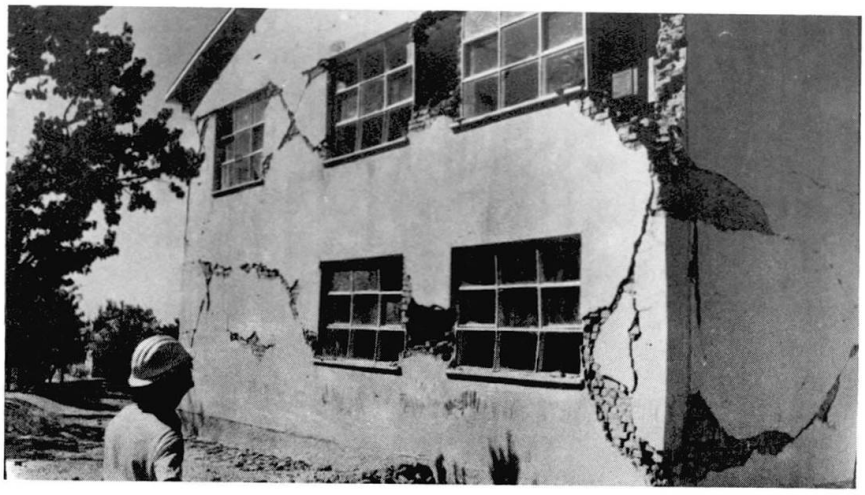
This initial diagonal cracking of the wall, if the earthquake continues at a high intensity, will result in the decrease of vertical load carrying capacity of the wall and vertical cracks due to vertical loads will begin to appear in addition to the existing cracks due to diagonal tensile stresses in the wall. This process will eventually lead to the complete collapse of the wall. Figures-5,6,7 show this kind of heavily damaged brick masonry walls

Figure-5 Typical Failure of Brick Masonry

Figure-6 Typical Failure of Brick Masonry

Figure-7 Typical Failure of Brick Masonry

As it is known brick masonry is not a construction system desired and used for earthquake resistant construction however certain economical conditions enforce its usage, specially for one to two stories high houses which are being built in considerable numbers in Turkey. The brittle nature of the brick masonry walls and rapid cracking of walls during earthquakes necessitates certain counter measures. Since the rapid shear cracking weakens the vertical load carrying capacity of walls thus increasing the possibility of collapse, measures are required to prevent extensive cracking and crack propagation. This is usually achieved by providing lintel beams of more ductile nature and of higher strength such as reinforced concrete at certain levels of the walls.

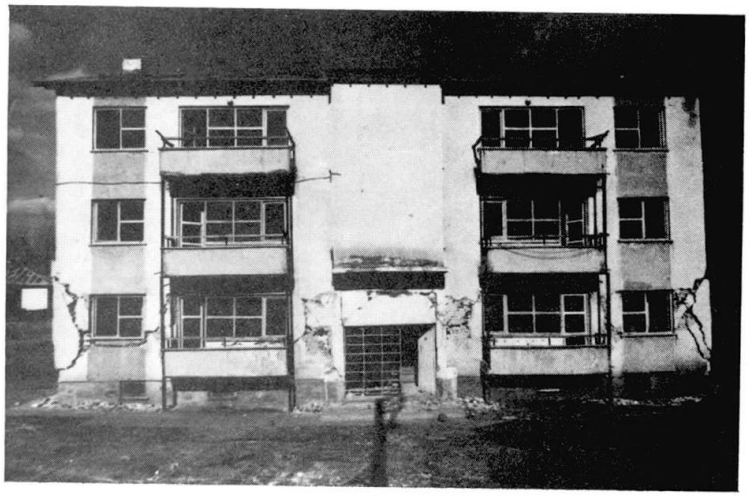
Building	External Wall Opening Ratio %	Wall/Floor Area Ratio cm/m2	Damage	Remarks
Çaldıran Staff Housing				
x-axis	41-37	26	No damage	I = IX
y-axis	0	31	No damage	(Figure-8)
Muradiye Staff Housing				
x-axis	54-55	12	Heavy damage	I = VII
y-axis	0	26	No damage	(Figure-9)
Muradiye Junior High School				
x-axis	15	20	Slight damage	I = VII
y-axis	53-37	12	Heavy damage	(Figure-10)
Palu Monopoly Office				
x-axis	42-35	21	Damage	
y-axis	0-16	24	No damage	I = VI
Palu Local Administration Building				
x-axis	55	25	Heavy Damage	I = VI
y-axis	29	30	No damage	(Figure-11)

Figure-8 Çaldıran Staff Housing

Figure-9 Muradiye Staff Housing

Figure-10 Muradiye Junior High School

Figure-11 Palu Local Administration Building

From these observed damage and properties of buildings, it can be seen that an external wall opening ratio more than 40 % causes damage in the walls.

On the other hand, buildings with wall/floor ratio less than 25 cm/m2 are also damaged heavily. This points out the fact that large sized rooms in masonry houses could lead to damage in case of earthquakes.
