THEME 6

Case Studies of Steel Structures

Fatigue Design of the Honshu-Shikoku Bridges in Japan

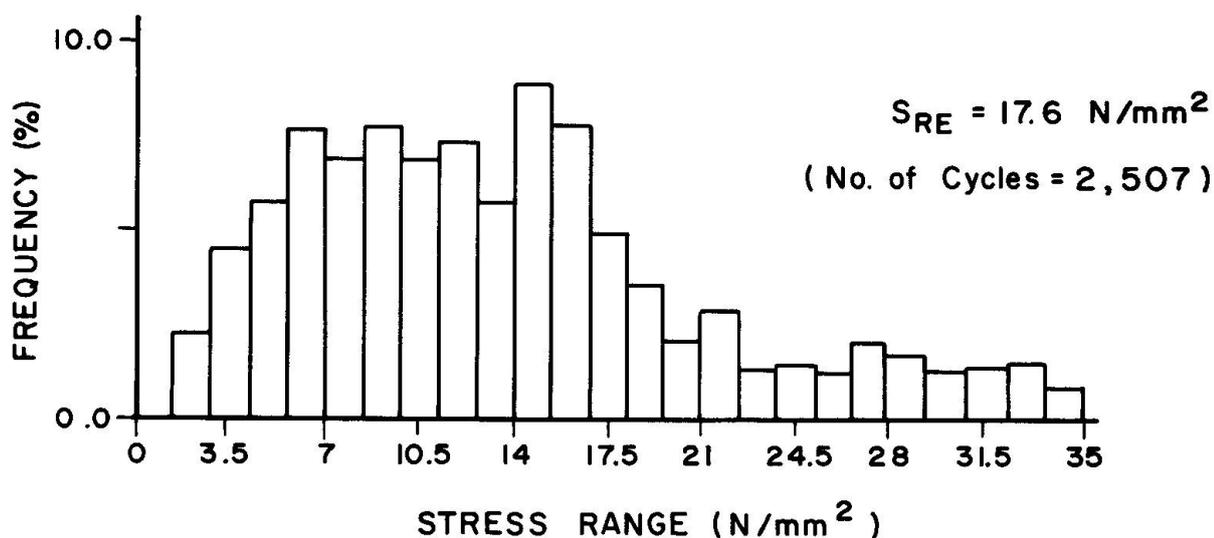
Figure 3 -- Histogram of Stress Range Spectrum for Gage No. 6

The processed strain data was used in preparation of stress range histograms. Figure 3 shows the stress range histogram for stresses recorded at gage No. 6, recorded on the Bridge No. 367.

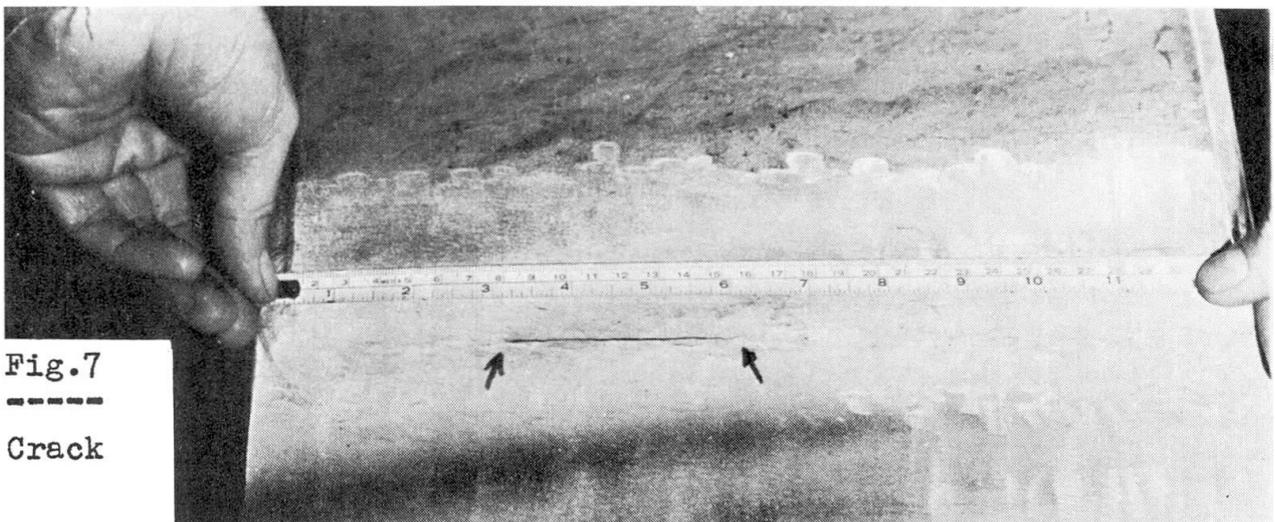
Fig.7

After about three and half service years cracks were detected on
several locations in the end zones of cover plates (lower flange)
e.g. see Fig.7. A slow crack propagation was observed in some
cases.After some complementary material tests (K_{IC},crack propaga-
tion rate,/7/) and with respect to the coming winter season it was

Crack

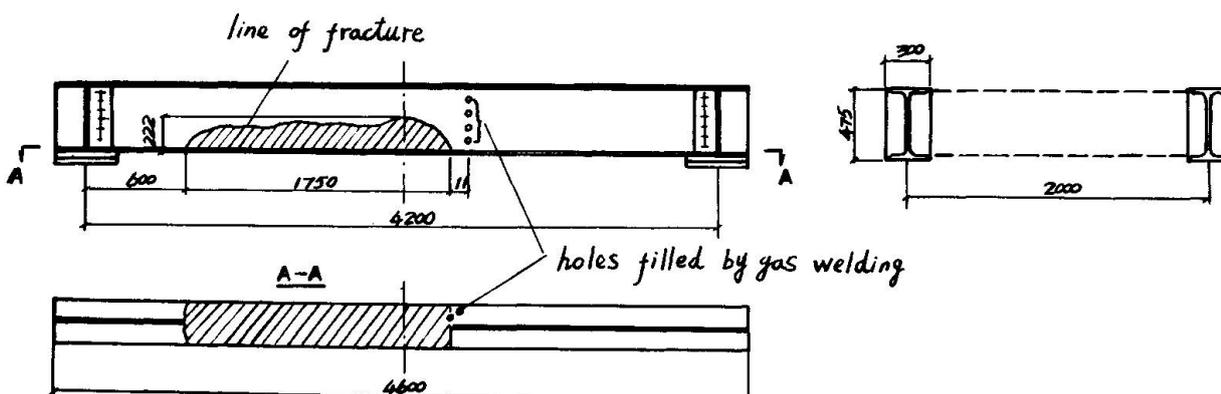
Bridge No. 248 on the Beijing-Baotou Railway Line was a rolled I-beam bridge which was manufactured in Britain in 1898 and erected in 1903. Its original length was 7 M and was cut down to 4.6 M in 1947 to be used as a simple span. There were four drilled holes of Ø19 on the webs and two on the bottom flanges. These holes were filled later by gas welding when it was cut. It so happened that at about 11 o'clock in the mroning of November 30, 1967, after a heavy snow fall, a large piece of flange metal broke off together with a portion of the web. Fig 1 is a sketch of the girder and the failure location. Photo 1 is the fallen off piece. From the fracture surface, we could find that the weld quality was very poor. Under repeated action of train load through a long period of time, fatigue crack was initiated at the notch (Photo 2).

Fig 1   Sketch of the girder bridge No. 248 and its failure location

This accident once more teaches that direct repair welding on steel girders
must be strictly forbidden. Otherwise it would be very much likely that weld
defects or weld cracks should appear and deterioration, a decrease in ductility
in particular of the weld metal and the heat affected zone would happen. And
these would certainly give rise for the formation of fatigue crack and brittle
fracture. This is an important problem we must pay attention to in the recon-

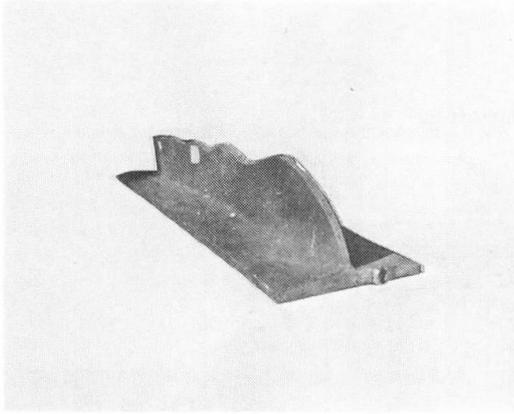
Photo 2   Fatigue crack at the notch
          of bridge No. 248

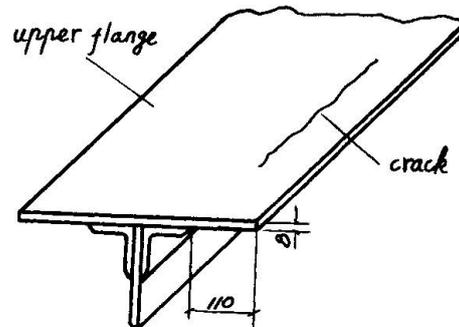
Fig 3   Crack on the upper flange

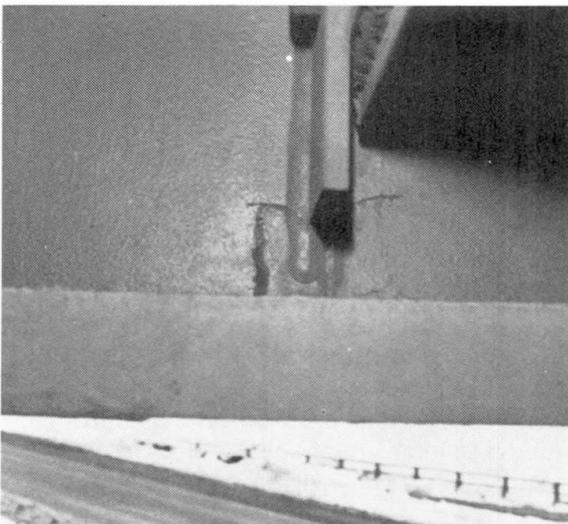
Fig. 1   Cracking at Transverse
Diaphragm Web Connection
Plate (Skewed Bridge)

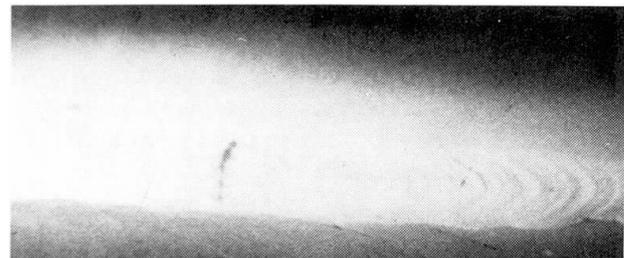
Fig. 3   Crack in Longitudinal Weld

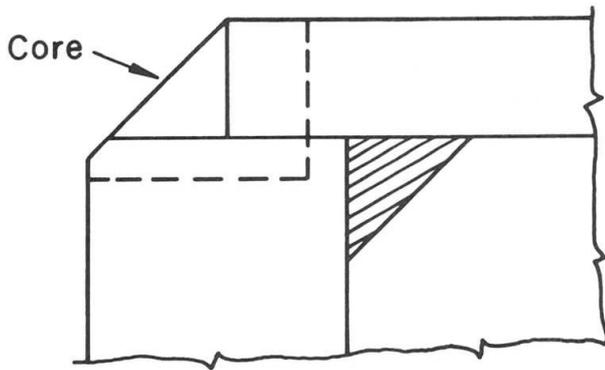
Several of the defects were removed from the box corners by coring (see Fig. 4a), so that detailed metallographic and fractographic studies could be carried out to ascertain the cause of cracking. Figure 4b shows the polished face of the box

Fig. 4a Schematic Showing Core Sample
at Web-Flange Corner Weld

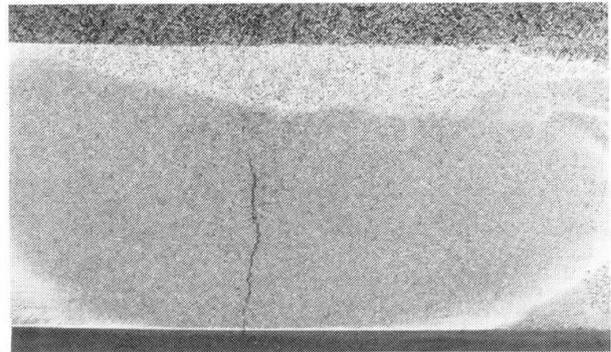
Fig. 4b Ground Surface of Weld
Segment Showing Crack

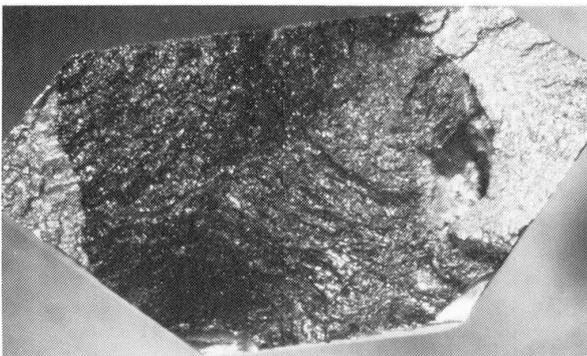
Fig. 4c Exposed Crack Surface

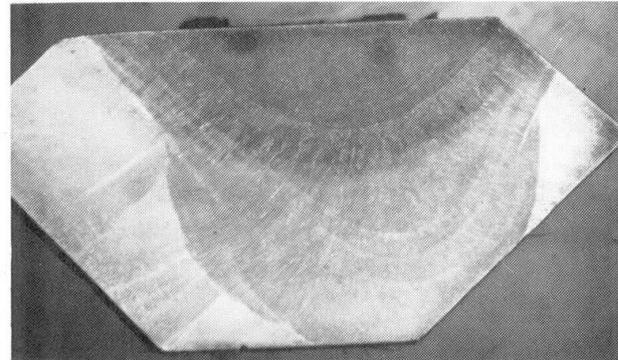
Fig. 4d Polished and Etched
Surface Behind Crack

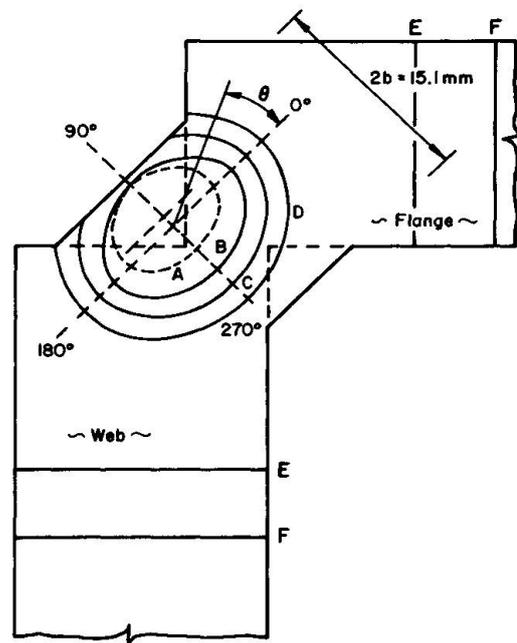
Fig. 8 Investigated Crack Shapes
        in Corner Weld, Box Girder

It was found that the stress intensity range is larger than ΔK_{TH} for all the crack shapes shown in Fig. 8. Crack shapes B, C and D exceed the crack growth threshold when the stress range is 14 MPa. The increase in the total stress intensity factor (due to traffic, dead load and residual stress) is rapid, as the crack approaches the back free surface. Figure 9 shows the stress intensity along the crack front for crack shapes C and D. A material with poor fracture toughness (i.e. 50 to 60 MPa $\sqrt{m}$) will likely fracture with crack propagation between crack shapes C and D. If the material has better fracture toughness, larger crack sizes can develop before crack instability. Fortunately all cracks were detected and retrofitted before this occurred.

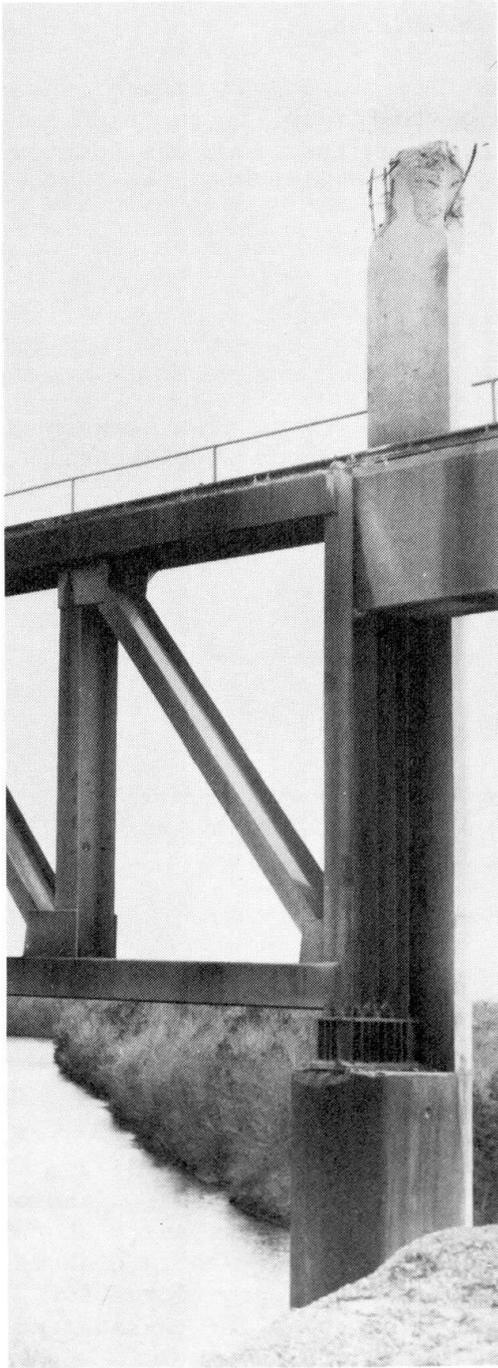
Fig. 1 View of Collapsed Truss and Crane

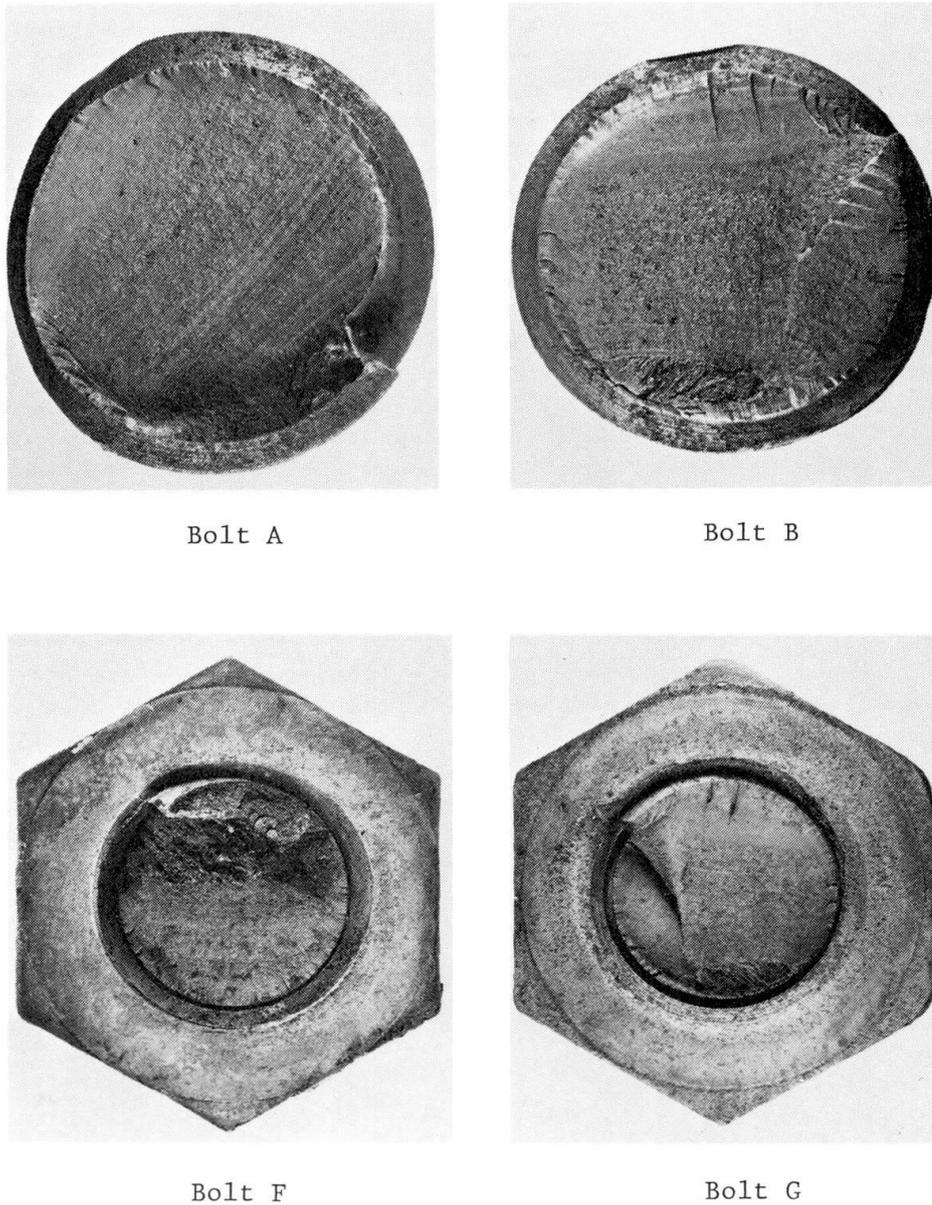
Fig. 5 Fracture Surfaces

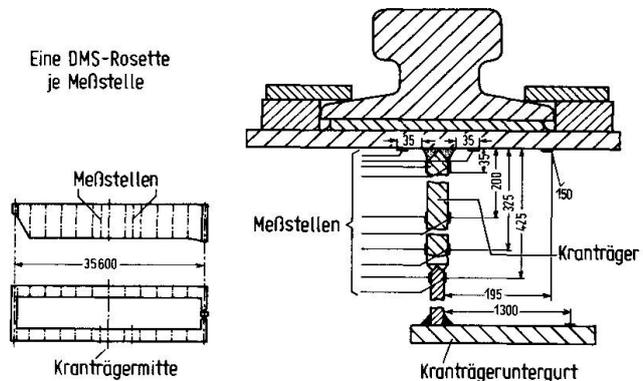
Bild 3: Meßstellenanordnung an einem 100-t Brammentransportkran
Fig. 3: Measuring point arrangement on a 100-t slab conveying crane

Bereich der Schweißverbindungen. Ein rechnerisches Verfahren zur Ermittlung der statistischen Verteilung der betrieblichen Beanspruchungsschwankungen unter Berücksichtigung der genannten Einflußgrößen ist bisher nicht bekannt. Im Rahmen der Untersuchung wurden deshalb die betrieblichen Beanspruchungsschwankungen im Bereich des anrißgefährdeten Querschnitts der Schweißverbindungen zwischen Obergurt und Stegblech mit Dehnungsmeßstreifen (DMS) ermittelt. Bild 3 zeigt beispielhaft eine Übersicht über die Meßstellen an einem Kranträger.

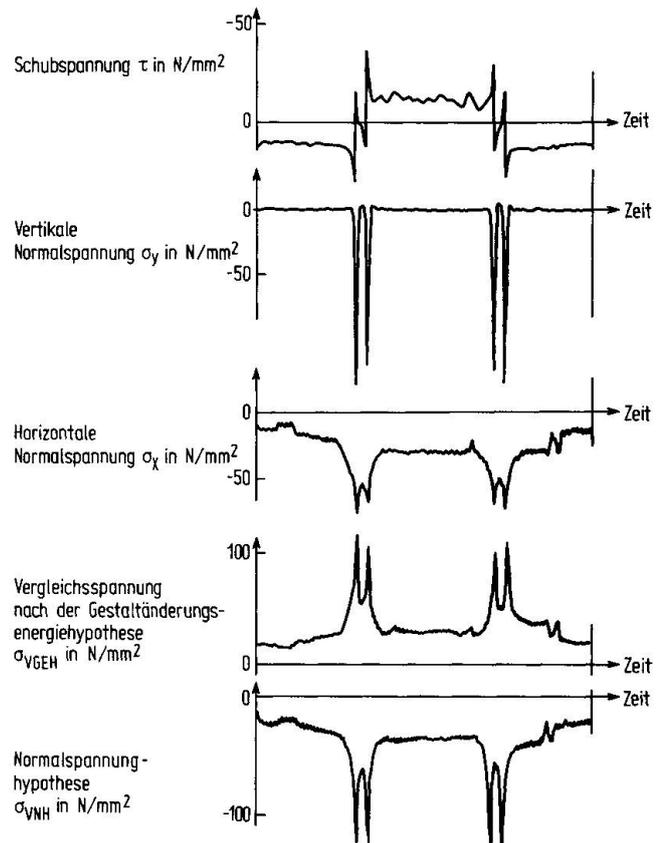
Bild 4: Gemessene Spannungen und berechnete
Vergleichsspannungen im Stegblech
eines 32-t Stripperkranes für zwei
Katzfahrten

Die umfangreichen Meßergebnisse sind in einem Bericht [3] dargelegt. Deshalb sollen an dieser Stelle nur einige kennzeichnende Teilergebnisse vorgestellt werden. Bild 4 zeigt die aus den gemessenen Dehnungen berechneten Spannungs-Zeit-Verläufe im Stegblech eines Kranträgers. Im Bild sind die Verläufe der Schub- und Normalspannungen sowie die daraus berechneten Vergleichsspannungen nach der Normalspannungs- und Gestaltänderungsenergiehypothese dargestellt. Die in vertikaler Richtung wirkende Normalspannung σ_y wird durch das Spannungsfeld der örtlich eingeleiteten Radlast bestimmt. Sie ist gleich Null, solange keines der beiden Katzräder in unmittelbarer Nähe des Meßquerschnittes steht.
Die Druckspannung σ_y steigt steil an und erreicht einen Höchstwert, wenn ein Katzrad den Meßquerschnitt überrollt. Dieser Verlauf wird hinsichtlich der

Größe der Spannungsschwankungen auf
beiden Seiten des Stegbleches beob-
achtet. Der Einfluß einer überlager-
ten Stegblechquerbiegung infolge ex-
zentrischer Radlasten verursacht
eine geringe Mittelspannungsver-
schiebung. Die Schubspannung τ im
Stegblech setzt sich aus zwei An-
teilen zusammen, die der Querkraft
und dem Spannungsfeld der örtlichen
Radlasteinleitung zugeordnet werden
können. Der Verlauf der Normalspan-
nung σ_x , die in Trägerlängsrich-
tung wirkt, setzt sich aus einem
Biegespannungsanteil, der dem Ver-
lauf der Zuggurtbeanspruchungen
proportional ist, und einem Anteil
aus der Einleitung der Radlasten
zusammen. Der ebene Spannungszu-
stand im Stegblech wird im wesent-
lichen von der Überlagerung der

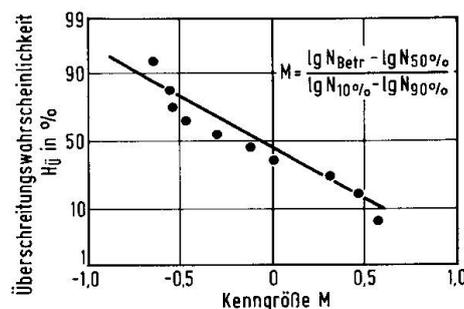
Bild 6 : Verteilungsfunktion der Kenngröße M für die untersuchten Schadensfälle

Mit den konstruierten Bauteilwöhlerlinien und den ermittelten Amplitudenkollektiven der Beanspruchungen im anrißgefährdeten Querschnitt von Schweißverbindungen wurden Schädigungsrechnungen nach der modifizierten, linearen Schädigungshypothese durchgeführt. Die berechneten Bruchlastspielzahlen wurden mit den betrieblich festgelegten Bruchlastspielzahlen verglichen. Dazu wurde, vergleichbar einem statistischen Mittelwerttest, eine Kenngröße M ermittelt. Dabei wird der Abstand zwischen der betrieblichen und der mittleren berechneten Bruchlastspielzahl ins Verhältnis gesetzt zum Abstand der berechneten Bruchlastspielzahlen für die Überlebenswahrscheinlichkeiten $P_{\ddot{U}} = 10\%$ und $P_{\ddot{U}} = 90\%$. Die Verteilungsfunktion der ermittelten Kennwerte M für die untersuchten Schadensfälle ist im Wahrscheinlichkeitsnetz (Bild 6) dargestellt.

Daraus geht hervor, daß die berechneten und die betrieblichen Bruchlastspielzahlen im Mittel übereinstimmen, weil der Mittelwert der Verteilungsfunktion bei Null liegt. Für den größten Teil der Schadensfälle liegen die betrieblichen Bruchlastspielzahlen innerhalb des berechneten Streubereiches für die Überlebenswahrscheinlichkeiten $P_{\ddot{U}} = 10\%$ und $P_{\ddot{U}} = 90\%$, das heißt, M liegt im Bereich $-0,5 \leq M \leq 0,5$.

Fig. 6 : Distribution function of the parameter M for the investigated cases damage
