Rubrik: Session 3: Rehabilitation and repair of bridges

Experiences with Orthotropic Steel Deck and Cable Stayed Bridges

Rehabilitation and Repair of Bridges

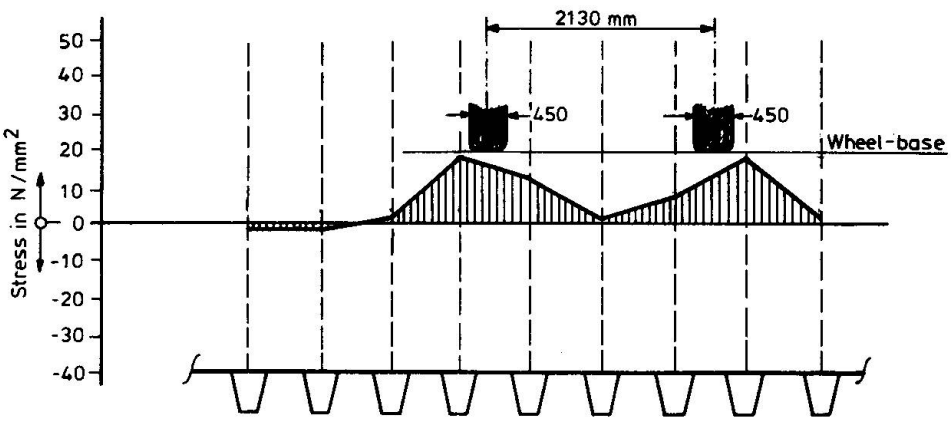
Fig. 1 Transverse Load Distribution

Orthotropic plates, even those with torsionally stiff stiffeners, have a poor transverse load distribution. Results of strain gauge measurements on the bottom flange of stiffeners of a "standard" orthotropic plate are shown in Fig. 1 [1]. Studies made under traffic in motion show that about seventy to eighty per cent of all wheels of commercial vehicles passed within about ± 300 mm of the centre line of the "ideal" wheel track. These two facts combined indicate that orthotropic plates have heavily loaded and less heavily loaded stiffeners.

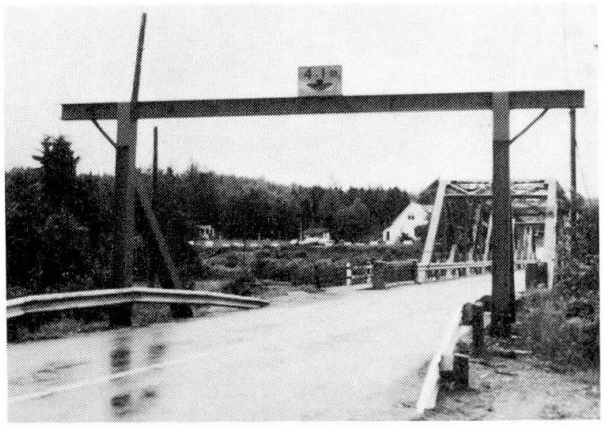
Figure 1 Height Protection

The solution shown in figure 1 is a lot more economical than building a new bridge. The construction of a new bridge can wait until the traffic warrants it, since the occasional high truck can get across by using a short detour.

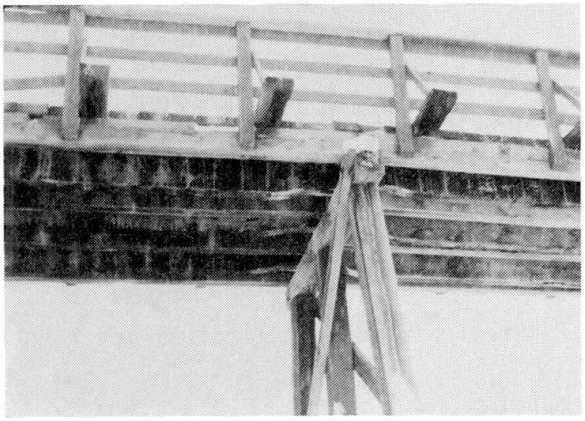
Figure 2 Crushing Timber

The structure shown in Figure 2 shows crushing of the outside stringers and floor beams which are wooden beams. Nevertheless, the center of the structure is used to get one farm tractor across daily. By blocking off the edges, repairs or replacement are avoided.

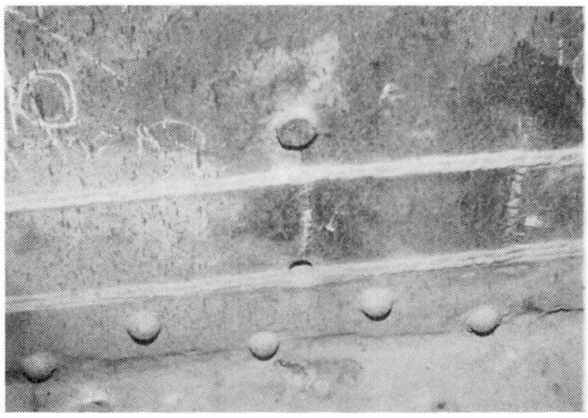
Figure 3 Crack in Girder

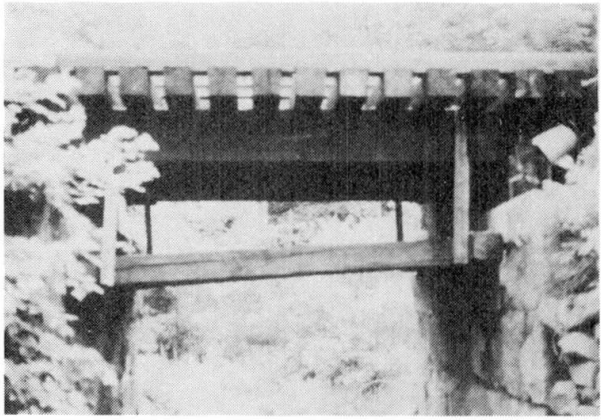
Figure 4 Temporary Support

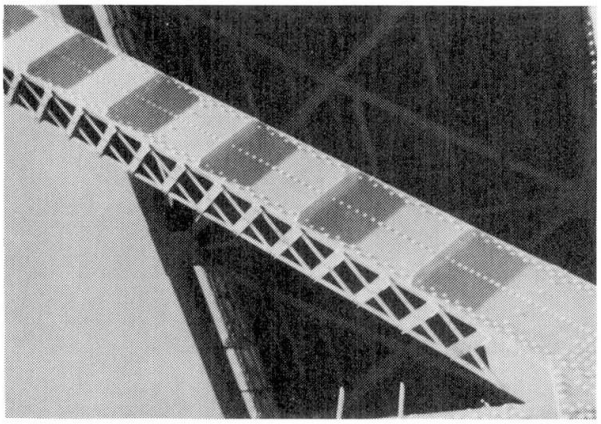
Figure 6 Well painted
(Photo by C. Seim)

There are (5) studies which show that preventive maintenance is the least expensive way of maintaining a structure that has full economic justification for existence. The structure shown in Figure 6, built in 1935, is so well maintained

that you could almost eat off it, and it has proved over the years to be very inexpensive to maintain. Constrast this with the member shown in Figure 7, built the same year, whose painting has been neglected.

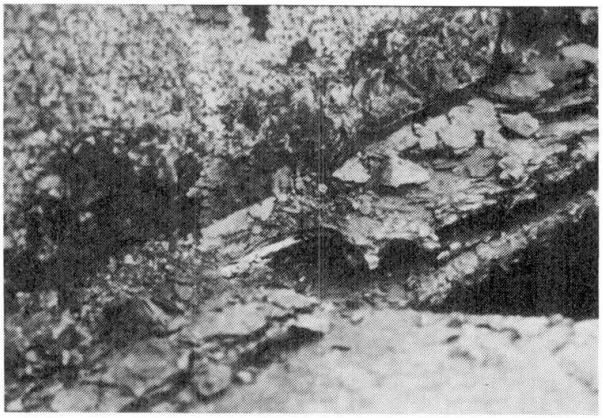
Figure 7 Not painted

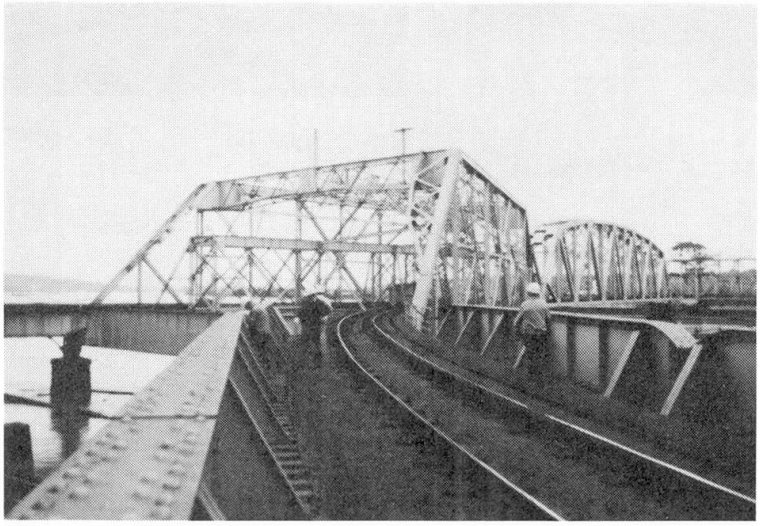
Figure 8 Well maintained

Structurally weak bridges should be maintained to a higher than normal level consistent with their use. The bridge shown in Figure 8, built in 1904 is one of the heaviest travelled and yet weakiest of our main line bridges (6, 7). Because of extremely good preventative maintenance the structure serves us well.

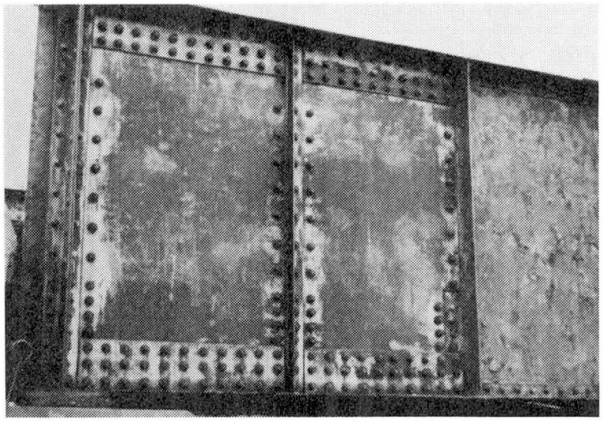
Figure 10 Replacement Web

corrosion is confined to the web near the stiffener, the stiffener can be removed and a small plate added to the web before replacing the stiffener.

I must warn against welding these replacements as weld terminations have very low fatigue strength. Cracks initiated in patch plate welds can go into the original web causing a potentially dangerous situation. Welding to a non-welded structure can destroy the inherent component redundancy in the structure (8). In a bolted or riveted girder, a crack in one plate or angle will not propogate to the rest of the member. Join these with a weld and the crack can propogate.

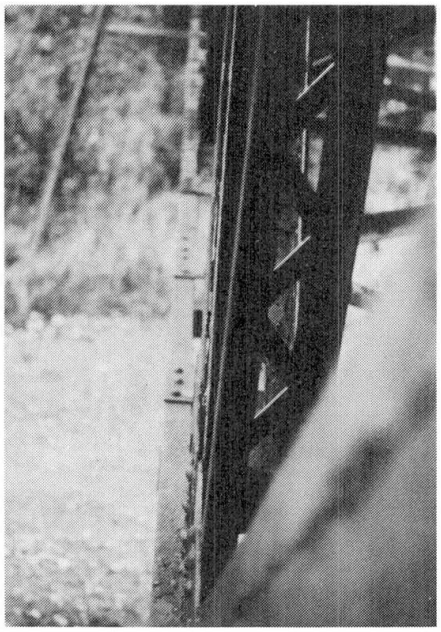
Care must be taken in the connection of all repair and rehabilitation schemes. The strengthening of a deck truss shown in Figure 13 was not very successful. The staggered welds eventually broke.

Figure 13 Broken welds

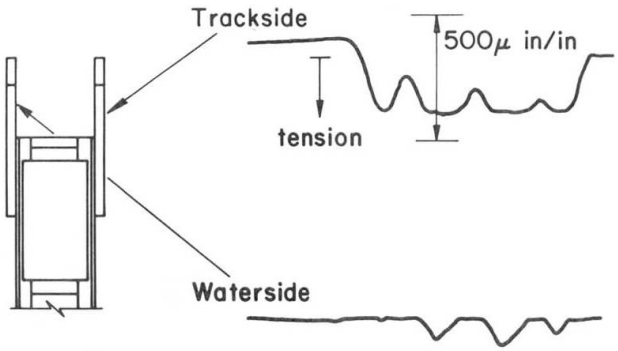
In trusses, when the pins or pinplates wear they can be replaced by larger pins after reaming to make the hole larger. If this is not possible, then a pin joint can sometimes be replaced by gusset plates. In order to minimize future fatigue problems, it is important to be very careful about compatible defections to ensure that the replacement gusset plates equally share all loads (Figure 14). If one plate carries no load, then the doubled stress range in the other could lead to unexpected fatigue problems (6,7).

Figure 14 Unequal loading

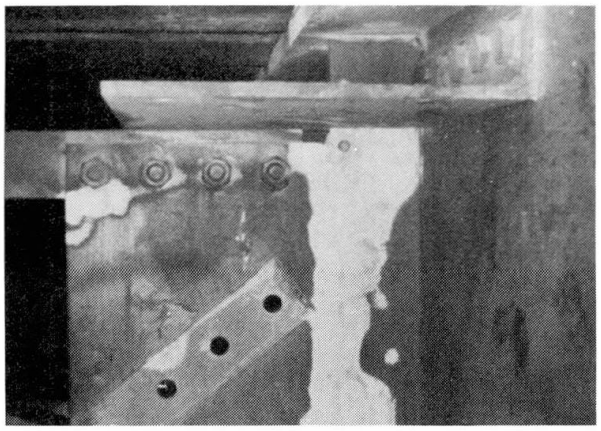
The crack shown in Figure 15 started where the gusset plate to vertical stiffener weld terminates (10). Many of these cracks were not detected until the crack front had reached the stiffener to web weld. In order to stop the crack from proceeding up or down this weld, holes were drilled. These holes, which were drilled from both sides of the interior stiffener and then from the outside, were quite difficult to do. If the crack is not stopped then a more costly retrofit would be necessary. A permanent repair is shown in Figure 16 (9).

Figure 15 Crack at sharp notch

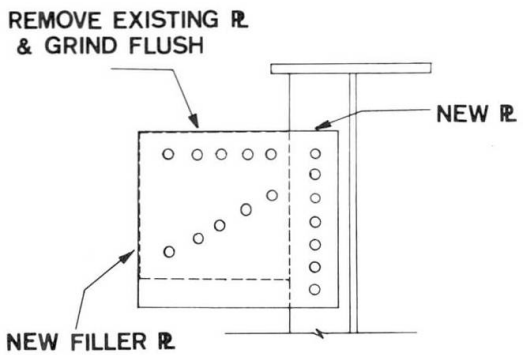
Figure 16 Typical repair

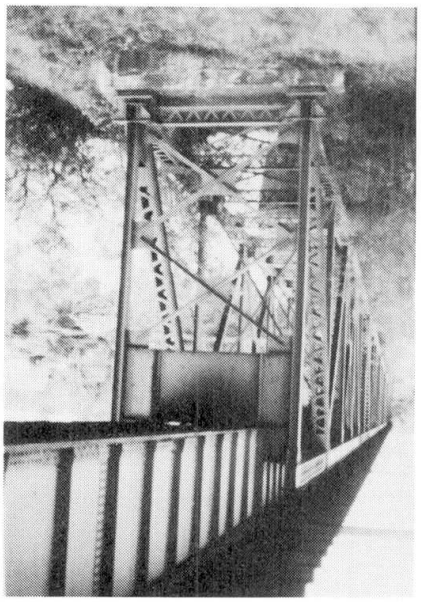
The structure shown in Figure 17 has cracked and been repaired once every ten years when in fact the problem is that there is no where for breaking forces to be dissipated.

Figure 17 End of deck truss

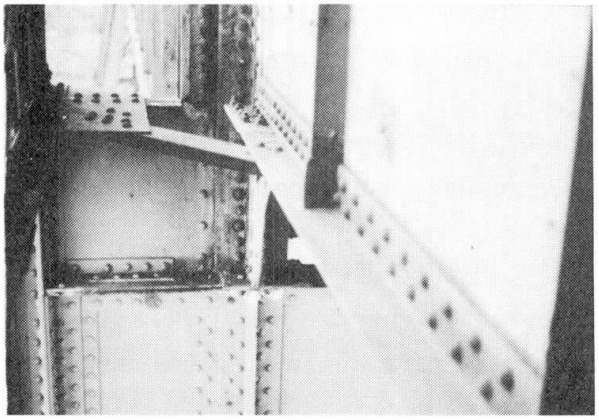
Figure 18 Bracing leads nowhere

The traction bracing ends at the top of the deck truss (Figure 18). Since the end post is relatively flexible, the load is forced to try and go through the deck plate girder. The connection is not designed for this force and movement, so it cracks. Changing the location of traction braking in order to get it directly to the bearings of the truss would permanently solve the problem.

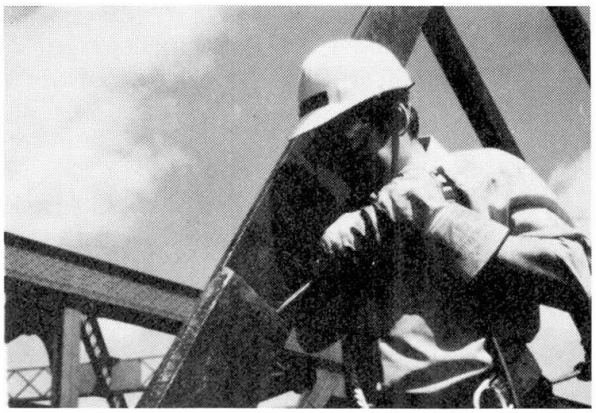
Figure 19 Peening welds

One technique, we have used, is to peen the ends of shallow cracked welds (Figure 19) to prolong their life. In other cases, replacing poorly installed rivets with high-strength bolts can prolong the life of a connection.

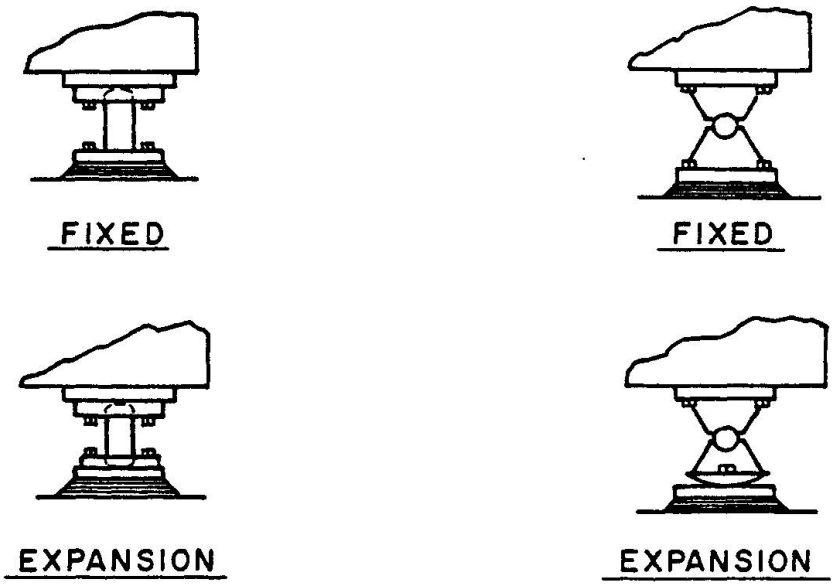
Bearings which are damaged or malfunctioning can fail during an earthquake. In addition certain types of bearings, such as those shown in Figure 6, have performed poorly during past earthquakes. A possible retrofit measure in these cases is the replacement of the bearings with modern types such as elastromeric pads which, in conjunction with adequately designed restrainers, are more effective in resisting seismic loading.

Fig. 6 Seismically vulnerable bridge bearings
