Non-linear Analysis and Strengthening of a Reinforced Concrete Building

Ester CANTÙ
Researcher
University of Pavia
Pavia, Italy

Aldo CAUVIN
Associate Professor
University of Pavia
Pavia, Italy

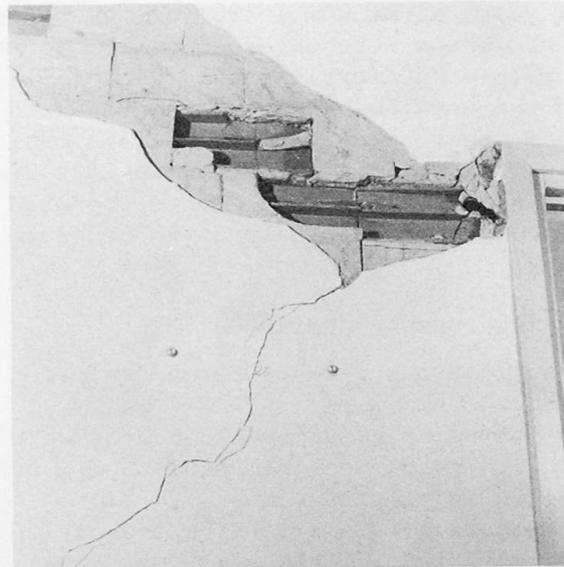
Fig.1 Typical floor

The aforesaid considerations were applied to the case of a recently built r.c.
building, where damages occurred due to excessive deflections (Figs.1 and 2).
The building is schematically shown in Fig.3: it is composed of 3 floors, the
ground floor being used as lecture-hall. The others were partitioned in order
to be used as studies and laboratories.
The floors, 15 meters square, are orthogonal grids of r.c. beams. These beams
were designed as simply supported, despite the fact that no discontinuities

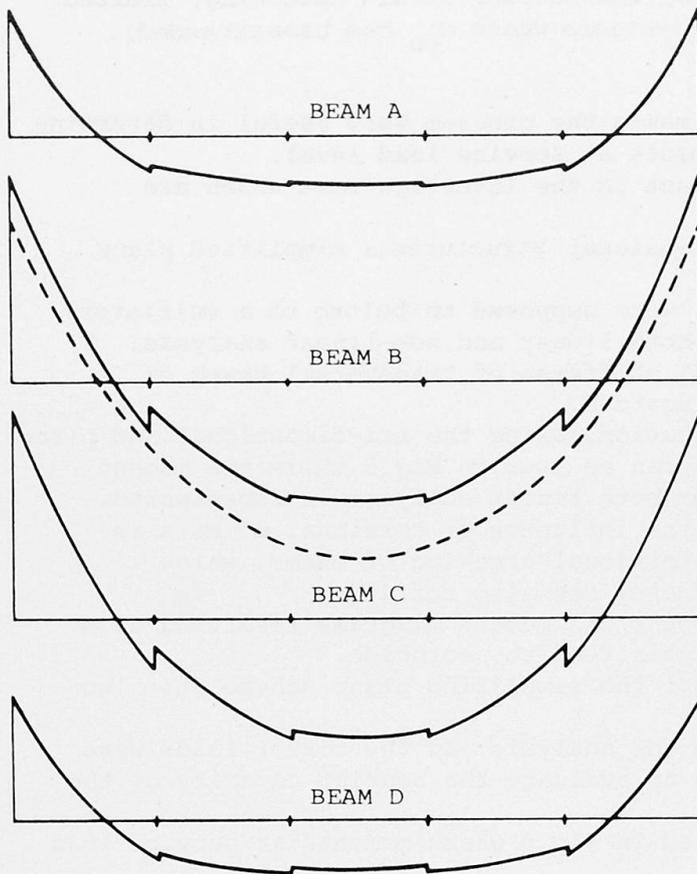
Fig.5 Tri-dimensional linear analysis: bending moments acting on 4 beams of 2nd floor grid

The differences in beam moment distribution, using the tri-dimensional and plane frame schemes are considerable, as it can be seen in Fig.5,where the moment distribution in beams deriving from both linear analyses is represented.

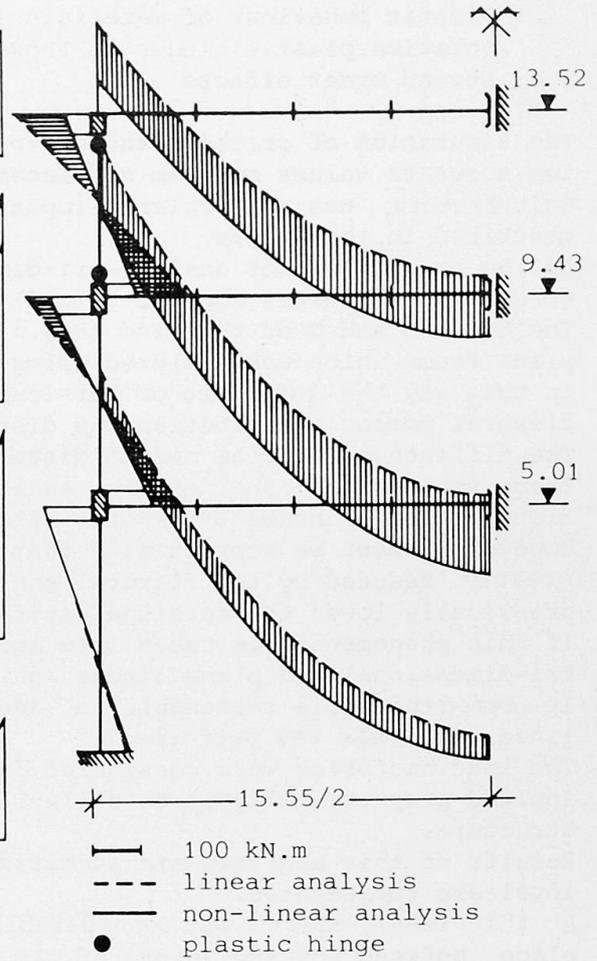
Fig.6 Linear and non-linear plane analysis: bending moments acting on the model structure

Results of this analysis are summarized in Fig.6 where moments at service load level are represented.

At this level, despite the considerable moment redistribution which has taken place between the end joints of the beams (underreinforced) and the midspan sections (overreinforced) a failure mechanism develops in the columns of the top floor. Therefore loads cannot be increased beyond this level and the safety coefficient γ_f is approximately equal to 1.

The available structural ductility does not permit to reach an adequate margin of safety and the need to strengthen the columns cannot be avoided.

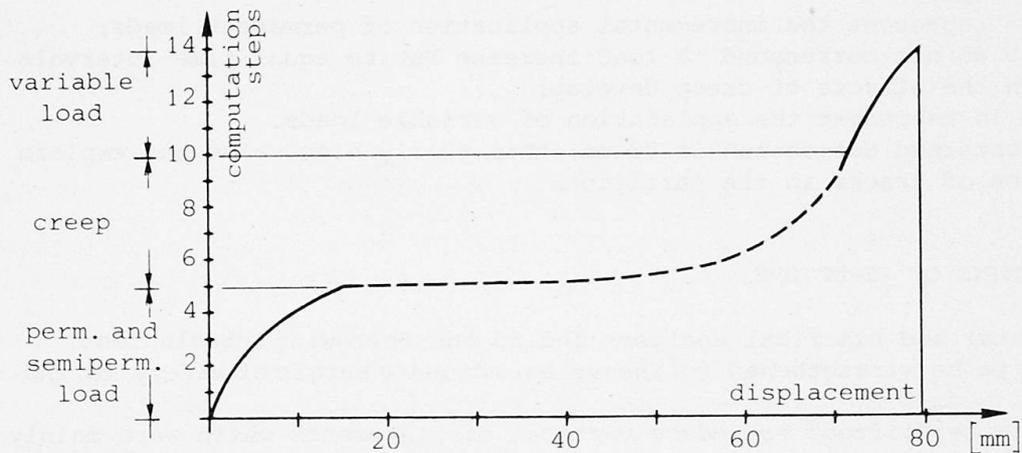
Fig.7 Evolution of vertical displacement at mid-span of a 2nd floor beam

The values of vertical deflections are represented in Fig.7, in function of the computation steps:

The maximum obtained deflection is 79 mm; this fairly high value may explain the formation of cracks in the partitions.

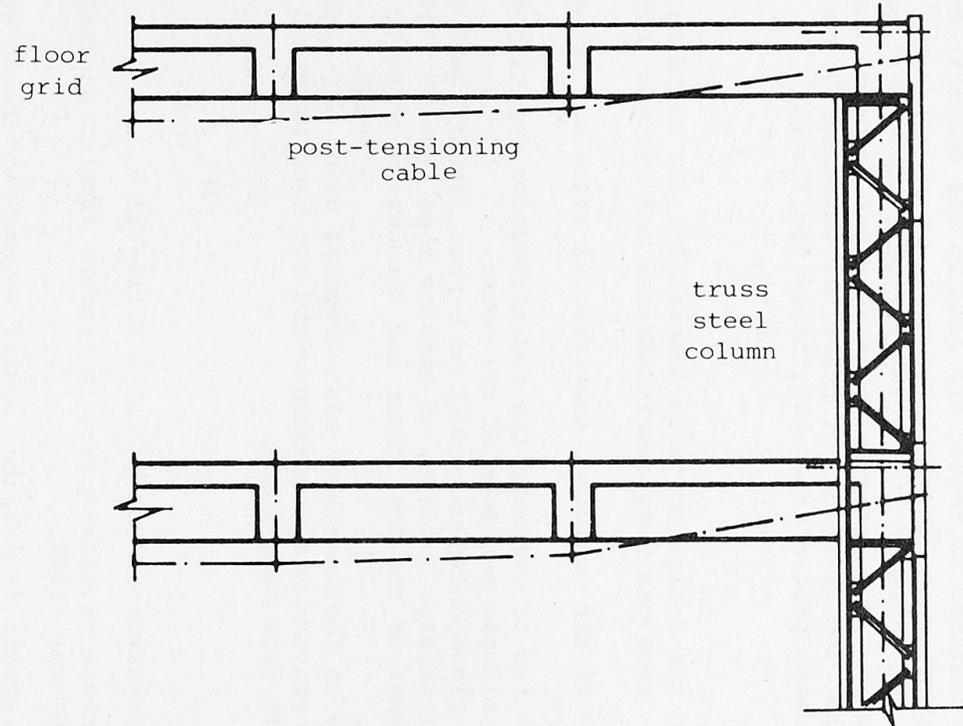
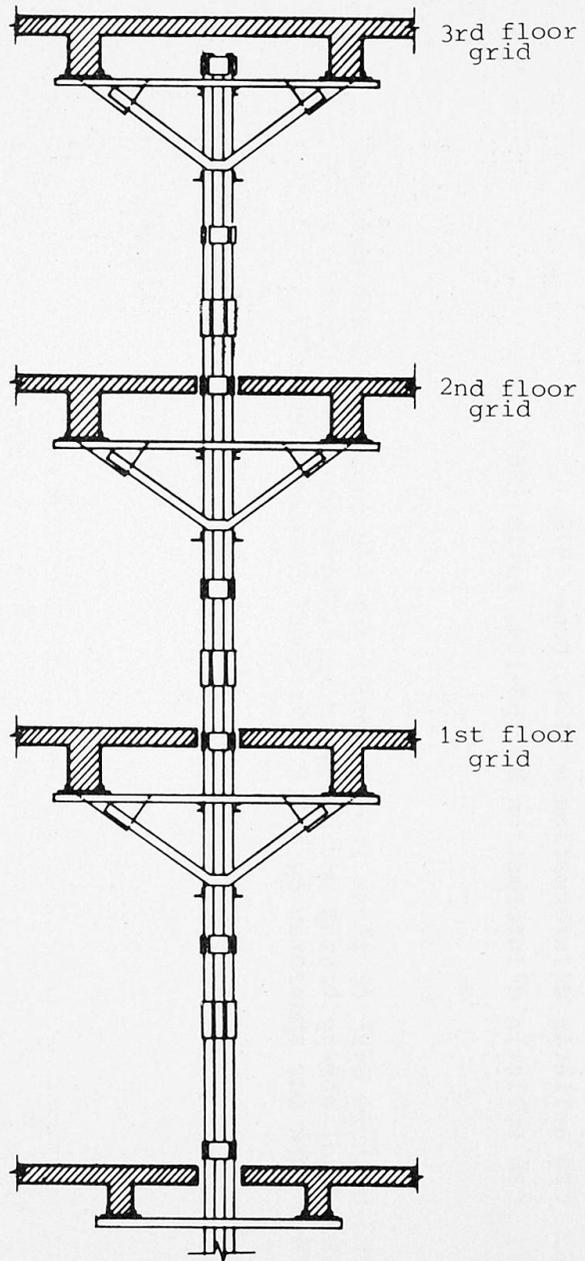
△ Fig.9 Final strengthening scheme (truss steel columns and post-tensioning cables)

◁ Fig.8 Temporary strengthening scheme to support grid beams

- Columns had to be strengthened to insure an adequate margin of safety to the structure.

- Beams had to be "lifted" to reduce vertical displacements which were mainly responsible for the formation of cracks in partitions.

A temporary support was first designed to reduce the load on the columns; the scheme of this support is represented on Fig.8.
The final strengthening scheme is shown on Fig.9: the vertical load bearing function was committed to truss steel columns which were put in place surrounding of the existing columns. The "lifting" of beams was obtained by post tensioning steel cables which were placed externally below the floor.
