Remaining Fatigue Life of Old Steel Bridges

Klaus BRANDES
Dr.-Ing.
BAM
Berlin (West)

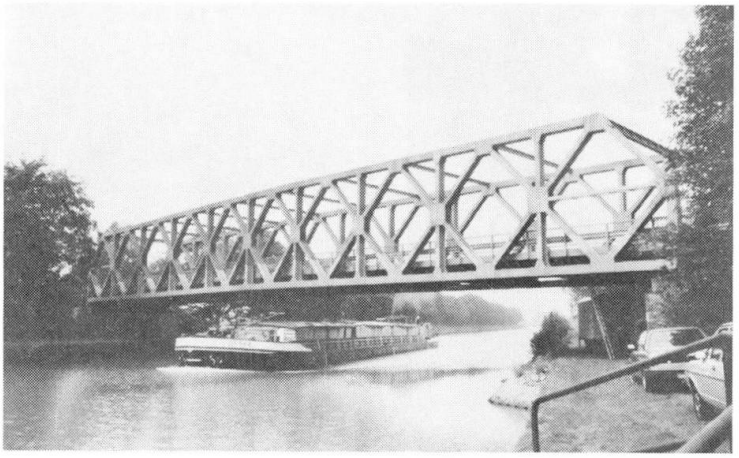
Figure 1. Riveted highway bridge of 59 m span in north-west Germany

The load bearing elements of the bridge (fig. 1) that crosses the Dortmund-Ems-Kanal near Osnabrück, are outlined in fig. 3. It was built in 1953, the rolled girders were produced in the thirties. During an inspection, cracks have been detected at some of the cross girders near the connection to the principal load bearing elements, trusses of 59 m span (fig. 4). The investigation of the bridge included strain measurements at longitudinal and cross girders under static load and under traffic flow and tests on the

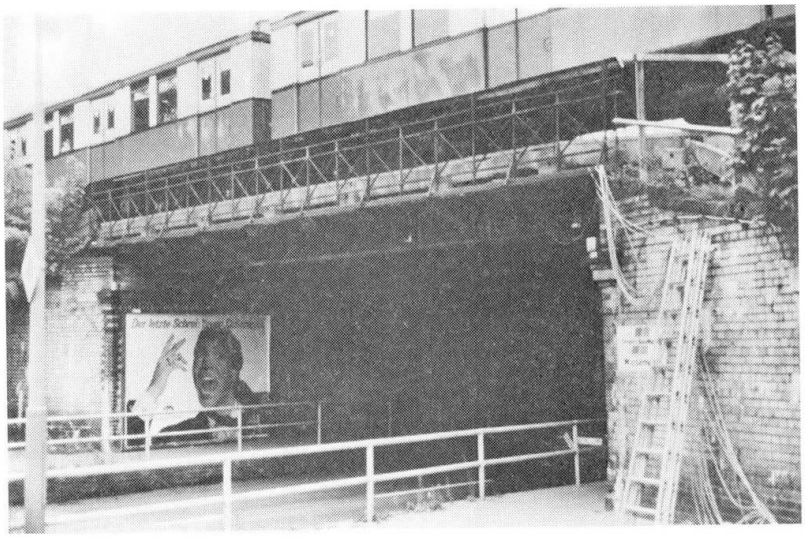
Figure 2.
Girder Bridge of Berlin Metropolitan, replaced in 1988

The single-track bridge (fig. 2) with a span of about 12 m was built in 1896. It had to be replaced because the road it crosses had to be widened.
Before the bridge was removed, we performed strain measurements at several points of the structure, at elements of the main girders and of cross girders. The stresses during the hours of measurement did not reach the cut-off limits of the standardized European Fatigue Strength Curves [6]. However, we do not know accurately which type of traffic passed the bridge during the nearly 100 years of the bridge's life in an eventful history.

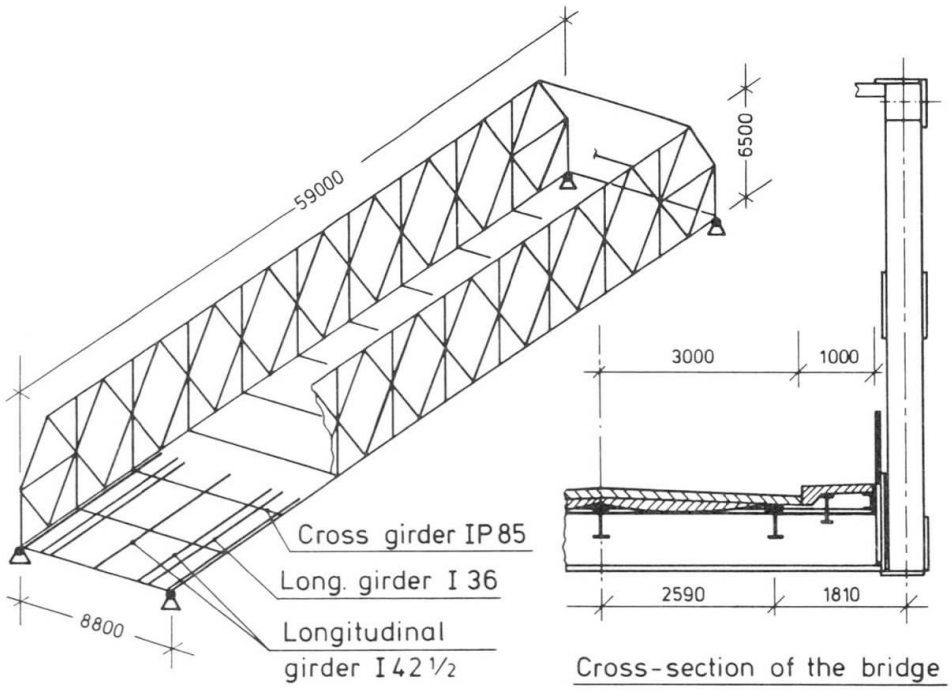
Figure 3: Load bearing elements of the bridge of fig. 1

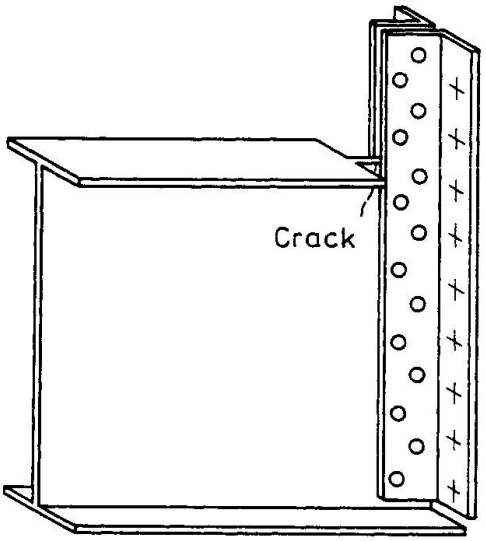
Figure 4.
Structural detail at the connection of the cross girders to the main truss girder and the location of cracks

The crack growth tests offered the possibility to assess the amount of growing of a crack of a certain length which was not detected during an inspection within the time interval up to the next inspection (3 years). From the measurements, it turned out that the cracks (fig. 4) were caused by residual forces.

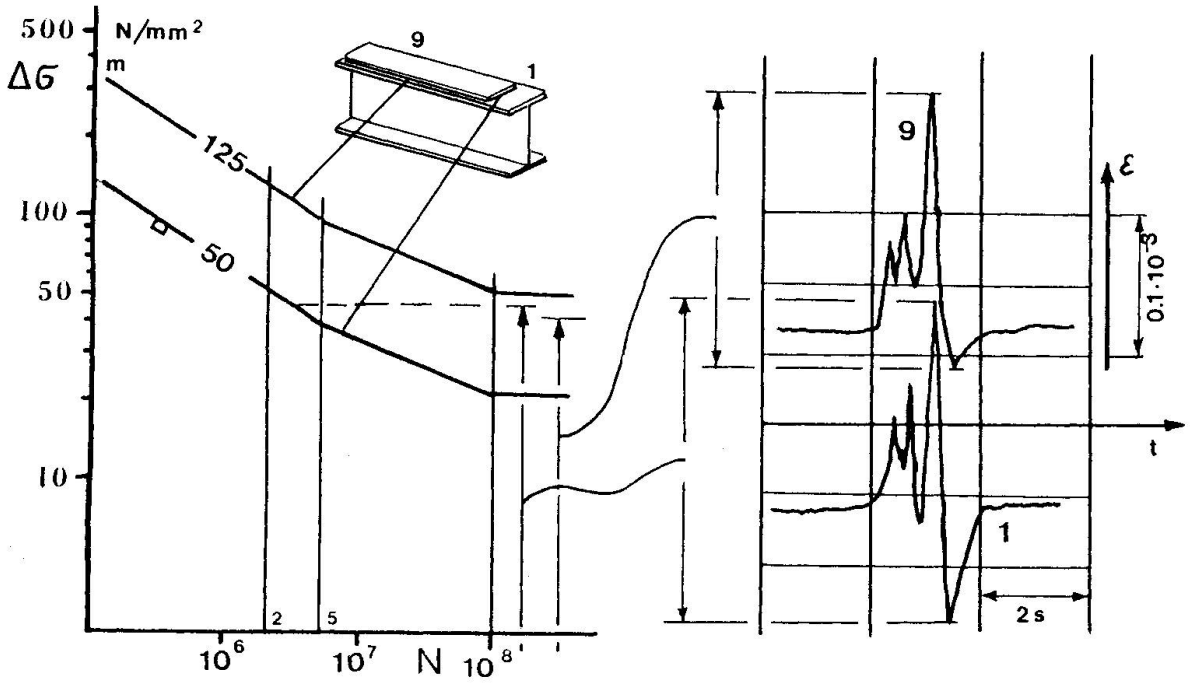
material of the structural elements in question. The measurements under defined static load by a two-axle truck of about 20 t weight showed that the calculated stresses at the points of maximum stressing are considerably higher than the measured ones. From the measurements under traffic we obtained that only in very few cases of passing of heavy trucks, stresses exceeded the cut-off limits of the standardized fatigue curves [6] (fig. 5). In addition to the standardized material investigation, we performed crack growth tests on CT-specimens as recommended in ASTM E-647-83. The results in terms of the representing Paris equation (fig. 6)

Figure 5 (below).
Fatigue strength curves (categories 125 and 50) and maximum measured stress cycle at two measuring points at the central longitudinal girder during passing of a heavy vehicle.

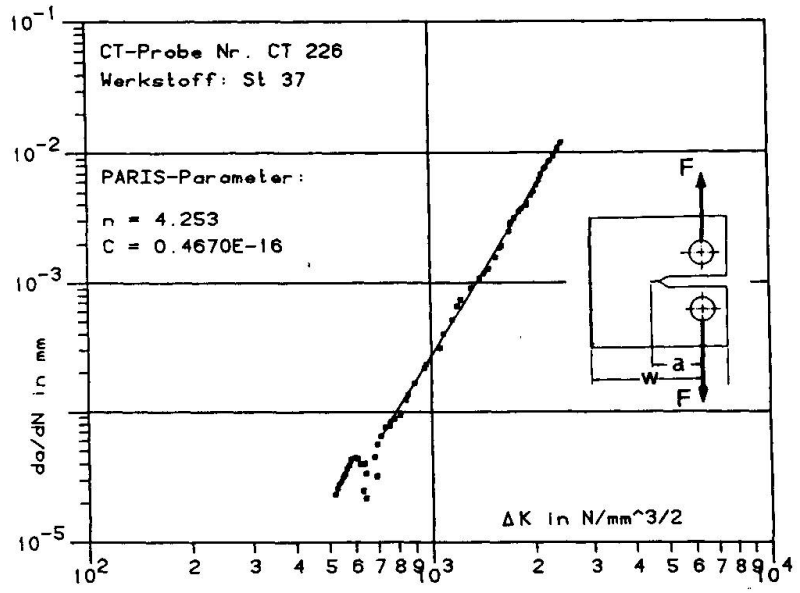
confirmed that the material could be regarded as mild steel concerning the fatigue behaviour.

Figure 6: Diagram of crack growth rate da/dN versus cyclic stress intensity ΔK as elaborated for a compact tension (CCT) specimen (ASTM E 647-83)

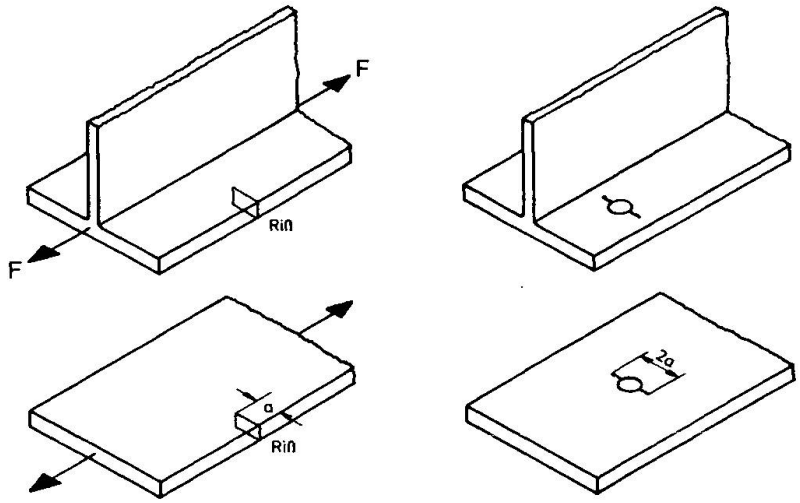
The application of fracture mechanics in the evaluation of remaining fatigue life implies the modelling of cracks in structural elements which can probably occur, fig. 7. The crack growth is only governed by the stress intensity at the crack's tip as expressed by the Paris equation (1). It is an advantage of the concept of fracture mechanics that it leads to a deeper insight into the problem of survival of structural members under cyclic loading than only the application of fatigue strength curves after calculation of cummulative damage by collectives of stresses. Fracture mechanics procedures are recommended when cracks have been observed, because the shape and the dimensions of the cracks are known as well as the surrounding stress fields.

Figure 7: Crack pattern for evaluating stress intensity factors and crack propagation
