**Artikel:** Aluminium curtain wall panel failure; assessment and repair
**Autor:** Cuoco, Daniel A. / Velivasakis, Emmanuel E.
**DOI:** https://doi.org/10.5169/seals-44285

# Aluminum Curtain Wall Panel Failure, Assessment and Repair

During a windstorm in December 1983, an aluminum curtain wall panel separated and fell from one of the upper floors of a high-rise building in New York City. The building was constructed in 1977 and its exterior contains more than 9,000 of these panels.

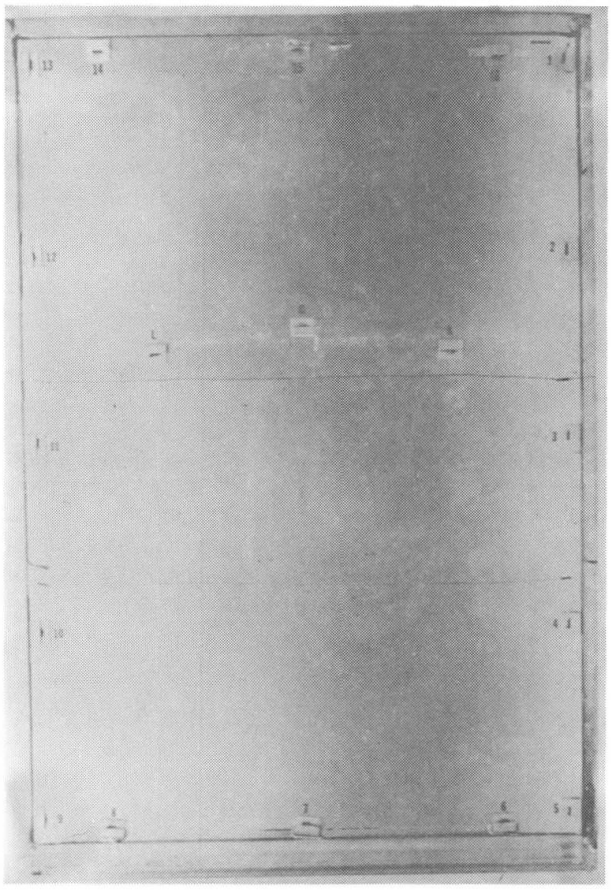
FIG. 1 Typical wall panel assembly

The typical wall panel assembly consists of a 1.42m x 2.13m x 4.76mm aluminum flat plate with 19 aluminum clips welded to the inside surface of the plate (Fig. 1). These clips attach the plate to the perimeter mullion system and an intermediate horizontal stiffener at the approximate mid-height of the panel. In addition, the top edge of the plate fits into a continuous groove formed into the upper horizontal mullion. Since the building has approximately 9,000 wall panels, there are almost 200,000 clips utilized on the building.

A metallurgical evaluation of the separated panel and its remaining clips was conducted. It was concluded that the fatigue-sensitive nature of the clip-to-panel weld detail, combined with poor welding, resulted in fatigue cracking of panel clip weldments which caused the panel to separate from the building.

In addition, a field survey of several thousand existing clip welds was performed from the interior of the building. Many of the welds were found to have defects in the form of shrinkage cracks, porosity, lack of fusion, and insufficient weld size. However, only one clip weld was found to have fractured due to fatigue loading under service conditions.

Clips that were found to be missing or broken during the field inspection and survey were repaired by fastening either the existing clip or a new replacement clip to the panel using stainless steel screws.

In addition, stainless steel screws were installed along the bottom edge of all panels by drilling and tapping into the panels from the inside of the building. This, along with the existing continuous groove support at the top of the panel, provided basic stability for the panel independent of the clips, and was performed as an advance safety measure while the investigation was proceeding.

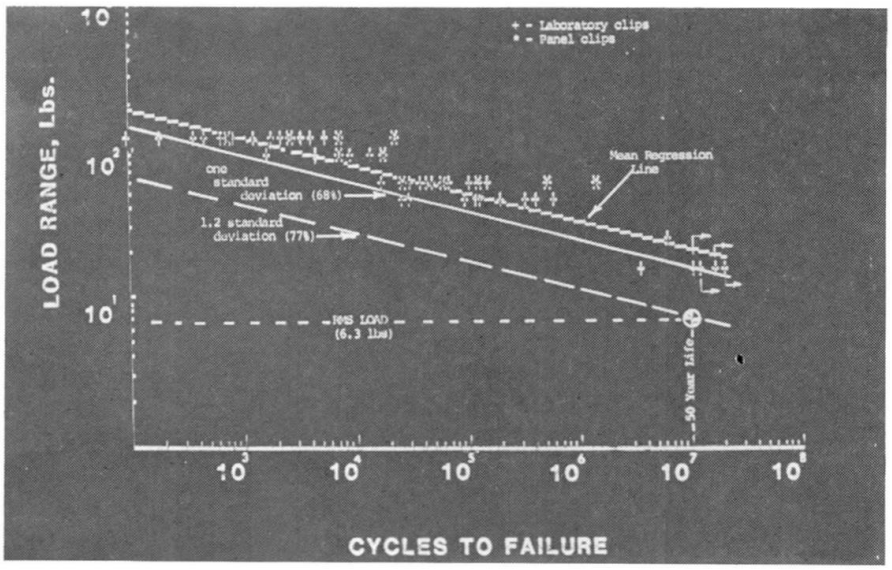
FIG. 2 Load vs. cycles to failure

In order to determine the expected fatigue life of existing panel clips, constant-amplitude cyclic testing of numerous panel clips was performed. These panel clips consisted of existing clips removed from the building, and also new clips fabricated with "imperfect" weldments simulating the existing weldments in the building. The test results were plotted to obtain a "load vs. cycles-to-failure" curve for the clips (Fig. 2).

Based upon the cyclic wind loading spectrum that was derived, a root-mean-square (rms) wind loading of 10.4 $kg/m^2$ at 10 million cycles, corresponding to a 50-year life, was computed. This translates to an rms load of 2.9 kg at 10 million cycles on the most highly loaded clip. Fig. 2 indicates that there is a 77% confidence level that a maximum-loaded clip weld will survive 50 years.
