East River bridge rehabilitation in New York

Autor(en): **Kotlyarsky, Edward / Trachtenberg, Eugene**

East River Bridge Rehabilitation in New York

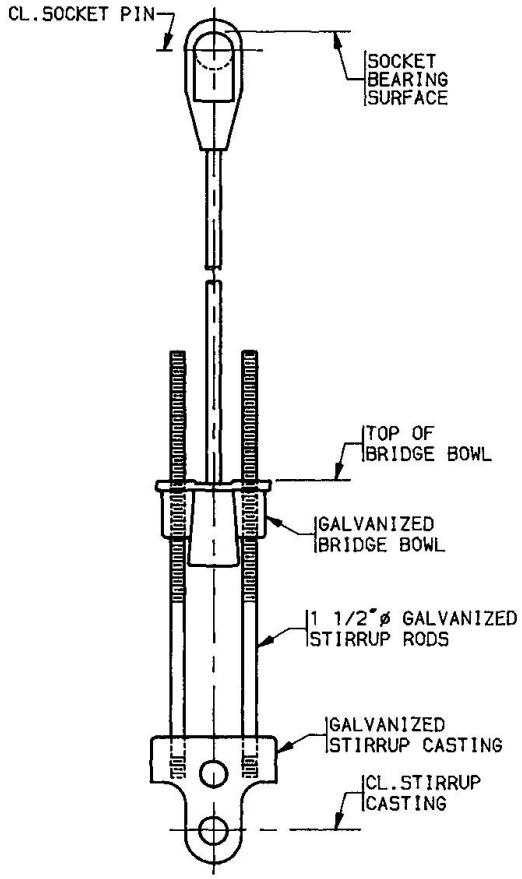
Fig. 1 New wire rope suspender

Inspection of the bridge revealed that the cable and truss chords were in generally good condition, but there was severe corrosion in the suspenders, stays, truss pins, truss verticals, diagonals, and floorbeams. Since replacement of this historic and much admired structure was not an option, the suspenders and stays had to be replaced along with truss pins, diagonals, some

Existing suspenders were replaced with new 35 mm (1 3/8 in) diameter galvanized wire ropes attached to the cable with new cable bands. Suspender attachment to the truss bottom chord consists of two stirrup rods, galvanized stirrup casting and bridge bowl (Fig. 1), provided for required adjustment of suspender length. The socket baskets were filled with zinc. Solid rods were used in areas requiring very short suspenders.

Upon completion of the suspender replacement, existing stays were replaced with 41.4 mm (1 5/8 in) galvanized structural wire ropes. The stay assembly and its attachment to the truss is similar to that of the suspender.

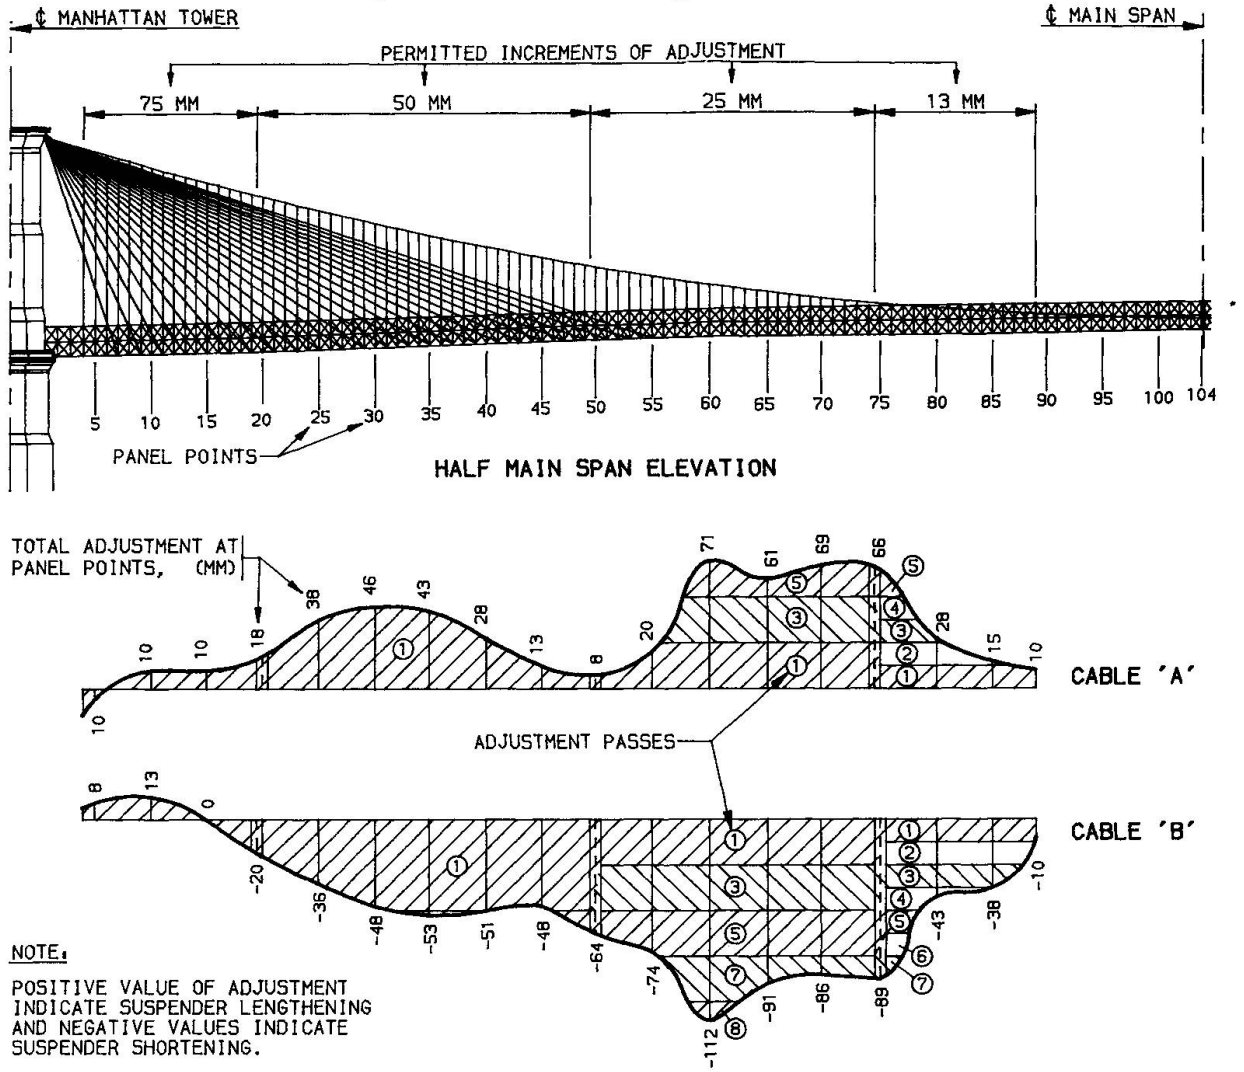
Fig. 2 Adjustment passes. Brooklyn half of Main Span

The values of adjustments and the number of passes for outer cable "A" and inner cable "B" for half main span are shown on Fig. 2.

The adjustments are mainly positive for cables A and D and negative for cables B and C. When done, these adjustments increase tension in the inner and reduce it in the outer cables thus achieving the desirable dead load distribution.

Almost all suspender adjustments were accomplished in increments, or "bites", to avoid overstressing members of the bridge. The maximum permitted "bite" at a particular location was determined using a 3D computer model. The values of the computed "bite" varied from 13 mm (1/2 in) for short solid rods to 75 mm (3 in)

The adjustments were done by passes based on computed "bite" values. All passes progressed in each span from the shortest solid rod suspenders toward the towers.

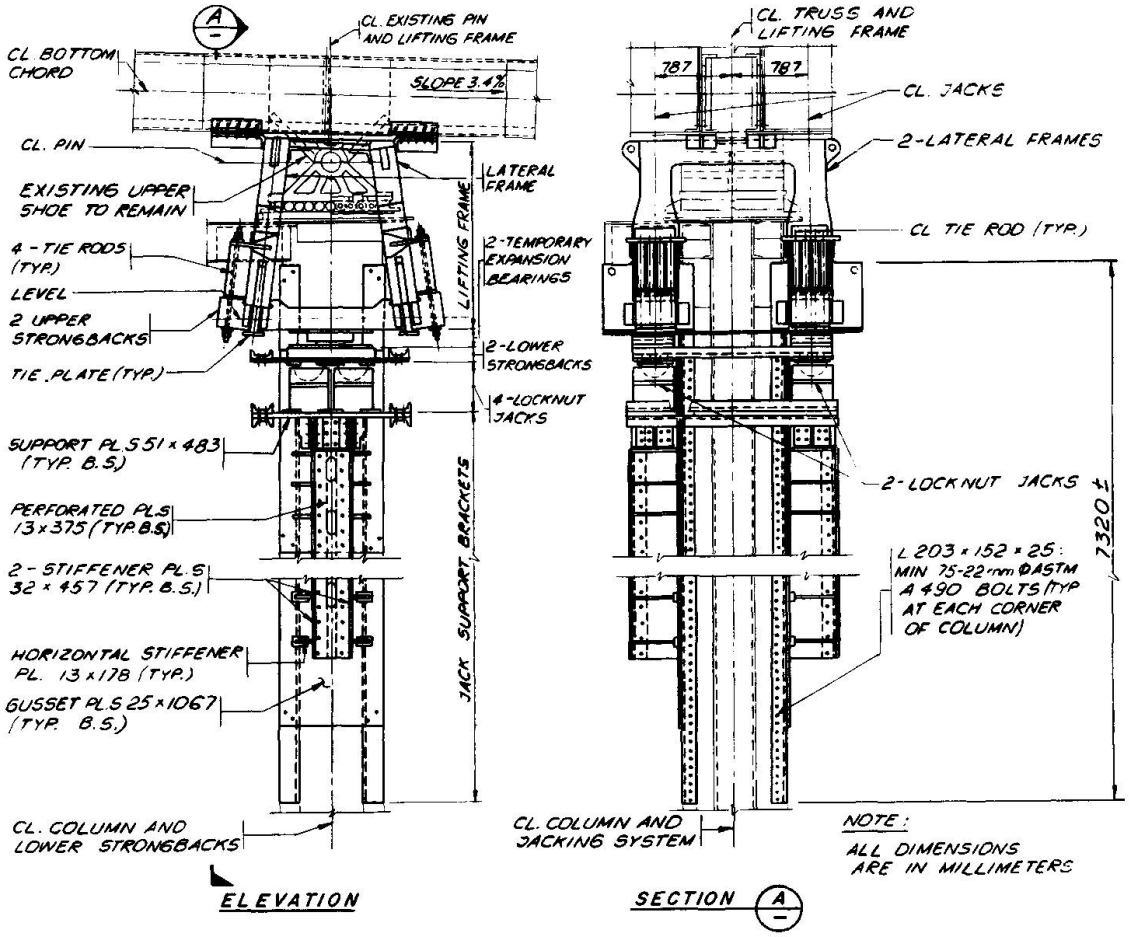
Fig. 4 Bearing replacement jacking system.

During the in-depth inspection, it was found that none of these bearings were functioning, and, as a result, some of the supporting towers had cracked at the top. Restoration of the existing bearing components was impractical and to correct the problem it was necessary to replace all of the expansion bearings with an improved type. While jacking of the trusses was required, the entire operation needed to be performed with no disruption of traffic which averages 145,000 vehicles per day. These were the basic requirements that influenced the construction technology and, in turn, the design.

The entire system for the lifting and lowering of the existing trusses (Fig. 4) consisted of a high strength steel space frame, two temporary expansion bearings each seated on a strongback, four 4448 kN (500 ton) capacity locknut jacks and the lower support system. The temporary expansion bearings allowed the truss and jacking frame to translate and rock during the entire jacking operation. There were two different types of lower support system used: jack support brackets bolted to the existing columns at pp Nos. 20, 40, and 58; and jack support columns seated on the existing footings at pp Nos. 78, 82 and 86. Another procedure was used to replace expansion bearings at pp 0.

Lifting frame geometry was complicated by the need to fit in a very congested area and to provide clearances required to dismantle and remove the existing bearing elements and to erect new bearing components. Structural analysis of the space frame revealed that after lifting the existing truss, the maximum combined unit stress in the frame legs due to axial force and biaxial bending was 371 MPa (53.8 KSI). Because of the high design stresses in the frame elements they were fabricated of high strength quenched and tempered low alloy steel ASTM A-514 plates with minimum tensile yield point 689.5 MPa (100 ksi). Because this material is not available in thickness greater than 63.5 mm (2 1/2 in) each frame was built up of five plates laminated to provide the total leg thickness of 254 mm (10 in), and bolted together with 25.4 mm (1 in) diameter ASTM A-490 high strength bolts, tightened to a minimum tension of 285 kN (64 kips). The two upper strongbacks were built up of seven 50.8 mm (2 in) plates and two 25.4 mm (1 in) plates. The 50.8 mm (2 in) plate thickness provided openings for four 44.45 mm (1 3/4 in) diameter tie rods at both ends of each

upper strongback, where moment connections to the lateral frames were required. All tie rods were pretensioned to 44.5 kN (10 kips) each prior to the lifting operation. Each lower strongback was supported by two hydraulic jacks seated on two support brackets. Each bracket was connected to the existing column by seventy five 22.23 mm (7/8 in) diameter ASTM A-490 bolts through existing and new holes. The length of each of these connections was about 7.3 m (24 ft). Based on ASHTO requirements, the allowable shear stress on high-strength bolts in these connections was reduced by 20%.

The height of columns at three panel point locations was not sufficient to provide such long connections. This circumstance required the design of temporary four column steel towers installed on the existing 203.2 mm (8 in) thick cast steel base and braced around and to the existing column. Two lower strongbacks were longer than that used at high existing columns to accommodate location of jacks directly above the temporary columns.
