Wind Induced Stresses in the Spire of Brussels Town Hall Tower

B. ESPION
Dr. Eng.
Univ. of Brussels
Brussels, Belgium

P. HALLEUX
Prof. Dr.
Univ. of Brussels
Brussels, Belgium

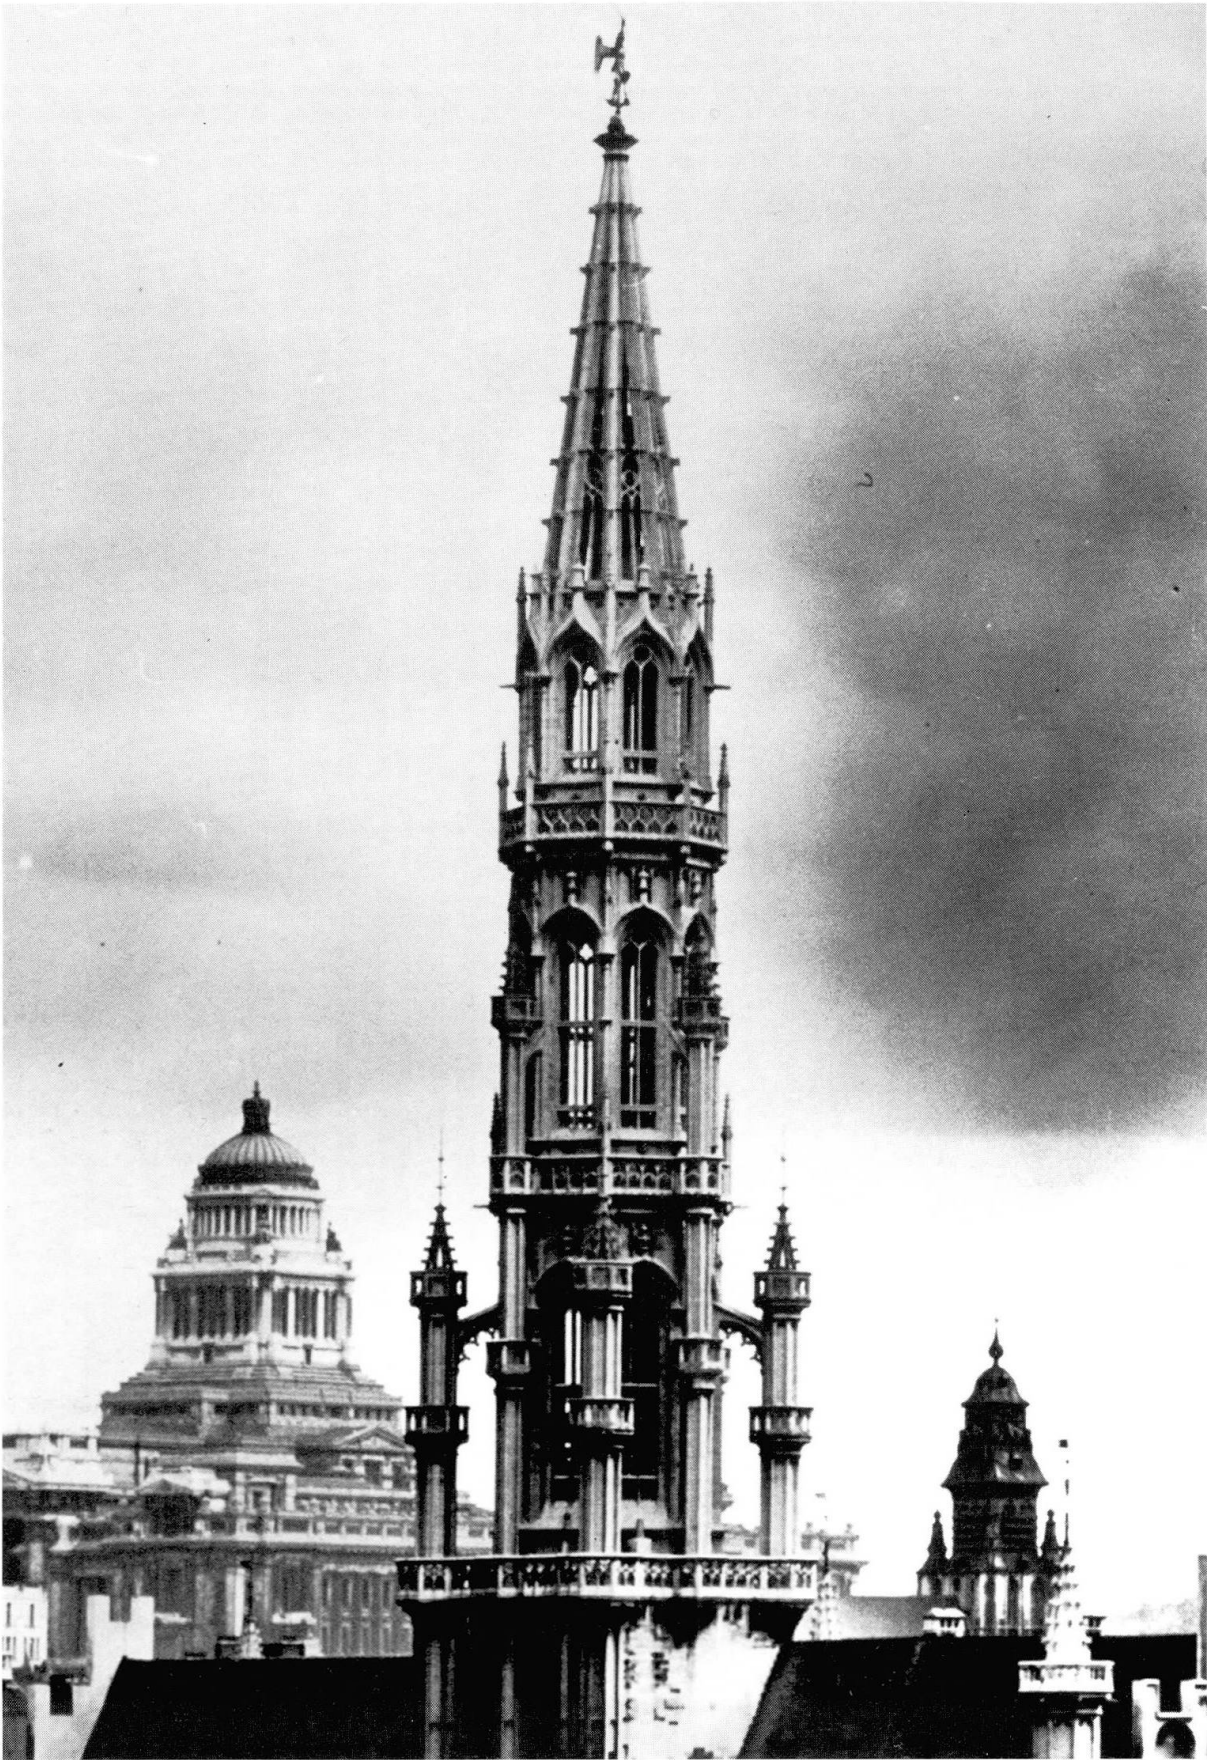
The main tower of the Brussels town hall (Fig.1) is a masterpiece of Gothic architecture dating back to the middle of the 15th Century (1449-1454). The tower suffers now from severe disorders which may be attributed to sequels of the bombing by the armies of Louis XIV and to unwise previous restorations with unsuitable materials and reinforcements like iron rods that rust and induce fracturing of the stones. A major restoration is therefore needed and is presently taking place.

Fig. 1 The tower of the Brussels town hall (96m)

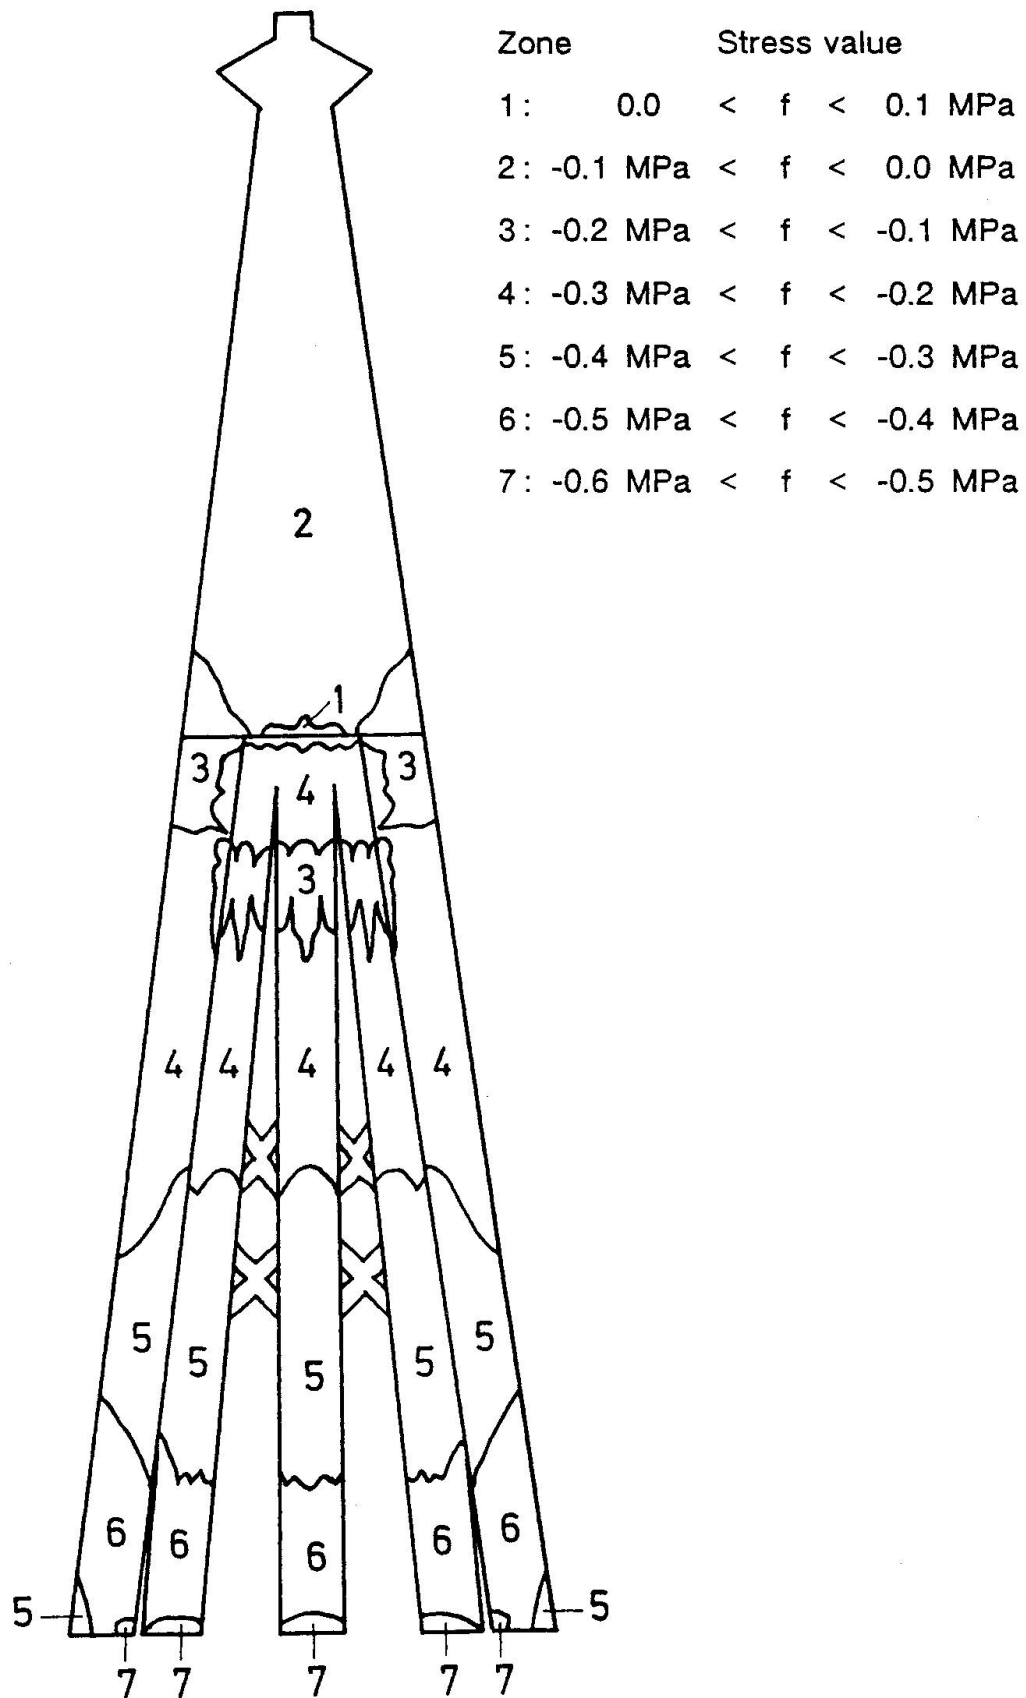
Fig. 2 Vertical stress distribution in the spire under self weight

practically no differences in this distribution when hoop reinforcement is added. Fig.2 exhibits a very limited zone of small tensile stresses (< 0.1 MPa) along the axis of symmetry at the connection between the ribs and the solid part of the spire, and compressive stresses elsewhere. The ribs are mainly subjected to normal force. The slope of the ribs with respect to the axis of gravity is small (8.5°), but nevertheless sufficient to induce a slight bending behaviour of the ribs which may be seen as columns built in at both ends and supported at mid-height by the tracery. If the tracery is omitted, the span of the ribs doubles and the bending behaviour is fairly more noticeable with tensile stresses ($\approx$ 0.2 MPa) appearing on the outer arrises at both ends of the ribs. The introduction of a solid stone disk behind the tracery has no influence on the stress distribution above the tracery and induces a slightly less favorable bending behaviour of the ribs between their springing and the tracery. We may therefore conclude that the tracery provides an effective support and that the introduction of a stiffer support behind the tracery seems neither necessary nor desirable.

2) the tracery provides enough stiffness to sustain the ribs and there is no need for additional bracing at this level.
3) the anchorage of the statue should be unveiled during the restoration and carefully assessed because it probably plays an essential role in the stability of the upper part of the solid part of the spire.

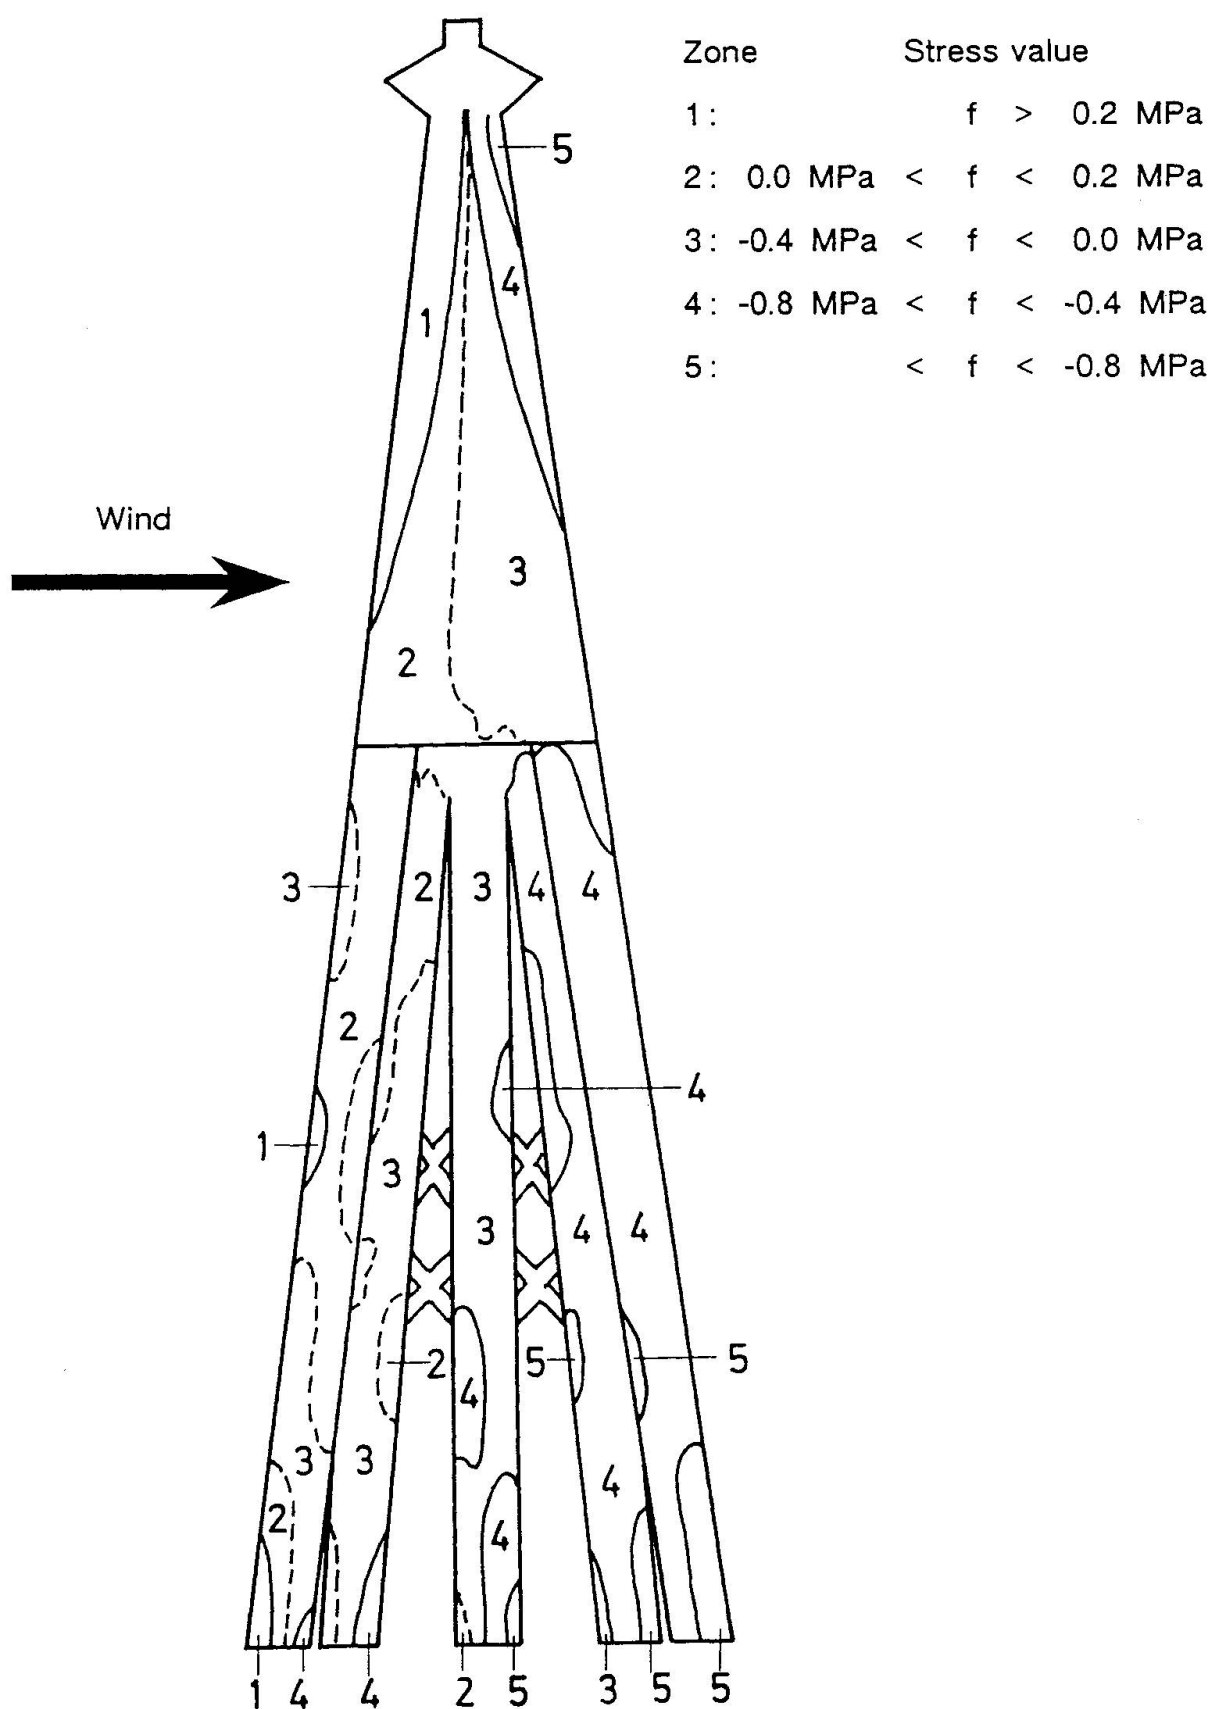
Fig.3 represents the distribution of vertical stresses under combined action of self weight and a wind with a period of return of 500 years. The section shown lies in the direction of the wind and the windward side is on the left. Once again, we hardly notice any difference when the hoop reinforcement is added: some rods are in tension, other in compression, and the largest computed force in one rod is 1.8 kN when E = 50 GPa for the stone. The stress distribution in the masonry remains practically unchanged when E = 20 GPa for the stone, while the mean force increase in the rods is 33%. The upper, solid part of the spire behaves like a tapered short column and is typically submitted to bending combined with compressive normal force. Nearly all the windward side exhibits tensile behaviour, with values around 1 MPa in a 2m height below the statue and 0.1 MPa at the base of the solid part of the spire. These values are roughly halved for a wind with a period of return of 10 years. In the skeletal part of the spire, the windward rib exhibits a definite bending behaviour with relatively large tensile zones and a peak tensile stress of $\approx$ 0.6 MPa at the springing of the windward arris. The largest compressive stress ($\approx$ -1.2 MPa) is observed at the springing of the outer arris of the leeward rib and remains a very low working stress for this kind of masonry.

The fact that nearly all the windward side of the upper part of the spire is submitted to tensile stresses is not astonishing and may be shown by application of elementary concepts of strength of materials. Heyman [1] furthermore recalls that the top of a solid slender spire is always subject to instability under wind. Heyman compares the overturning (wind) and stabilizing (self weight) moments computed with respect to the leeward arris. If we add the stabilizing effect of the weight of the statue ($\approx$ 4kN) and the overturning effect of the action of the wind on the statue to the application of Heyman's analysis of equilibrium, we find that the upper half of the solid part of the spire is subject to overturn by wind. It has never been reported for this spire, and we must therefore infer that the anchorage of the statue (whose state is unknown and which has not been accounted for in the finite element analysis) contributes to the bending resistance of the upper

Fig. 3 Vertical stress distribution in the spire under self weight and wind loading

part of the spire. This favorable element could easily be estimated during the restoration and the theoretical existence of tensile stresses in the solid part of the spire is not worrying. More concerning is the magnitude of the tensile stresses at the springing of a windward rib. We cannot conclude from the present elastic analysis that such stresses are high enough to jeopardize the stability of a rib, or even the durability of joints which would open under strong wind and remain close under self weight and moderate wind. The answer to this question justifies further studies -more precise evaluation of wind action in an aerodynamic tunnel and modeling the nonlinear behaviour of a unilateral material like masonry- which are presently under progress.

4) further studies are necessary to determine whether the springing of the ribs needs strengthening to be able to withstand the tensile stresses occurring, if any, under the most severe wind loading.
