Artikel: Structural analysis of the damage at the cathedral of Sibenik
Autor: Simunic Bursic, M. / Bjelanovic, Andrijana / Zagar, Zvonimir
DOI: https://doi.org/10.5169/seals-53336

Structural Analysis of the Damage at the Cathedral of Sibenik

M. SIMUNIC BURSIC
M. Arch.
University
Zagreb, Croatia

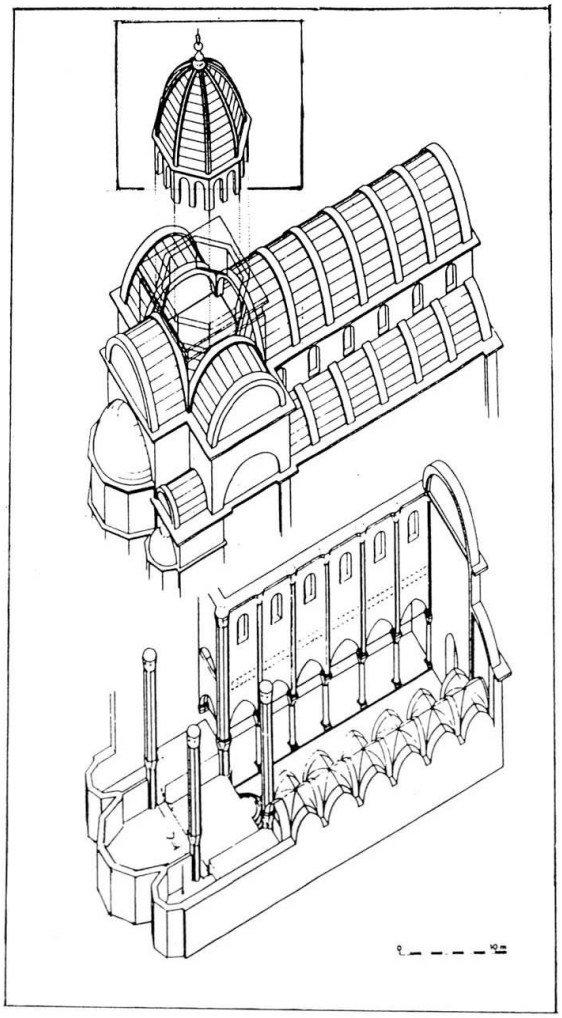
Fig. 1. Vaults of the Cathedral of Šibenik and the substructures.

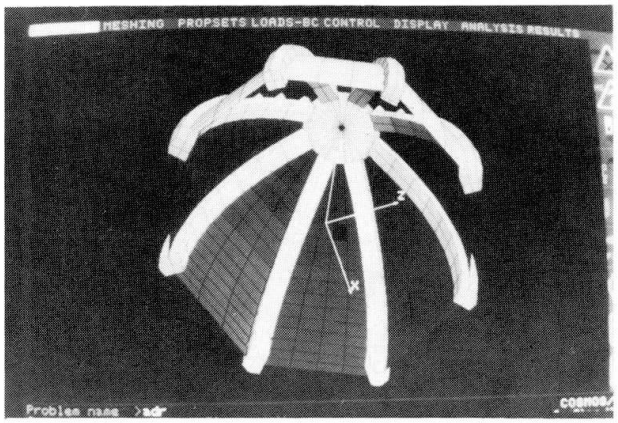
The main objective of this research was the FE computer modeling and analysis of the dome, demaged by a bomb- projectile explosion. The modeling and the static FE analysis was carried out using the COSMOS/M FE program. As we have suspected, the demage, a circular hole in the upper part of the stone slab-shell dome system has not much consequences on the carrying capacity of the dome. Luckily that it is on the part of the dome where the stresses are low, and the deformations extremely small. Fortunately, it is not a structurally dangerous injury which could jeopardize the stability of the Chatedral because only a secondary element was damaged. This could be seen on the presented screens. Only by chance the projectile has missed the rib: there could be done a devastating effect to the dome stability, if the rib has been hit and demaged.

Fig. 2. The FE mesh of the dome-macroelement. The damaged part (a hole) is clearly visible.

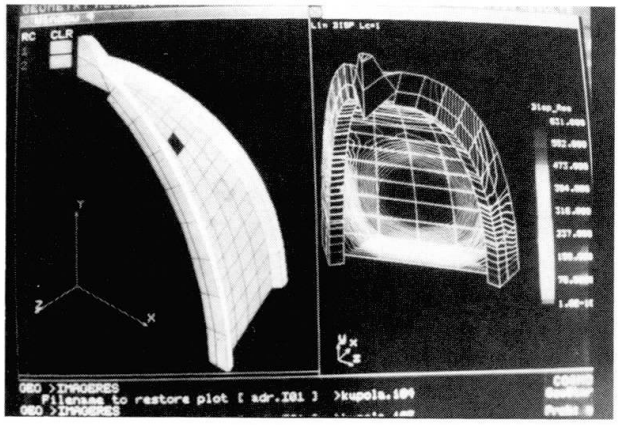
Fig. 3. The deflection lines of the substructure due to the selfeight.
