Seismic Evaluation of a Brick Masonry Building of 1895

Kazuhiro KANADA
Taisei Corporation
Japan

Kimio UDAGAWA
Taisei Corporation
Japan

Toyakazu SHIMIZU
Ministry of Construction
Japan

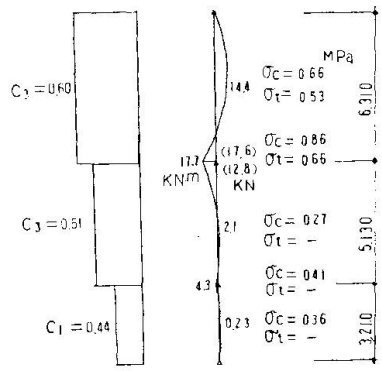
Fig 4 Bending Diagram Perpendicular to Wall

Regarding out-of-plane direction (perpendicular to masonry walls),shear forces based on the maximum response acceleration of inplane direction are adopted as the external forces to check the wall bending bearing capacity (Fig.4). By means of this calculation, at thin walls such as 380mm THK.,510mm THK. steel plates (3.2mm THK.) are installed at both sides of the wall surface to strenghthen flexural capacity.
