Field Measurement of a Steel Railway Bridge with Rubber Bearings
Mesures sur des ponts ferroviaires métalliques avec appuis en caoutchouc
Vermessungen einer Stahleisenbahnbrücke mit Gummilagern

Kenichi YAGINUMA
Civil Engineer
East Japan Railway Company
Tokyo, Japan

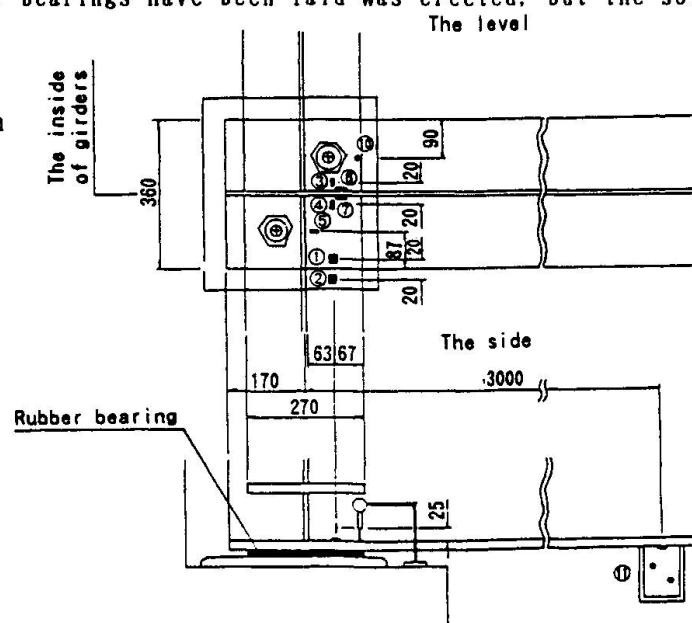
Figure 1 Measurement position (①-⑪ in figure corresponds to No. in Table 1)

We carried out a measurement at the support to Tokyo (the fixed side), of Minami-Senju Anti-Overflow Bridge (Overbridge) on Joban-Up Line described in Document [1], as a follow-up survey. This bridge is a deck plate girder, measuring 6m span length, for about 10 years in service. The rubber bearings have been laid was erected, but the sole plate is not set up especially. The measured position is shown in Figure 1 and the content of the measurement at each point of measurement is shown in Table 1.
