Strengthening of Reinforced Concrete Beams by External Reinforcement

Julio APPLETON
Professor
IST
Lisbon, Portugal

In order to correct some design shortcomings, the reinforced concrete structure of the Central Post Office of Lisbon was recently subject to an important strengthening intervention.

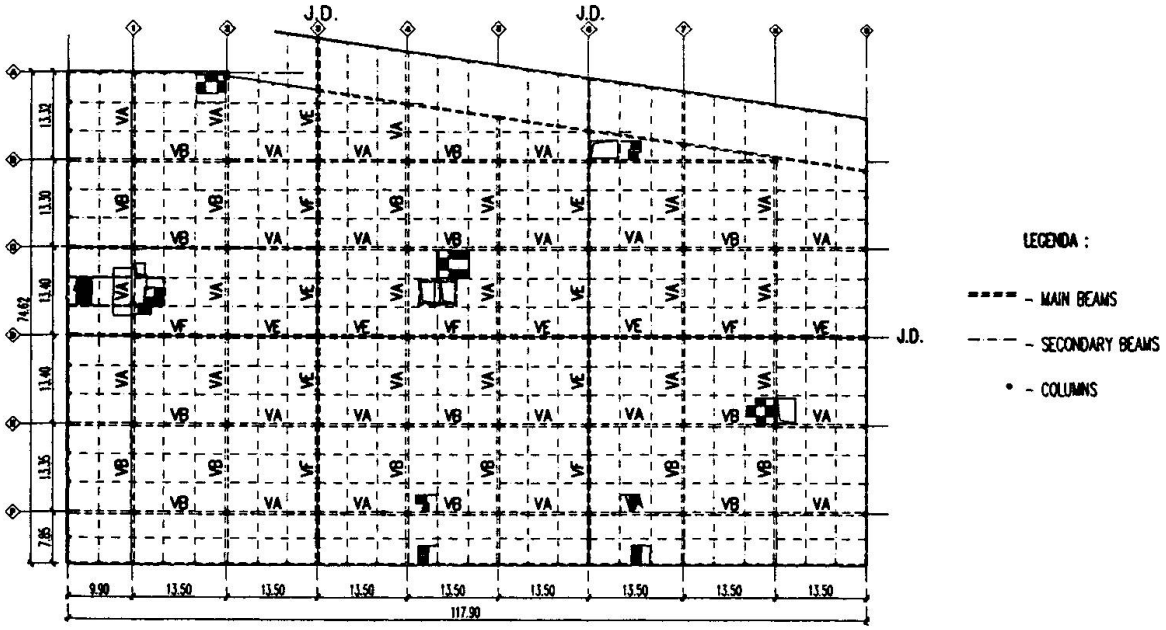
Fig. 1 - Floor level 2 - Structure

The building has two large reinforced concrete floors consisting of a slab 0.22 m thick, supported by a grid of beams spaced 4.5 m. The main beams with a 13.5 m span are supported by circular columns. The building is subdivided by expansion joints in substructures of 40.4 m x 36.0 m (Fig. 1).

Regarding the improvement of the live load capacity and the seismic resistance of each substructure, the central columns were strengthened by jacketing and the beams by the addition of an external reinforcement consisting of bonded steel plates.

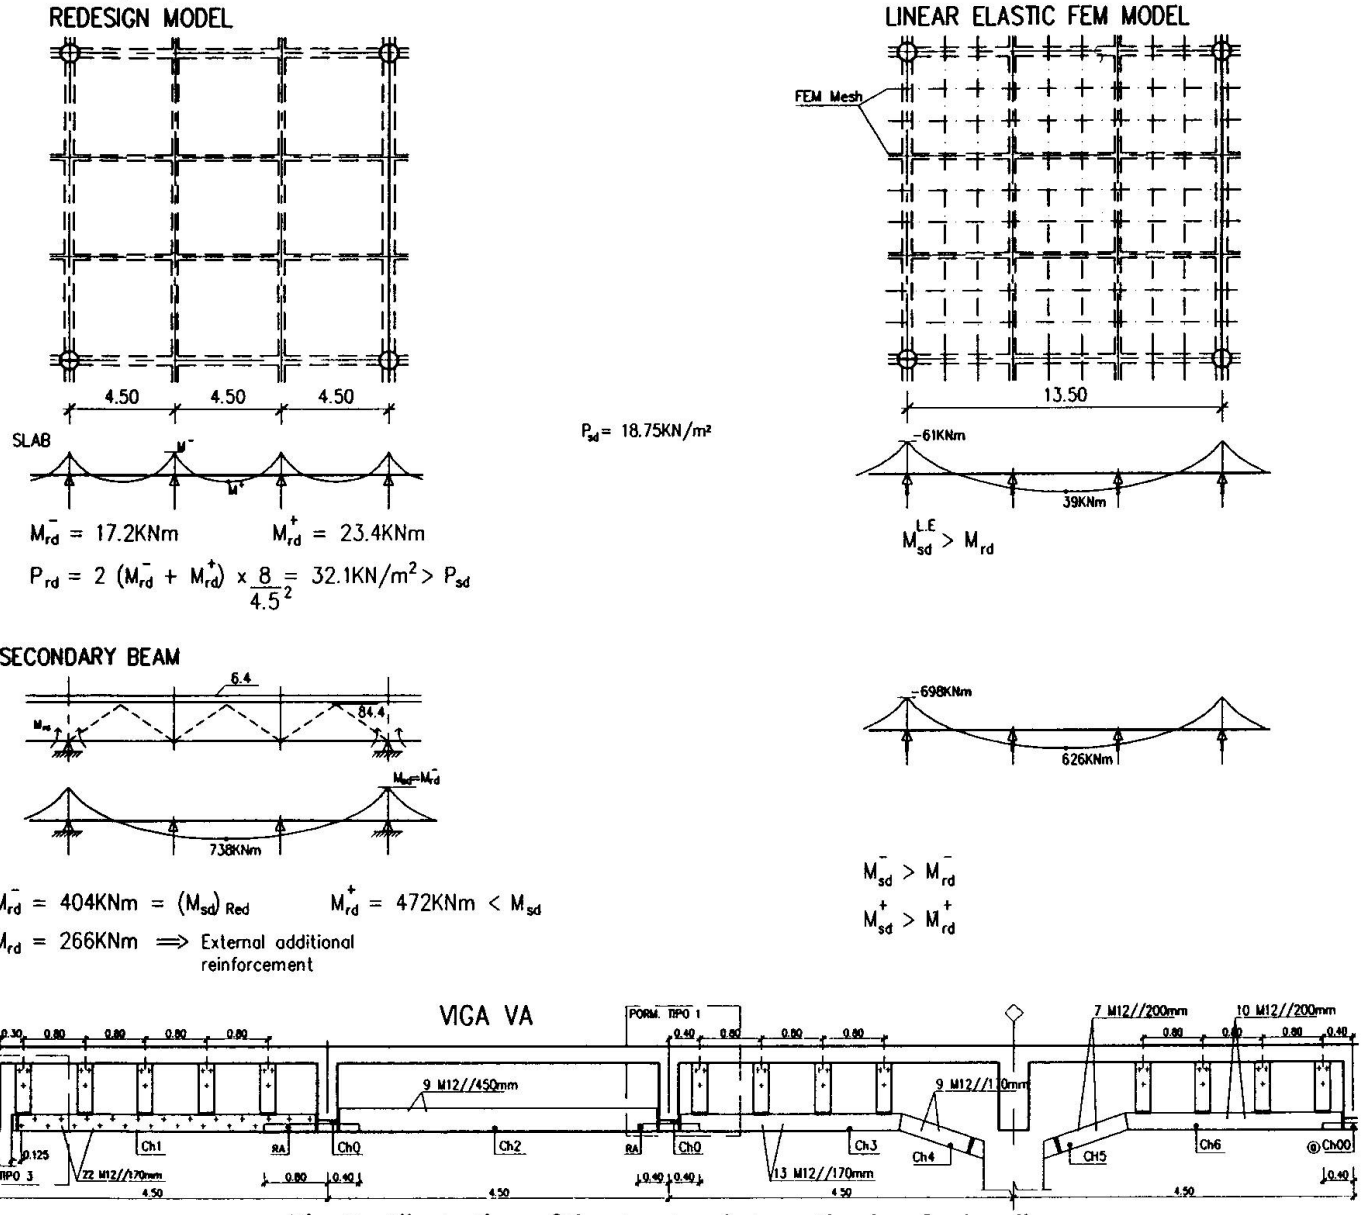
Fig. 2 - Illustration of the structural strengthening for bending

- The slab was assumed as a series of continuous panels 4.5 m x 4.5 m supported in the grid mesh. The bending moments obtained in this model, usual in building design, are much lower than those obtained in the FEM model where the global behaviour and different stiffness of the main and secondary beams is important. On the basis of this criteria and the acceptability of the structural model, no strengthening of the slab was required.

- For the main and secondary beams the slab load transfer was considered consistently with the slab model and to avoid the need to strength for the negative flexure resistance, redistribution was considered and the strengthening concentrated in the beam soffit.

Due to the concentration of the existing reinforcement in the beam soffit it was decided to locate the external steel in both sides of the web avoiding difficulties in the application of the mechanical bolts.

The strengthening was dimensioned by applying the monolitism coefficient technique, using the previous experience in designing and testing similar structures and the steel/resin/concrete connection.

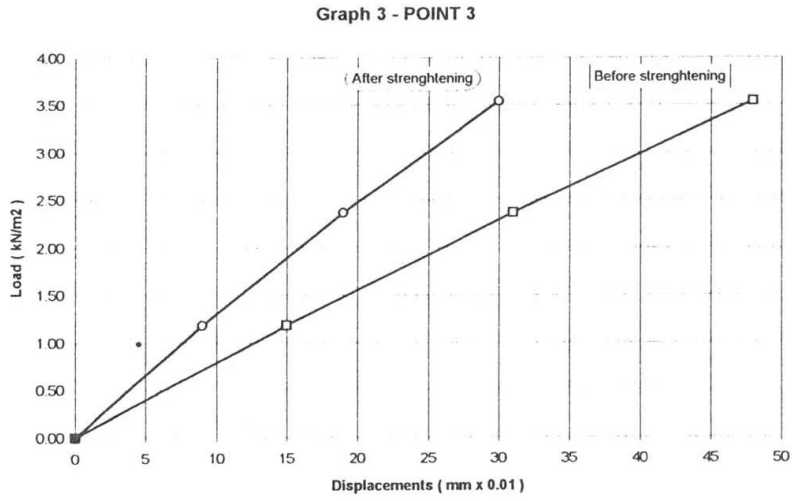
Fig. 5 - Load Test - Before and after strengthening

In order to assess the results of the strengthening work, two load tests were also carried out on the same panel of the concrete floor, before and after the strengthening. A load of 3.5 kN/m² was applied, first in a central panel of 4.5 x 4.5 m², then over one of the main concrete beams, in a 4.5 m strip over its whole length. A reduction of the beam deflections was recorded as shown in Fig. 5.
