Strengthening of an Unreinforced Masonry Building

Jon A. HEINTZ
Design Engineer
Degenkolb Engineers
San Francisco, CA, USA

Thomas D. WOSSER
Senior Principal
Degenkolb Engineers
San Francisco, CA, USA

50 Green Street is a historic brick building located in San Francisco's warehouse district. Originally built for warehouse and manufacturing use, the massive structure possessed many of the deficiencies common to unreinforced masonry construction. The strengthening scheme was sensitive to the architectural fabric of the building and included steel knee-braced frames, steel tension-rod roof diaphragm strengthening, and a pioneering effort incorporating the use of "CenterCore" reinforcement in the existing brick walls. The owner was actively involved in the process and his special concerns for cost, time, appearance, and tenant disruption were incorporated as the system evolved.

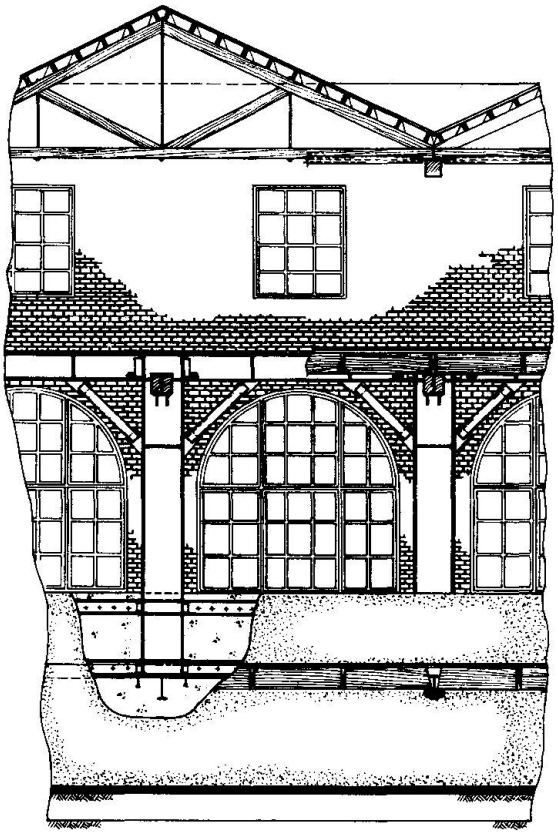
Fig. 2 Drawing of Knee-Braced Frame System

The massive nature of the construction at 50 Green Street, so strong for vertical loads, was actually contributing to the seismic deficiencies of the building. Code prescribed capacities for brick walls and wood diaphragms were not adequate for the seismic forces generated in the building. It was an interesting challenge to point out walls, 71 cm thick, and heavy timber framing to an owner who is very proud of his building, and attempt to explain just how "weak" they can be. In-plane wall strengthening was required in both directions, and diaphragm strengthening was required at all levels. The thick exterior walls satisfied UMB Ordinance slenderness requirements, but the thinner interior walls required out-of-plane stabilization.

A steel knee-braced frame was selected to supplement the longitudinal walls. A relative rigidity analysis was performed using the structural analysis program, RISA-2D, to verify that the knee-braced system would draw load from the existing brick walls. The resulting W36x150 column members are stiffness controlled. They are embedded in a concrete foundation wall that extends up to the sill of the arched windows, providing a fixed base and shortened effective story height. Centered on the arched piers, the new columns must support the existing floor girders that frame into the wall at the same location. The girders were shored, cut back from the wall to erect the columns, and then seated on a bracket welded to the column web.

The most critical connections occurred along the length of the drag strut which delivered load to the knee-braced frames located at one end of the building. The drag consists of a large tube section running along the wall just below the floor joists. At each pier the existing wood girders interrupted the continuity of the drag. Horizontal slots were drilled though the girders to allow splice plates to pass through and weld to the tube on either side. The drag strut also served as a horizontal strong-back, anchoring the walls to the heavy floor girders for out-of-plane loads. Diaphragm to wall connections were made using threaded epoxy anchors, installed after the drag strut was in place. The anchors were drilled to within 5 cm of the exterior surface of the wall, and were responsible for both in-plane shear transfer and out-of-plane wall anchorage.
