X-Ray Diffraction Measurement of Stresses in Post-Tensioning Tendons

Michael G. CARFAGNO
Structural Engineer
Port Authority of NY & NJ
New York, NY, USA

Michael E. BRAUSS
R & D Manager
Proto Manufacturing Ltd
Oldcastle, ON, Canada

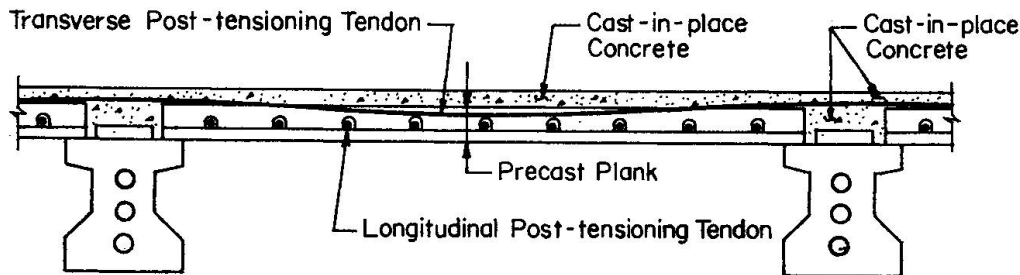
Figure 1:   Typical transverse deck cross section

The deck slab transverse post-tensioning consists of parabolically draped bundles of 6.35 millimeter (1/4 inch) diameter high strength (f_{pu} = 1,655 MPa = 240 ksi) wires conforming to the BBRV post-tensioning system (Figure 1). The number of 6.35 millimeter (1/4 inch) diameter wires in each tendon varies from 20 to 32 with the spacing of tendons at either 0.75 meter (2'-6") or 1.5 meter (5'-0") intervals, with both parameters, depending on its location, e.g. runway, taxiway or field area. The tendons were initially stressed to $0.7f_{pu}$=1,067 MPa (168 ksi). Depending on the location along the tendon, the theoretical effective stress (after all losses) was initially estimated to range from 986 MPa (143.0 ksi) to 703 MPa (102.0 ksi). After stressing the tendons were grouted.

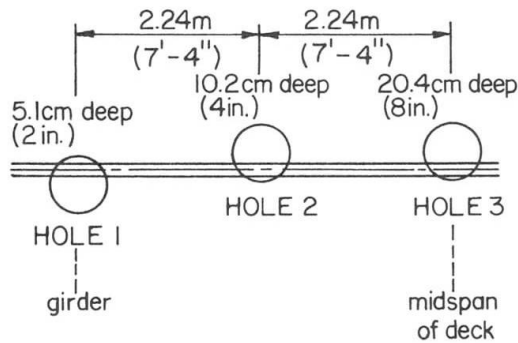
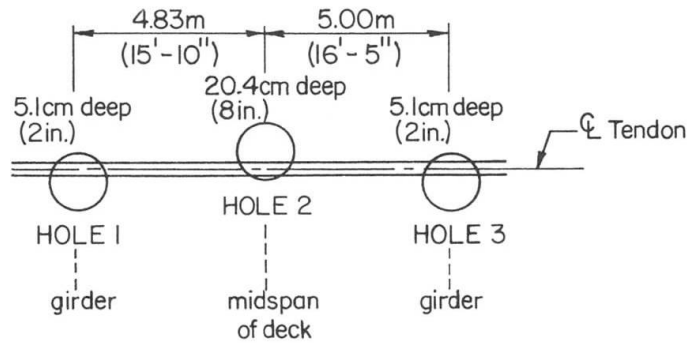
Site 1 - Adjacent to Taxiway R   Site 2 - Adjacent to Taxiway P

Port Authority personnel core drilled 20.3 centimeter (8 inch) diameter access holes in the runway deck concrete to intersect the transverse (parabolic) tendons (Figure 2) such that it formed a "chord" approximately 4 to 5 centimeters (1.5 to 2 inches) (radial) into the core. Concrete removal was accomplished using a small pneumatic jack hammer just to expose the tendon conduit. The depth of the individual holes ranged from 10 to 25 centimeters (4" to 10") (Figure 2) due to the vertical parabolic drape (Figure 1) of the post-tensioning tendon. Then the conduit (galvanized flexible metal pipe, 0.25 mm =0.01" thick) was peeled back to expose the grouted bundle of 6.35 millimeter (1/4 inch) diameter post-tensioning wires. The grout surrounding the wires was carefully removed by hand with a small chisel. Water and debris were removed from the access hole via compressed air. Surface preparation was not applied to the wire surfaces to be measured.

Figure 2:   Access hole locations and depths,

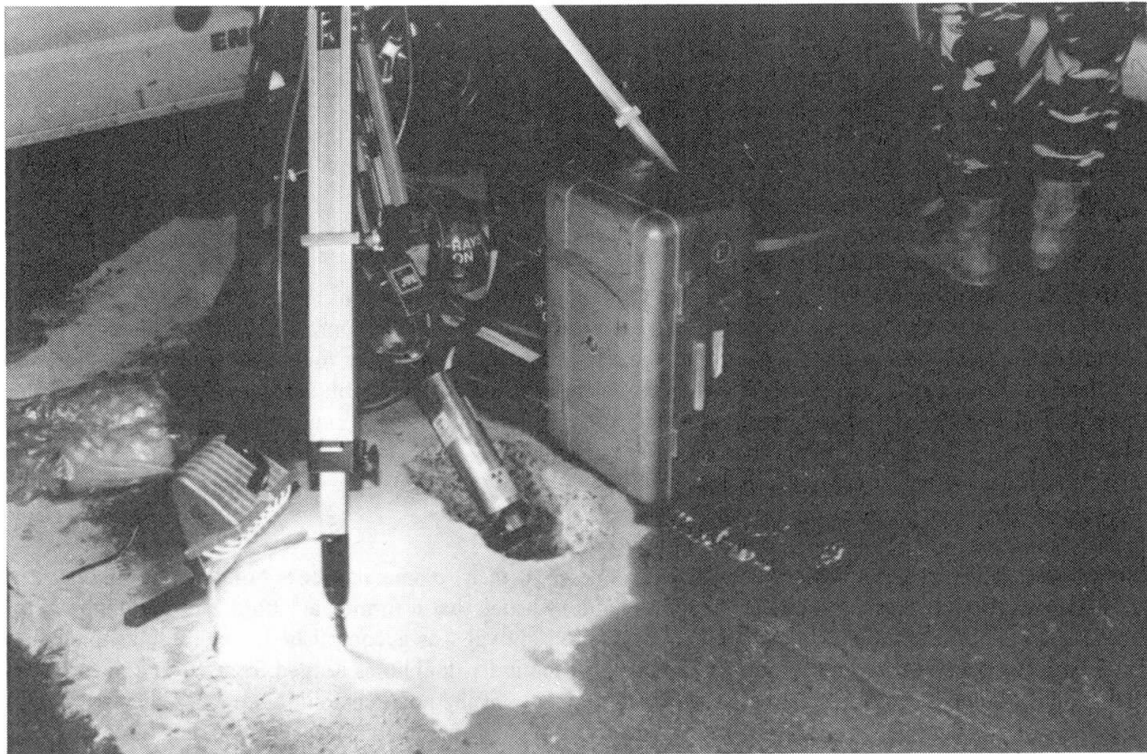
Figure 3:   X-Ray stress measurements being performed adjacent to Taxiway R at La Guardia Airport, New York City. The modular instrument fits inside a van and was powered by a portable generator.
