Load Testing of Chicago's 100-Year-Old Mass Transit Structures

Richard A. WALTHER
Senior Structural Engineer
Wiss, Janney, Elstner Assoc. Inc.
Northbrook, IL, USA

Michael J. KOOB
Consultant
Wiss, Janney, Elstner Assoc. Inc.
Northbrook, IL, USA

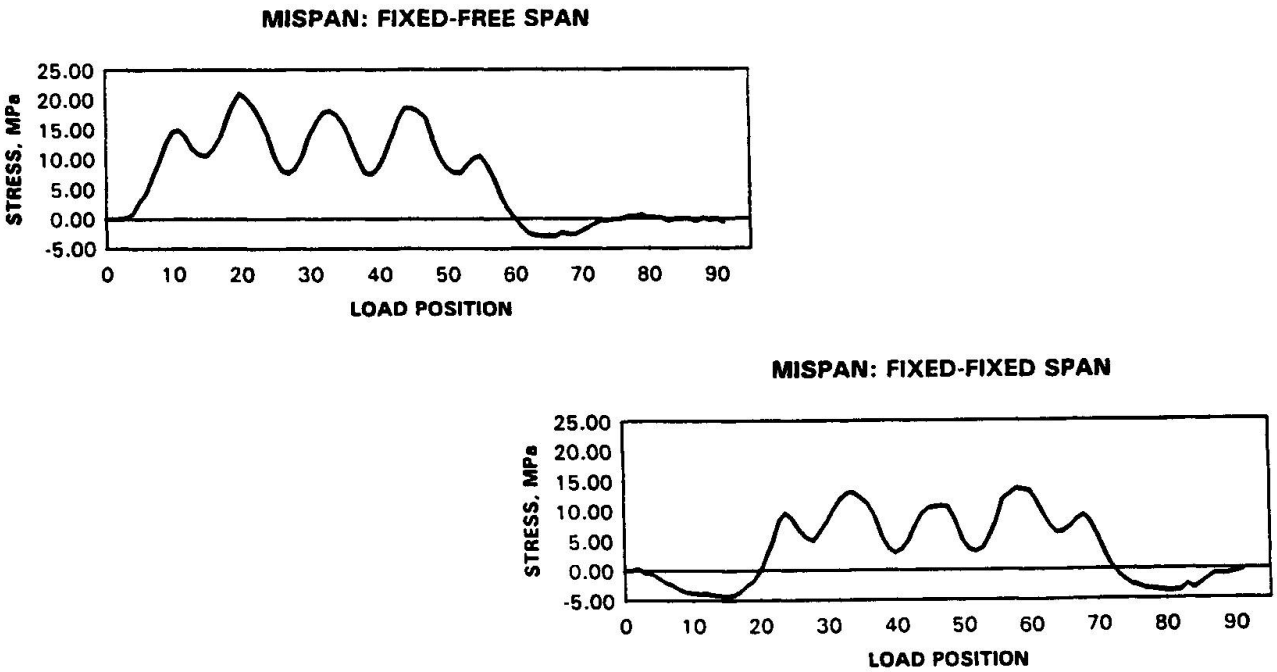
Strains due to the control loading were plotted with respect to load position to develop influence lines for all gages at each test location. The ordinate and abscissa correspond to the calculated stress and load position of the train, respectively. Positive stress represents tension and negative stress represents compression. In general, data show five distinct humps as shown in Figure 2 for the two midspan locations at test location 0116. The first hump is the first truck (2 axles) of the leading car. The middle three humps represent pairs of trucks (4 axles) at the coupler connection between cars. The last hump is the rear truck (2 axles) of the last car. The middle humps show a larger magnitude because they represent the loading of four axles rather than two axles. Data plotted for other gaged locations and included in Reference [2] were similar to that shown in Figure 2.

Midspan deflections were corrected for support displacements and plotted with respect to load position for all test locations [2]. Maximum deflections did not exceed 4 mm. Both the deflection and stress plots indicate significant continuity at stringer end to cross-girder connections. The deflection plots show upward displacements of 1.8 mm when the train is positioned in an adjacent span. In general, upward deflections did not occur across expansion joints. Similarly, negative bottom chord plots in Figure 2 indicate continuity across stringer to cross-girder connections.

Figure 2 - Midspan stress response for midspan gages at Test Location 0116

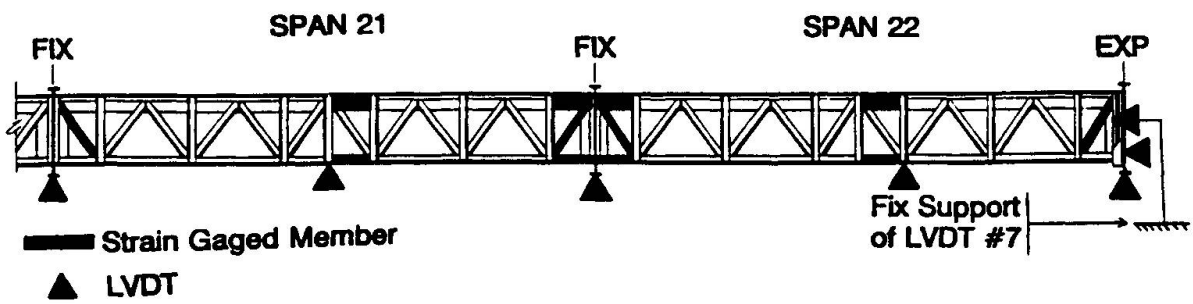
The overall structure is comprised of multiple spans each having an average length of 15.2 m, with expansion joints located every third span. Each track is supported by two, open web truss stringers as shown in Figure 1. The stringer top chord is a built-up member consisting of two angles and a vertical plate. The stringer bottom chord and web members consist of double angles. Each stringer pair is braced laterally using angles in the plane of the top chord and diagonal cross bracing at stringer midspan and end supports. Stringers frame into riveted built-up cross-girders which span between riveted built-up columns. Riveted full-depth web angles are used to complete the stringer to cross-girder attachment. At expansion joints, the stringer is supported by a seated bearing connection.

Figure 1 - Typical Loop structure and instrumentation plan
