Innovative Method for Repairing Masonry Buildings

Investigation and Repair of Old Culturally Valuable Concrete Structures

Repairs of Vertically Deflected Buildings

Damages and Rehabilitation of the Orthodox Cathedral in Belgrade

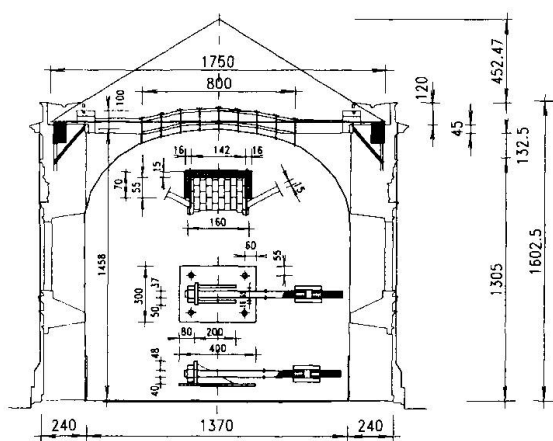
Fig. 1 Additional ties in arches including specific details

After detailed inspection, the conclusion has been made that the basic cause of structural
damages is the loosening of steel ties of the lateral brick arches in the ceiling, because they
have been partially pulled out due to loosening of their anchorages in longitudinal walls.

It has been decided to make "Π" - shaped strengthenings of recycled brick concrete which will be so modelled as to achieve the composite with the properties which will, to a suitable extent, be compatible with the properties of the materials within the existing arches.

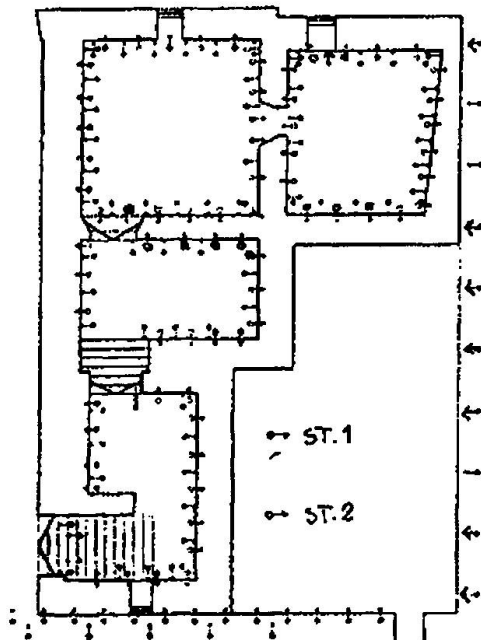
Fig.1 The consolidation of the foundation in two stages

As time went on, the building underwent structural defects whose repair was much delayed. Fissures and cracks appeared in the basement, ground and upper floor walls, in the cylindrical vault of the floor over the ground-floor and the entrance vault.

The consolidation of the foundation ground was carried out by injections of cement suspension, made in tow stages. (Fig. 1)

In the first stage – the precints were injected to insulated the area and to prevent potential leakage leading to fracture pressure in the second stage.

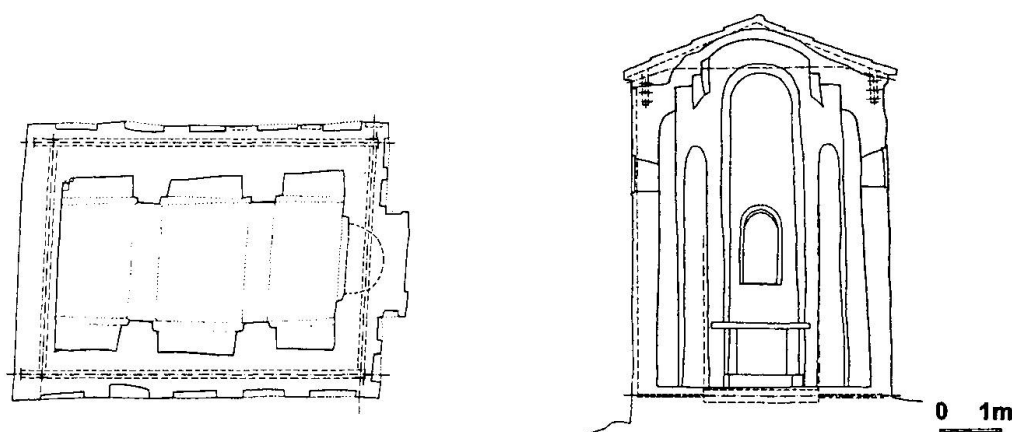
Fig. 1 Strengthening of the church of St. Mihajlo: plan (left) and section (right)

The small church, built of rough stone in lime mortar, using primitive building methods in the 10[th] century, proved its structural strength by resisting weathering, remodelling and strong earthquakes in the region for a millennium. Even a series of earthquakes in 1996, which caused serious damage to the ancient town of Ston (a small town north to Dubrovnik), provoked but a scant damage to the church of St. Mihajlo, situated on the top of a nearby hill - in spite of its poor condition even before the earthquakes. Therefore, we decided to strengthen it with a minimal possible intervention, in order to prevent further deterioration.
