Artikel: Damages and rehabilitation of the orthodox cathedral in Belgrade
Autor: Pakvor, Aleskandar / Muravljov, Mihailo
DOI: https://doi.org/10.5169/seals-58252

Damages and Rehabilitation of the Orthodox Cathedral in Belgrade

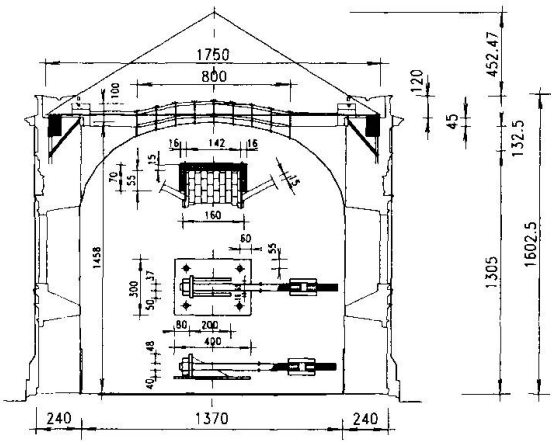
After detailed inspection, the conclusion has been made that the basic cause of structural damages is the loosening of steel ties of the lateral brick arches in the ceiling, because they have been partially pulled out due to loosening of their anchorages in longitudinal walls.

The Figure 1 shows the vertical section of an arch whereat the height position of additional ties, as well as several specific details.

Fig. 1 Additional ties in arches including specific details

The solution for rehabilitation included the following: (a) building in a pair of prestressed steel ties ϕ 36mm on every arch whereby the forces of approximately 200 kN would be inserted into the structure; (b) production of concrete anchor blocks for the new ties; (c)

making the strengthening on extradoses in the arch vertexes zones in the shape of "П" elements bonded with the existing arches.

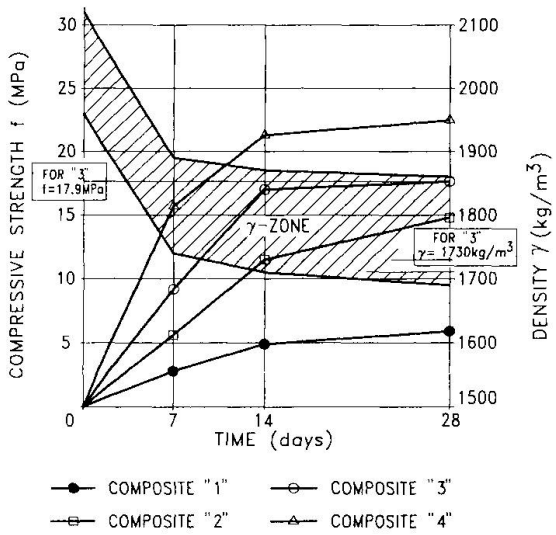
Fig. 2 Bulk densities and compressive strengths of all composites

The presentation of bulk densities and of compressive strengths of all investigated composites - concretes - at the ages of 7, 14 and 28 days is given in Figure 2. As it is obvious, the optimum meeting of the set conditions is achieved by the mixture - composite marked by number 3.
