BEHAVIOUR OF AN ASEISMIC STRUCTURE  
DURING CAUCETE EARTHQUAKE  
OF NOVEMBER 23, 1977

SILVESTRO BRUSCHI

TECHINT Engineering Company

S U M M A R Y

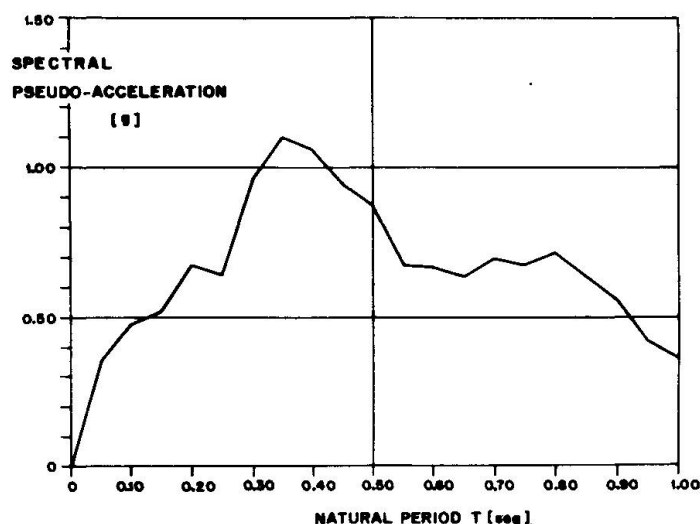
Fig. 3 - Pseudo-accelerations spectrum of Caucete 23.11.77 earthquake

To investigate this behaviour we used the spectrum shown on fig. 3, which was obtained from the spectrum calculated by IDIA, by multiplying its ordinates by the ratio between the records of two seismoscopes, one located in Caucete town, about 200 m distant from the structure, and the other beside the IDIA accelerograph in the city of San Juan,

$$\frac{R_{\text{seism. Caucete}}}{R_{\text{seism. San Juan}}} = \frac{0.52}{0.26} = 2$$

These spectra are calculated for a damping ratio of 5% of critical damping. This figure is assumed to occur in reinforced concrete structures reaching yield, according to records from San Fernando earthquake of 1971.
