Zeitschrift: IABSE reports = Rapports AIPC = IVBH Berichte
Band: 59 (1990)

Artikel: Fatigue crack detection and repair of steel bridge structures
Autor: Fisher, John W. / Menzemer, Craig C. / Yen, Ben T.
DOI: <https://doi.org/10.5169/seals-45726>

Fatigue Crack Detection and Repair of Steel Bridge Structures

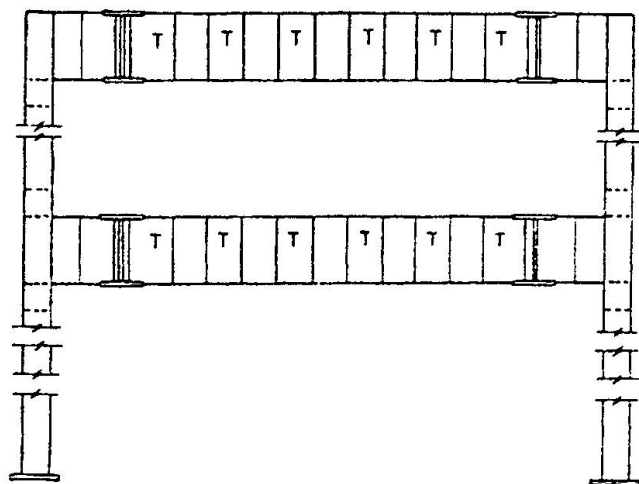
Fig. 2 Typical Bent Elevation

The Central Artery carries traffic through Boston, Massachusetts and surrounding communities. A viaduct structure, located in the Artery's northern area, consists of bilevel rigid steel frame bents which support a two girder floor-beam stringer system on each level. Columns of the rigid bents have box section while transverse beams have either box or I sections (Fig. 2). I-beam

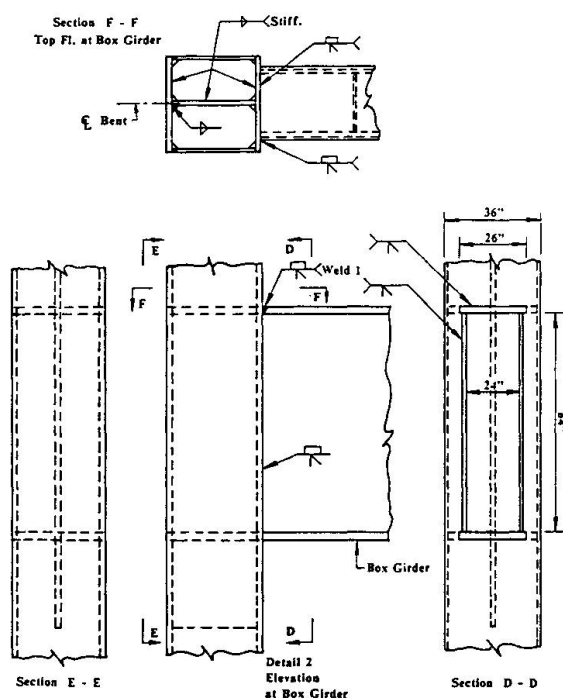
Fig. 4 Representative Box Beam to Column Connection

to column connections contain closure plates fillet welded to the edges of the I section and column flanges (Fig. 3). Webs of the I beams are groove welded to the columns while beam flanges (both box and I) and box beam webs of the lower portion of the bents are connected via full penetration groove welds with back-up bars (Fig. 4).

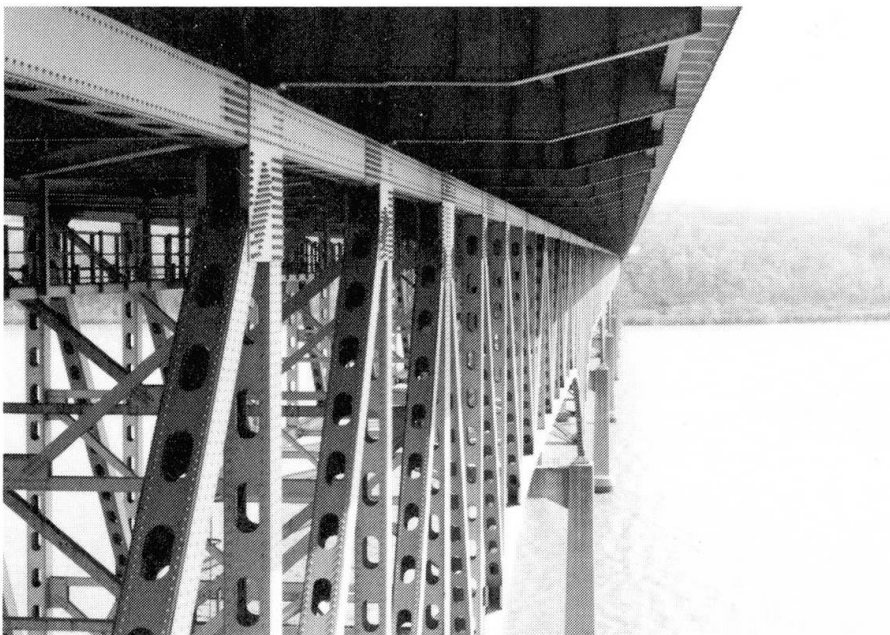
Fig. 12 Truss System of the Susquehanna River Bridge

I-95 crosses the Susquehanna River in Maryland. The structure is a multiple span deck truss bridge whose members are either built-up riveted construction or rolled structural shapes. Transverse floorbeams and longitudinal stringers of the floor system are composite with the reinforced concrete deck. All of the floorbeams are supported by the top chord of the main deck trusses (Fig. 12). Suspended truss spans contain pin and hanger assemblies which consist of riveted box sections [2].
