Repair and Consolidation of the Masonry Structure of a Building

Sevastean Ioan IANCA

The paper presents a study of a case about the damages caused by the 1977 earthquake to the structure of a building in Craiova, Romania, as well as repairing and consolidation solutions for this structure. The proposed solutions intend to restore the initial bearing capacity of the structure and its safety.

One of these old buildings, damaged during the earthquake from March 4, 1977 with the epicentre in Vrancea - Romania, is the building of the Faculty of Agronomy from Craiova - Romania.

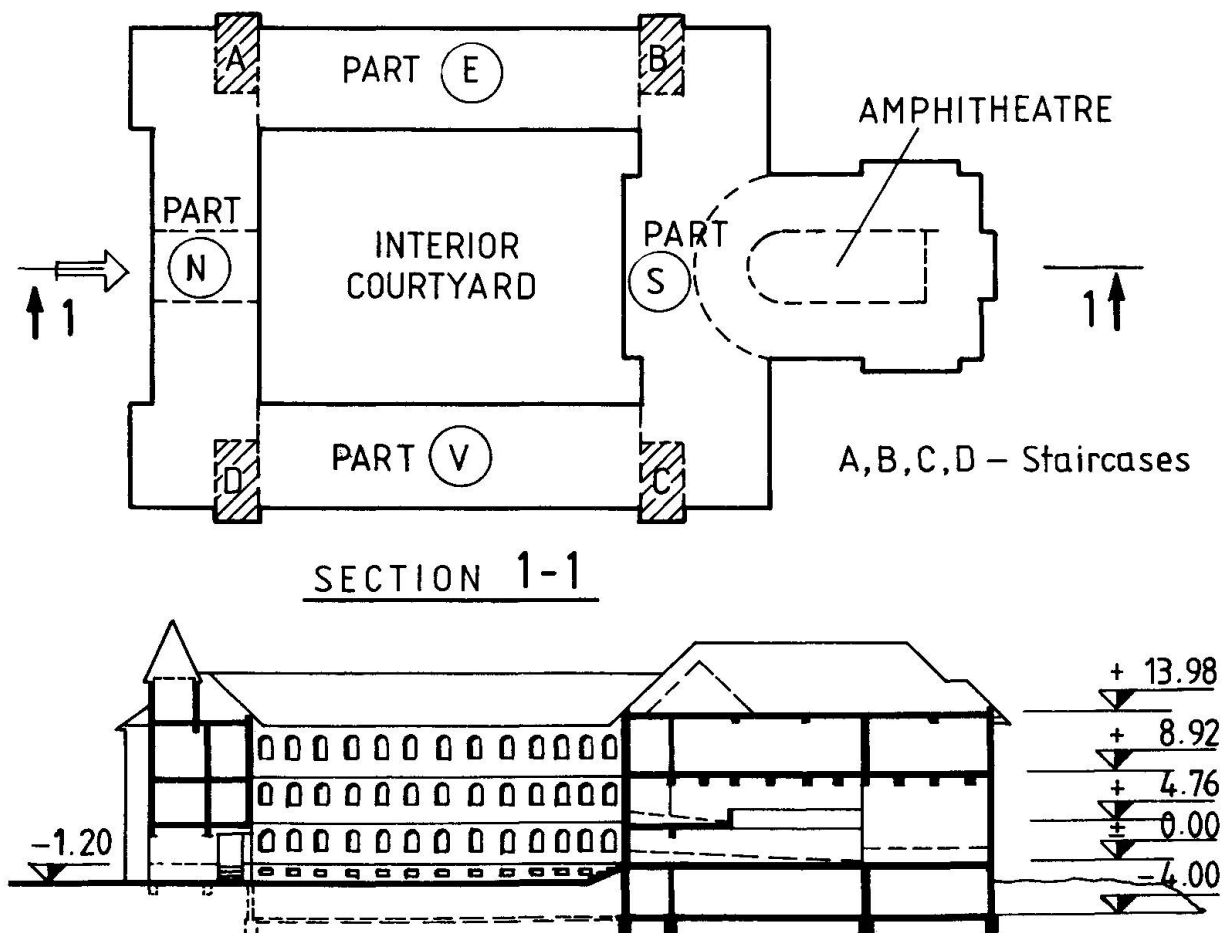
Fig. 1 The geometrical characteristics of the building

Having a quadrilateral principal plane form, with an interior courtyard, and with an amphitheatre in the South part (see Figure 1), the building is developed on three levels (ground floor and two storeys) in the North part and four levels (basement, ground floor and two storeys) in the South, East and West parts.
