Session C3: General repair of buildings

General Repair of Buildings Aspects généraux de la réparation des bâtiments Allgemeine Fragen der Instandsetzung im Hochbau

Extending the Lifespan of the Architectural Heritage

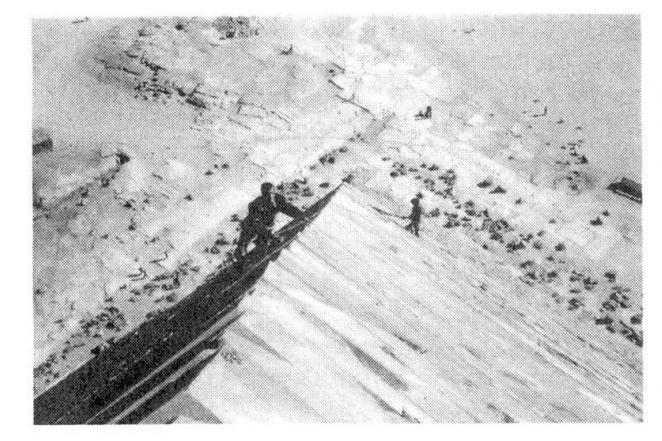
On 17 November 1994, a scientific mission made an ascent of Chephren's Pyramid (Figure 1) to evaluate the role of temperature and wind in the decay of the stone and to assess the stability of some blocks that have been shifted by earthquakes in the past (Figure 2). On the one hand the survey contributed new and important elements for deeper understanding of the construction of the pyramid and, on the other, showed that, apart from the problem of weathering, no radical structural interventions were necessary, it being sufficient to add some supports in the same limestone to ensure the stability of blocks at risk.

Fig. 1: The ascent of Chephren's Pyramid

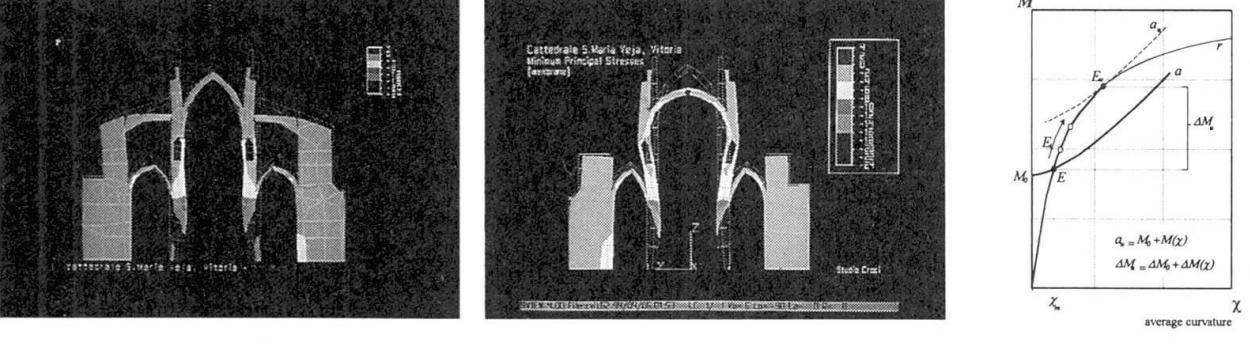
A general elastic finite element model was used to clarify first the scarce spatial cooperation in this kind of structures and, subsequently, the influence of the sequence of construction on the resulting stresses and deformations (Figures 5 and 6): the results obtained were found to correspond well with the actual state of the building (Figure 3). However, it was also necessary to carry out a non-linear analysis, taking into account the influence of the weakest zones, such as the triforium, and reductions in the resistant sections of the columns in order to define present safety levels in terms of ductility. The diagram in Figure 7 shows the equilibrium conditions in the middle section of the column, where the line "r" represents the resistant moment-curvature relationship and the line "a" is the external moment, taking account of the second order effects; the point "E" represents the equilibrium situation and the related curvature X is very close to the actual curvature measured. AMµ indicates the moment increment necessary to reach collapse, thus giving a very low real safety margin, especially taking into account possible errors in the evaluation of the limit deformations.

Fig. 5: Stresses and deformations where the buttresses were built before the vault

Fig. 6: Stresses and deformations where the buttresses were built after the central vault

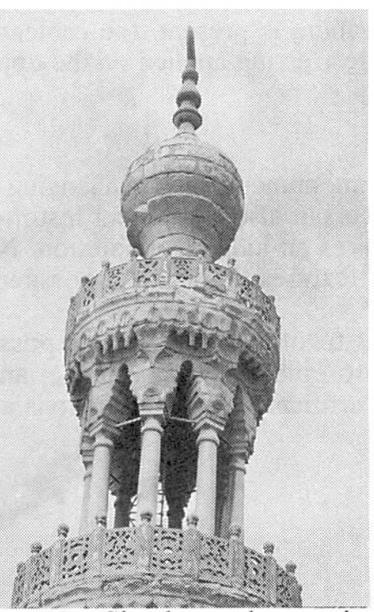
monuments. Earthquakes are the most prevalent phenomena for which preventive measures can substantially reduce damage and avoid collapses. The damage to monuments in Cairo caused by the earthquake of 12 October '92 offers an interesting example. Many minarets collapsed not only because the masonry was of poor quality but also on account of the intrinsic weakness of the structural behaviour, especially in the upper parts where slender columns cannot withstand both flexural and twisting actions 13 14). (Figures and The connection between the minaret and the main part of the mosque is another weak zone, as is shown both by mathematical

Fig. 13: Slender columns in some minarets

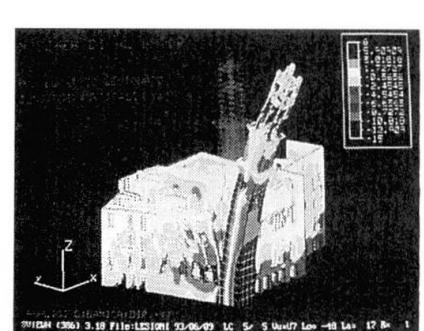
Fig. 15: Concentration of stresses and deformations revealed in a mathematic model

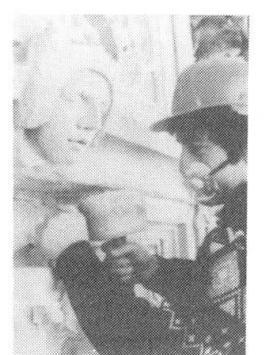
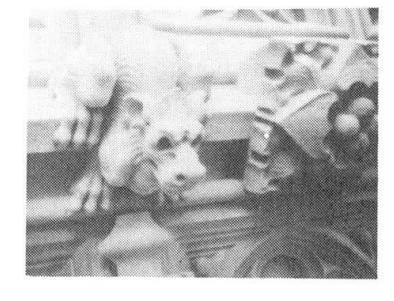
5.1 After cleaning, each area was reinspected and a detailed schedule of repairs was prepared. Defects included sulphate attack, stone spalling. clay beds and faults within the stone, missing pieces and water traps. The aim was to retain as much of the original stonework as possible, accepting weathered profiles. Repairs were undertaken where failure was likely during the 40 year maintenance cycle, to prevent water traps, to reduce the rate of decay and to reinstate important architectural details.

Fig.3 New Carvings

5.2 The stone repairs ranged from repointing, to dressing out water traps, repairing with stone dust mortar, piecing in small areas, the renewal of ashlar blocks and the replacement of elaborate carvings. For the Victoria Tower, which was by far the largest phase and included particularly rich ornamentation, a stone carving workshop was established on site staffed by masons and stone carvers who were able to recreate accurately the decayed decorative carvings, heraldic devices, statues and building details which it was necessary to cut out and replace.

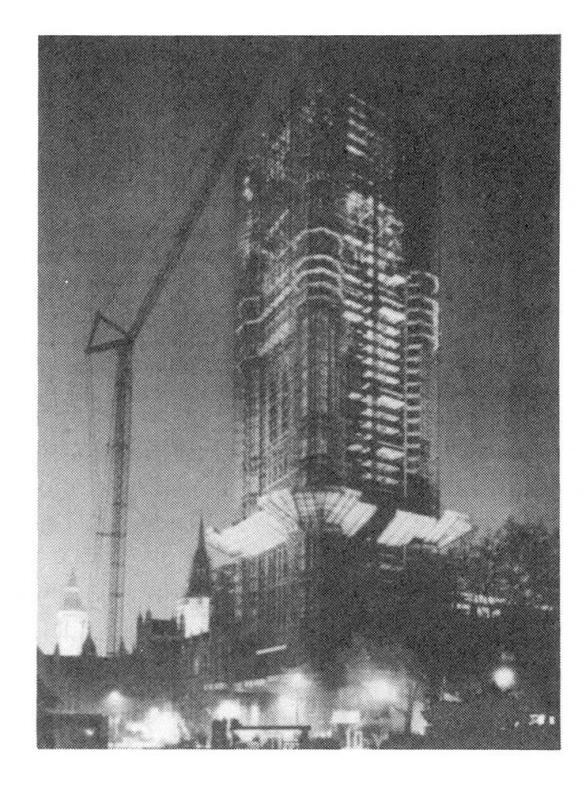
6.1.1 The access scaffolding for the 119m high Victoria Tower, which weighed 1000T and used 110km of scaffold tube, was founded on bored piles and supported over the adjacent roofs of the Palace on Bailey bridge towers and trusses. In view of the prominence and importance of the site, it was designed to the wind loading and other standards of a permanent structure. At upper levels the scaffold was tied back into the masonry using stainless steel drill anchors which were later made good with stone plugs and the positions were recorded for future use.

Fig.4 Victoria Tower Scaffold

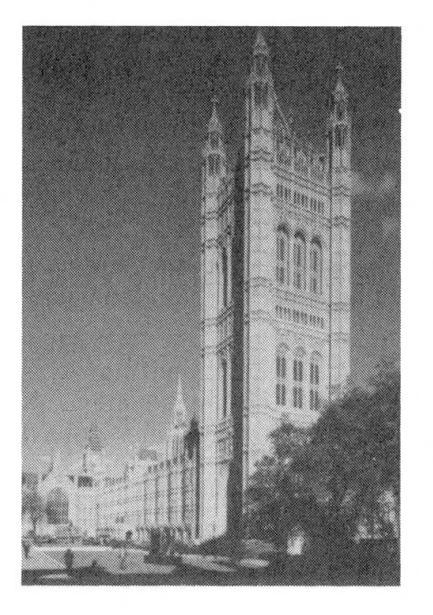
6.2.1 The Victoria Tower is roofed with large cast iron tiles on a trussed framework of cast and wrought iron. This is surmounted by a 28m high flag mast supported by ornate ironwork. Originally the tiles had a zinc anti-corrosion treatment which had failed very quickly in the acid Victorian city air and had been overcoated with a patent treatment. Research showed that many layers of lead based paint had also been applied over the years.

Fig.5 Restoration Complete

6.2.2 The aim was to put the roof in repair and provide a protective treatment which would last some 40 years. The accumulated layers of dirt and paint were removed back to bare metal by air abrasive blasting. Lead precautions included a full working enclosure, protective suits with air supply, air sampling outside the enclosure, disposal of the spent grit and dirt under controlled conditions and a decontamination unit for workmen. Broken cast iron tiles and jointing rolls were repaired by stitching, cold cast welding and off-site welding in an oven with controlled heating and cooling. Some new iron tiles, rolls and missing decorative features were cast, and after reassembly the roof surface was shot blasted and hot zinc sprayed. Pitting in the metal surface was stopped with an epoxy filler, followed by a sealing coat and finally a colour finish of vinyl co-polymer paint.

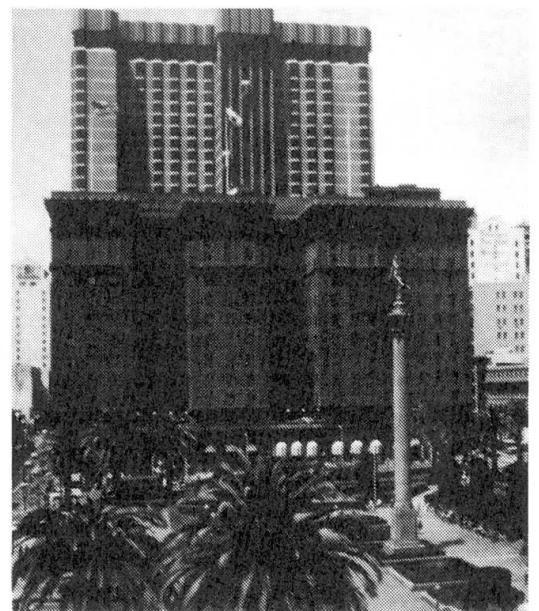
The St. Francis Hotel, shown in Figure 1, is a thirteen-story steel framed structure with brick infill and sandstone cladding on the street facades, and brick walls on the west facade. The typical sandstone walls have 30 cm courses with alternate courses projected out 2.5 cm (projecting course). The building was constructed in three stages: 1904, 1907, and 1913. The original drawings of the building were not available.

Figure 1 - St. Francis Hotel

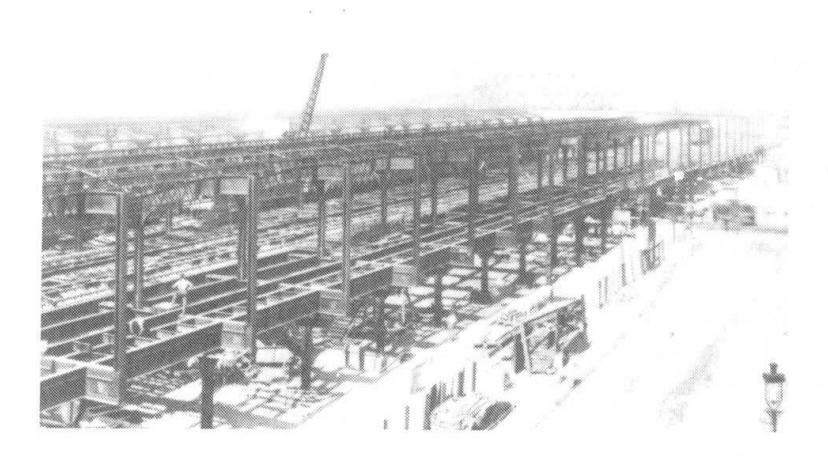
Street level corrosion damage was also a problem. In each street viaduct, salt water splashing on the exposed steel columns gradually reduced their cross-sections at the ground line. Moreover, water flowing through track level breaches oftentimes collected at interior column bases, sometimes causing rust holes.

Fig. 1 C&NW Trainshed looking along the east side (circa 1910)

To address the steel damage from corrosion, an extensive steel repair program was planned and later refined as the project progressed. As discussed in the next section, several factors guided the decision on where to call for repairs.

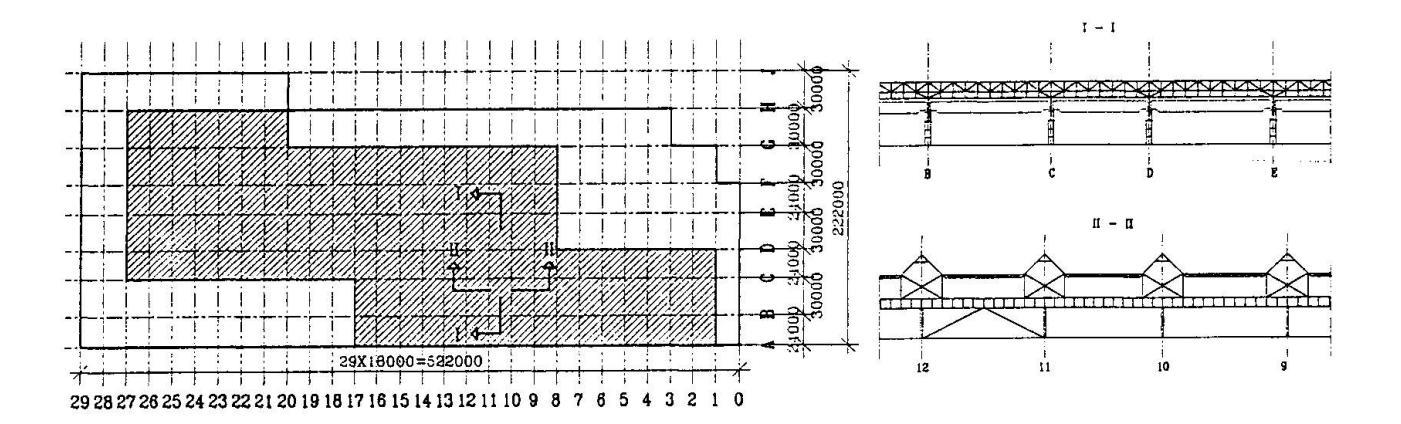
The plan view and the sections of the industrial building (first stage is shaded part of plan drawing), having unite total useful area of 104.241 sq.m and structural steelwork of total weight 17.000 t, is given in Fig. 1.

Fig. 1 Plan view and sections of the industrial building

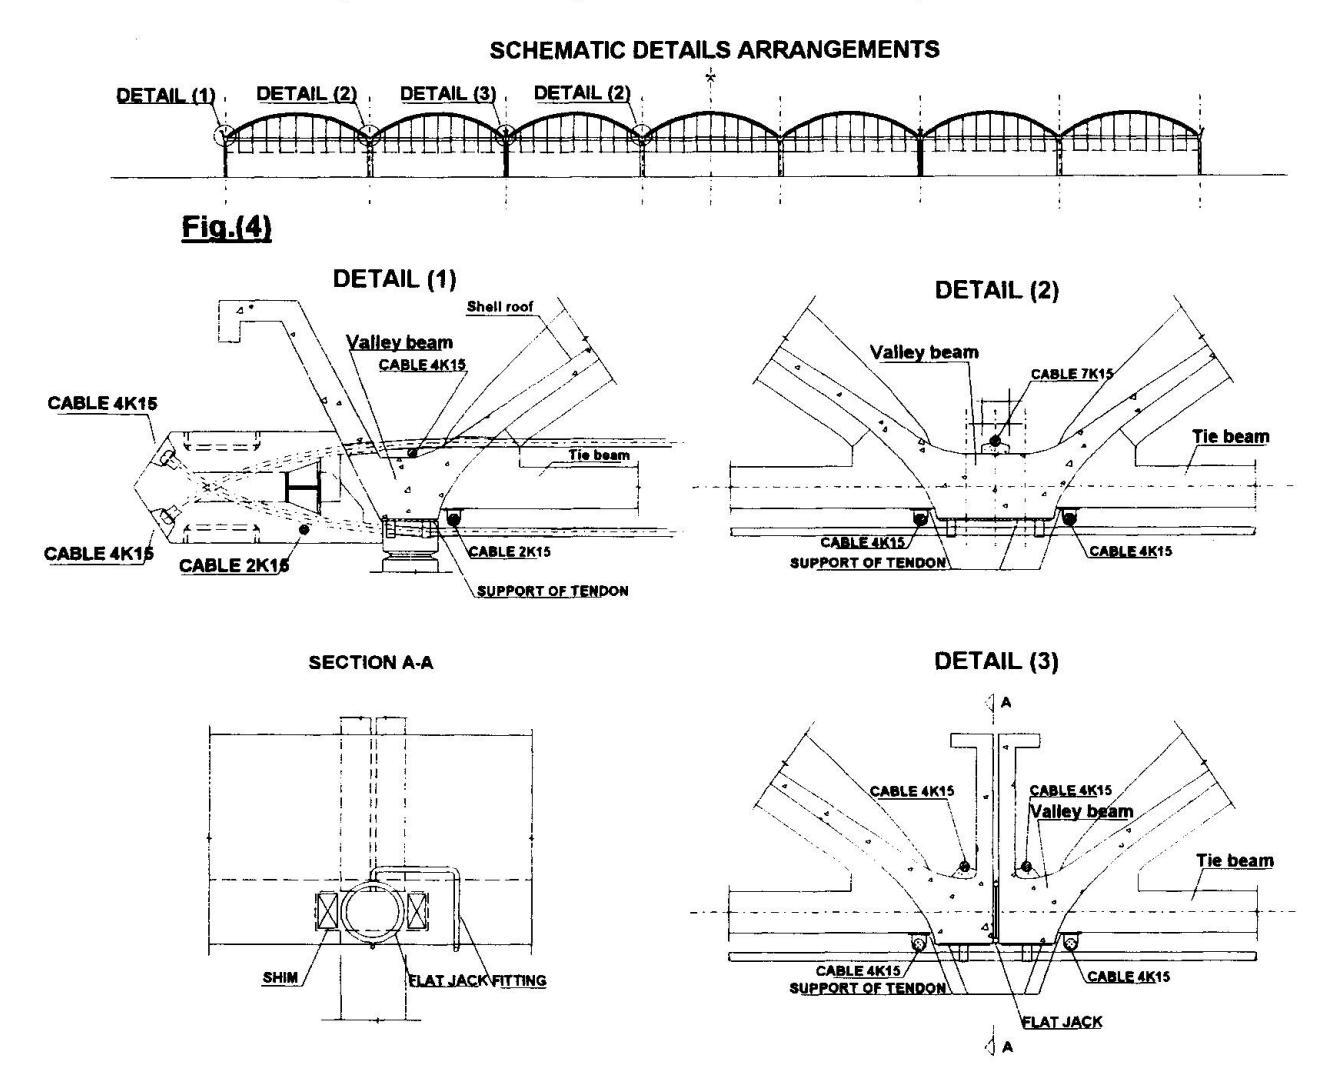
The isolated layers and the expansion joints filler were damaged causing leakage of rain water. Inspection of the roof showed presence of cracks, damage in concrete parts of the shell and corrosion of reinforcing bars and prestressing cables. Two tie beams were seriously damaged.

All the isolated layers over the valley beams were renewed to protect the shell roof .

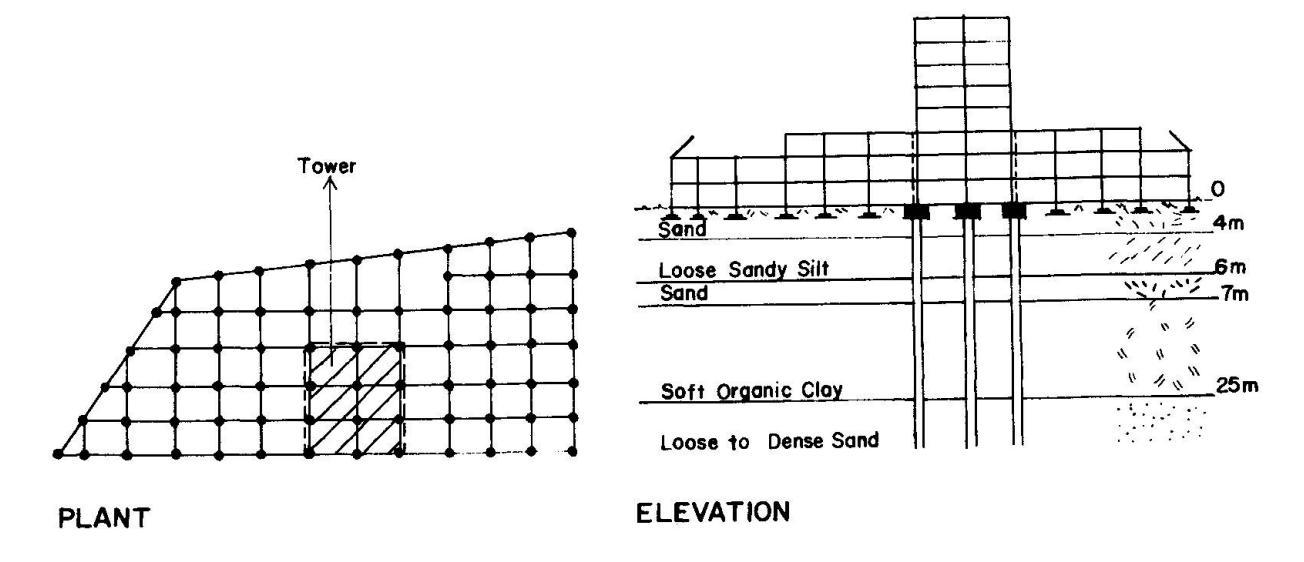
Fig. 1 Lay-out of the structure and foundation conditions

One building that is a medical center in Recife, Brazil, started having cracks due to foundation settlement soon after the end of its construction. It was a reinforced concrete structure with two types of foundation. The central block is an eight floors tower having deep foundation of steel piles near 40 m long. The outter block has three floors in spread foundation at the depth of 0.85 m with columns spaced 6m per 5m and takes 90 % of the ground area. The blocks are separated by a joint but the beams of the lower block were set on consols at the columns of the tower. Figure 1 shows the general lay-out.
