Strengthening beams in the shear zone

Strengthening Beams in the Shear Zone

Anna KOSINSKA
Dr. Engineer
Technical University of Lodz
Lodz, Poland

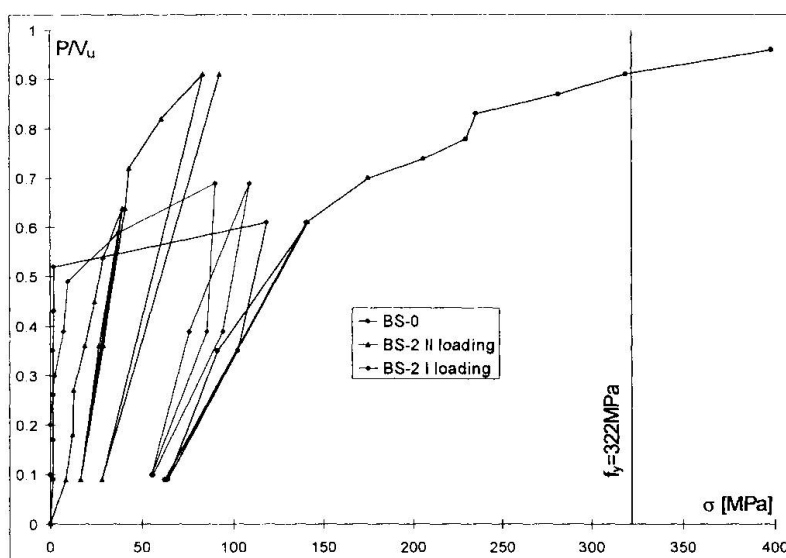
Fig. 3. Stresses in stirrups

Two beams ($b=0.20\text{m}$, $h=0.30\text{m}$) were made as underreinforced in the shear zone. The control beam BS-0 was not repaired and the beam BS-2 was first preloaded to about 65% of its ultimate load and precracked. Next it was strengthened by steel plates $5\times 40\text{mm}$, bonded and anchored to side faces in the support region using epoxy resins. Both beams failed as the result of diagonal tension cracking in the shear span regions. The effectiveness of the strengthening was 19 percent. The strengthened beam BS-2 failed prematurely by tearing off the concrete and plates before yielding of the external reinforcement. The stresses in the steel plates at failure were only $0.19f_y$. Their full ultimate capacity was not developed. But the stirrups were significantly unloaded (about 70%) by the external reinforcement comparing with the control beam, short before failure - see fig 3. It appeared to be important problem how to design the strengthening to avoid the premature failure of the beam. The strength of repaired concrete should be high enough and the maximum shear and peeling stresses at the interface should not exceed the limiting values at which tearing of the concrete takes place.
